## RAILWAY OCCURRENCE REPORT

**05-112**      hi-rail vehicle passenger express Train 200, track occupancy  
incident, near Taumarunui

**7 March 2005**

**TRANSPORT ACCIDENT INVESTIGATION COMMISSION  
NEW ZEALAND**

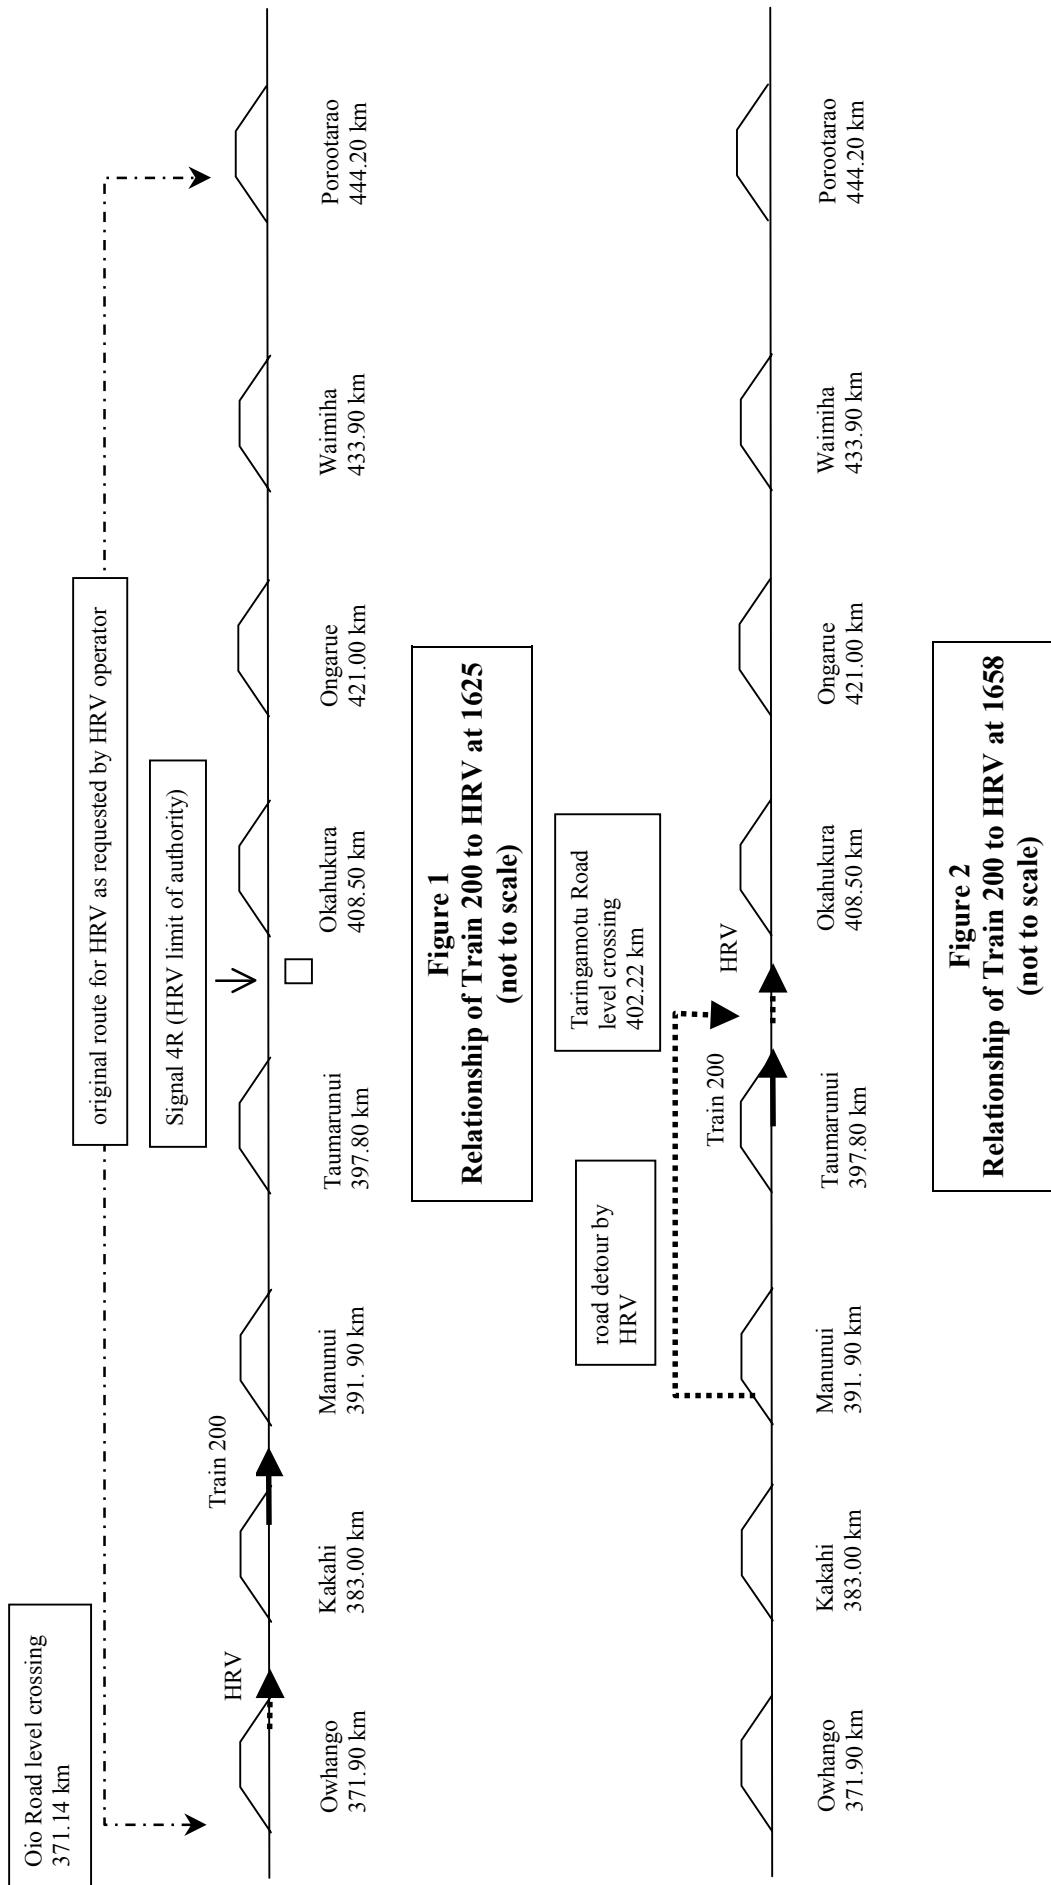
Figure 1	Relationship of Train 200 to HRV at 1625 .....	iv
Figure 2	Relationship of Train 200 to HRV at 1658 .....	iv

- 1.1.3 On the same day, at about 1625, a ganger radioed train control from Owhango, about 26 km south of Taumarunui, and requested authority to travel by hi-rail vehicle (HRV) north to Porootarao, a distance of about 72 km to carry out a special hot-weather track inspection (see Figure 1).

- 1.1.6 After calling at his depot, he continued north by road to Taringamotu Road level crossing between Taumarunui and Okahukura (see Figure 2) where he on-tracked his HRV. He had just started to move when he noticed Train 200 approaching from behind so he stopped.
