RECONSTRUCTION OF BURNSIDE INTERLOCKING.

The extensive reconstruction of the Burnside, Ill., interlocking plant on the Illinois Central, which has been under way, is now nearing completion. The changes were required by a raise in grade of about one foot at a street

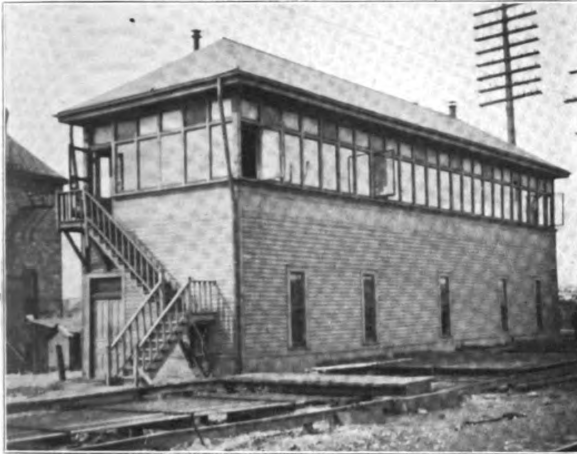
Fig. 1. Burnside Interlocking Tower.

spaces. The tower is provided with Hall disappearing disc annunciators for the Illinois Central tracks and Continental Signal Co., indicators for the Chicago & Western Indiana tracks. Route locking is used only on the Chicago & Western Indiana. All signals are mechanically operated except

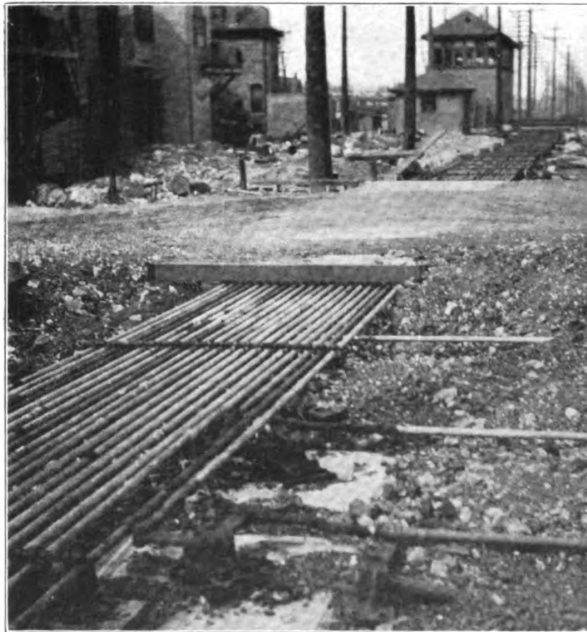
Fig. 5. Pipe and Wire Lines Under Street Crossing.

the home signals on the Chicago & Western Indiana, which are power operated. The leadout is of the rocker shaft type with hexagonal rocker bars. In carrying the pipe and wire line under a street which crosses the tracks at grade, the concrete slab construction shown in one of the accompanying illustrations was adopted. The slab was made long enough to span the road and wide enough to contain iron pipes to carry all the operating pipes and wires.
