Quick Restoration of Wire Service at Broad Street Station

THE BURNING of the train shed of the Pennsylvania railroad at Broad street station, Philadelphia, on June 11, involved partial destruction of about 500 wire circuits, the majority of which were for telephone connections, besides some 35,000 ft. of twisted pairs used for fire alarm connections, call bells and other services; and within 72 hours after the fire started, the telegraph and signal department had 400 pairs of wires ready for use, many of them suspended from the housetops on Filbert street and connected thence to the wire terminal room in the office building

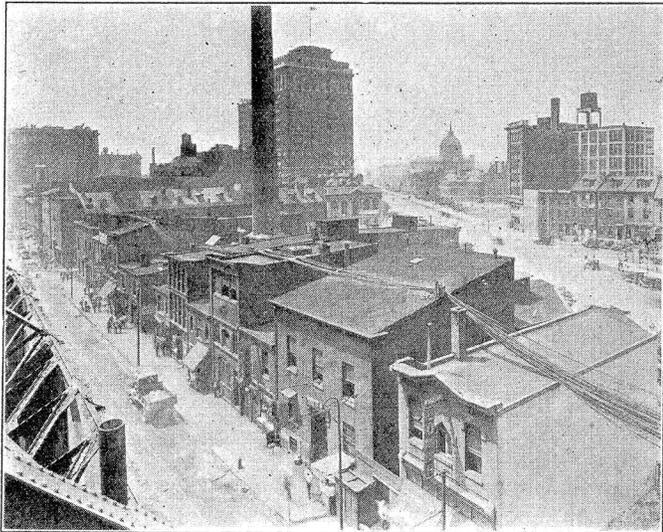
Fig. 1.—Extra Wire Run Over House-tops

The wires strung on the housetops north of the station (Filbert street) are shown in Fig. 1. The magnitude of the work of restoring the tracks in the train shed is illustrated by Fig. 2, where the distortion of the beams by the heat is shown.

where connection is made to the general office telephone and telegraph instruments. Intermediate pole supports were provided on the west side of 15th street.
