New Interlocking Construction Ideas

Chicago & Western Indiana Installs 120-Lever Plant Using Parkway Cable, Unique Outlets and Novel Charging Apparatus

By *F. E. Jacobs*

Signal Engineer, Chicago & Western Indiana, Chicago

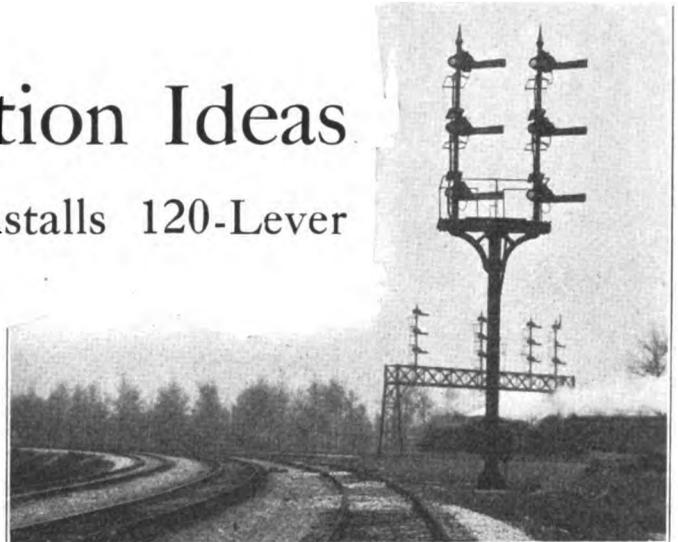
120 lever machine frame

5 spare levers for switches
5 spare levers for signals
31 spare spaces

The interlocking machine is of the General Railway Signal Company's Model-2 unit type, enclosed in a steel case and has:

- 29 levers for 29 movable signal arms,
- 5 levers for 5 movable dwarf signal arms,
- 14 levers for 14 derails,
- 9 levers for 9 single switches,
- 6 levers for 2 single slip switches with M. P. frogs,
- 15 levers for 5 double slip switches with M. P. frogs,
- 1 lever for 1 M. P. frogs,

79 working levers.

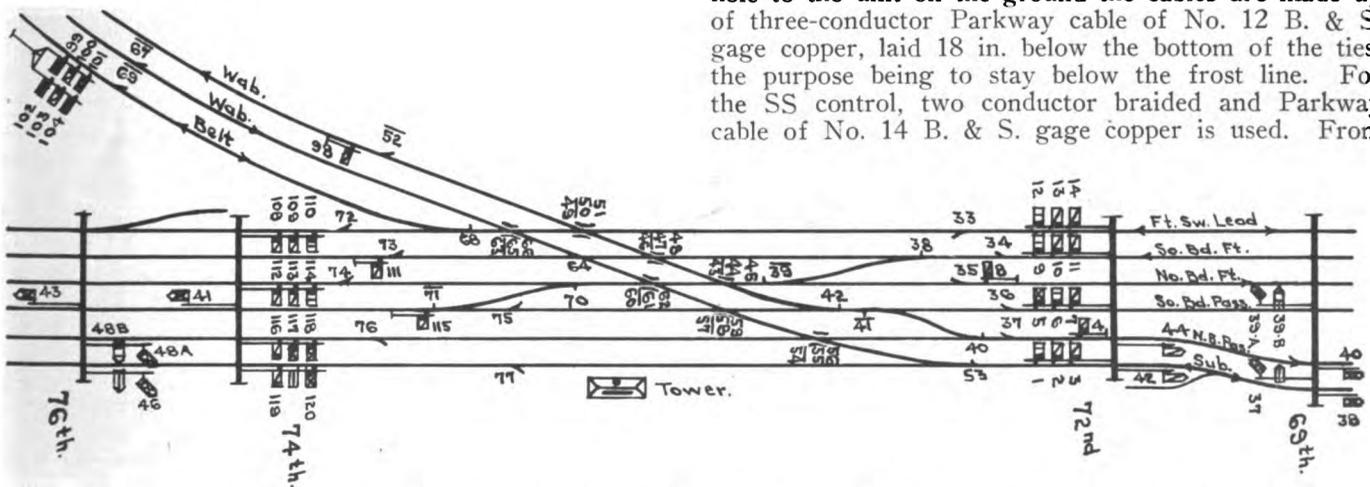
Fig. 1—Track and Signaling Plan of New Electric Interlocking at 74th Street, Chicago, on the C. & W. I.

AN electric interlocking with 120 levers has recently been placed in service by the Chicago Western. Indiana near 74th street, Chicago, at the junction of this road with the St. Louis division of the Wabash and the Belt Railway of Chicago. Included in this installation are 19 three-position automatic signals between 55th street and 81st street located on tracks No. 1, 2 and 3, which replace manual block signaling on these tracks. The home signals at the Ford street interlocking were changed from two-arm to three-arm interlocking and are now semi-automatic.

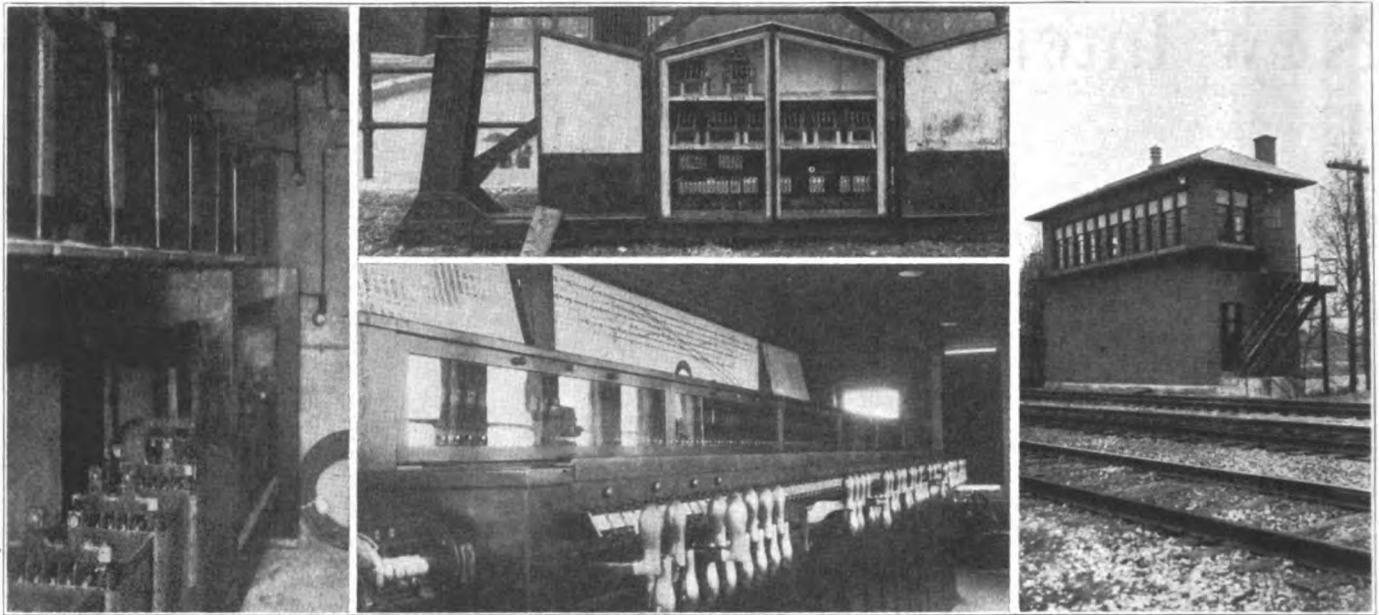
Fig. 2—Section of Storage Batteries

The power plant consists of three motor-generators and a 400 a. h. battery of 57 cells of Exide storage batteries. One machine has a 15 h.p., 220-volts. 3-phase, 60-cycle, motor direct connected to a 50-amp., 100-175-volt generator for charging the 57-cell battery at the normal charging rate or for feeding the interlocking machine. The second machine has a 1 h. p., 220-volt, 3-phase, 60-cycle motor directly connected to a 3 amp., 100-130-volt generator for floating the 57 cell battery under normal operating condition.

Two batteries each of 6 cells with 400 a. h. capacity are used, one for supplying the track circuits and one for supplying the lever locks. One motor-generator for this set of battery has a 2 h. p., 220-volt, 3-phase, 60-cycle motor directly connected to a 50-amp., 17.5-volt generator for charging at the normal charging rate and there are also motor-generators with 1 h. p., 110-volt, 1-phase, 60-cycle, motors that are directly connected to 3 amp., 100-130-volt generators for floating these batteries under normal condition. The track diagram and lever lights are fed from either the low voltage battery or the 50-amp. low voltage generator or from a transformer having 12-volt secondary and 110-volt primary connections. Miniature instruments are used to read both the charge and discharge of the low voltage batteries.

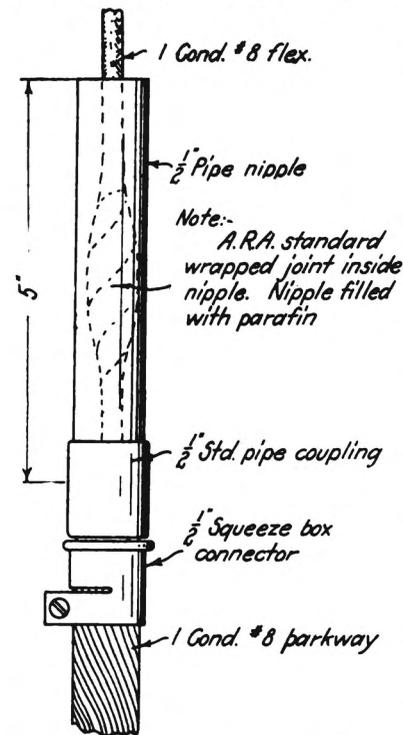
Fig. 6—Method of Protecting Splice of Parkway Cable With Regular Conductor

The cables coming out of any one manhole are run across the tracks in the same trench as far as practicable. Three feet of surplus cable is left underground at each operating unit. The Parkway and braided cable are brought into a junction box in the concrete manhole for jointing, using molded copper connectors. This box serves as a housing for the fuses and resistance units as well.

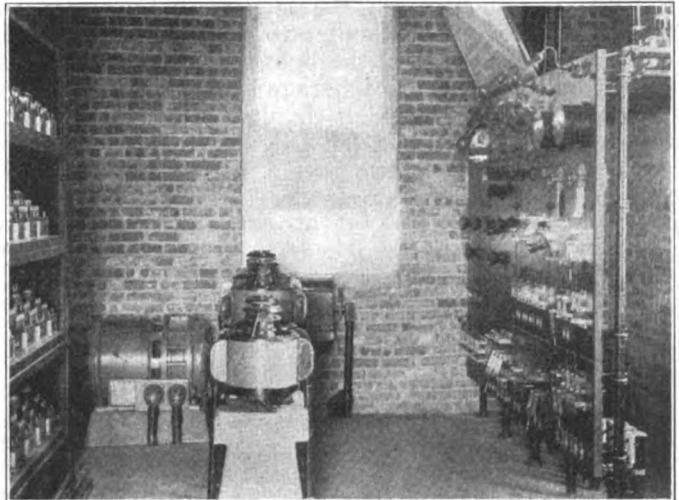
Above, Fig. 10—Motor Generators and Switchboard
Below, Fig. 11—Portion of Relay Cabinet to Left

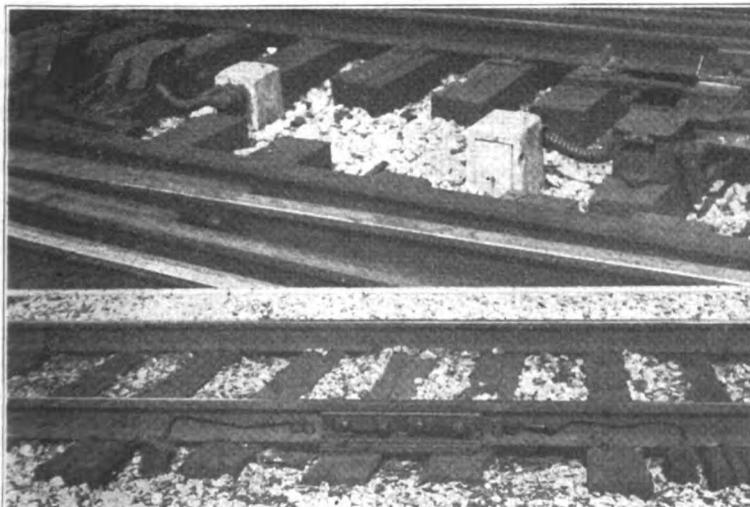
Above, Fig. 7—Typical Concrete Riser and Hose Connection
Below, Fig. 8—Track Outlet at Rail

The end of the two and three-conductor Parkway cable leading to the switch machine and switch circuit controller are brought up from underground in a vertical concrete riser, thence through 1½ in. double metal strip flexible conduit and the coupling is fastened to the riser with stove bolts. See Fig. 7. The steel armor is removed from the end of the cable at a point near the top of the concrete riser and a squeeze connector, similar to Fig. 6, is fastened around the steel armor at the point where it terminates. The wires are carried on up into the mechanism case.

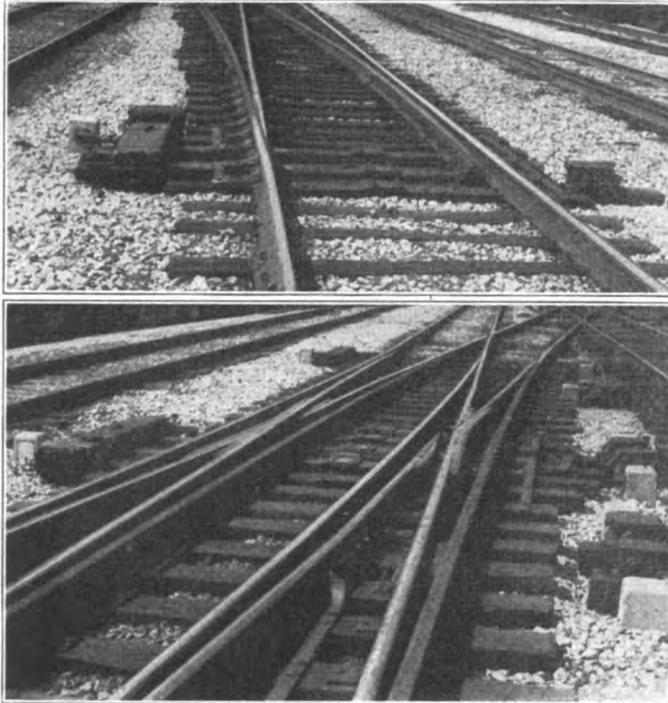
Fig. 12—Above—Typical Switch Layout
Fig. 13—Below—One of the Slip Switches

Switch machines and switch circuit controllers are Model-5 as shown in the view of a single switch layout. Section locking circuits are used in lieu of detector bars, including route and approach locking for the route governed by the top or middle arm.
