Automatic Interlocker Saves Over

8,000 Train Stops Annually

Simplified control system used at C.& A.-N.Y.C. crossing at Streator Junction, Ill. - Push-type release employed

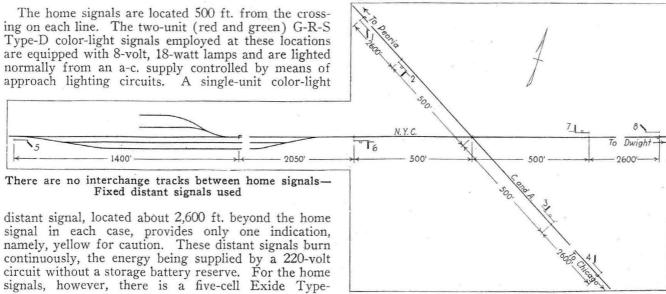
One of the distant signals on the C. & A.

ing on each line. The two-unit (red and green) G-R-S Type-D color-light signals employed at these locations are equipped with 8-volt, 18-watt lamps and are lighted normally from an a-c. supply controlled by means of approach lighting circuits. A single-unit color-light EMGO-7 120-a.h. storage battery at the crossing for emergency lighting. Each home signal is equipped with a red marker light to designate it as an absolute stop signal. As each marker light is equipped with an 8-volt, 10-watt lamp, it is not quite as brillant as the home signal which has an 8-volt, 18-watt lamp. In connection with the lighting of the home signals, two Type-H power-off relays are employed, one for each line, in order to reduce the current carried by each contact in the relay.

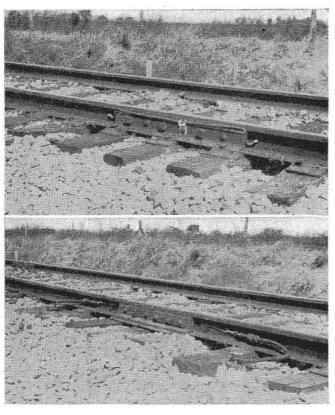
Top—Stranded cable bond and protector Bottom—Parkway rail connections at an insulated joint

All of the track circuits are operated by means of Edison 500-a.h. primary battery connected four cells in multiple. The maximum dead section at the crossing diamond is 27 ft. The rails are bonded with stranded copperweld cable bonds, about 36 in. long. All rail connections to track circuits and all of the lighting and control circuits between the home signals and the cross-

ing are carried in Okonite parkway cable buried in sand alongside the ballast toe line. For the lighting circuits, No. 6 conductor parkway is employed, and for the relay control circuits No. 14 conductors are used. The parkway rail connections are made with No. 8 conductors.

At a rail connection, the parkway comes up out of the ground through a 2-in. pipe embedded in a concrete pedestal about 2 ft. long. The parkway passes out of

this riser through a slot in the top of the pipe just below the pipe cap. The cable is then carried through a short length of rubber hose which is secured to the web of the rail by means of a short length of wire. A soldered connection is made between the end of the parkway conductor and the copperweld bond wire. The end of the parkway cable is taped and painted with P. & B. compound. At the main relay box the parkway cables enter through the foundation, there being a number of two-inch iron conduits for this purpose.
