# Midwest RRs fight the weather

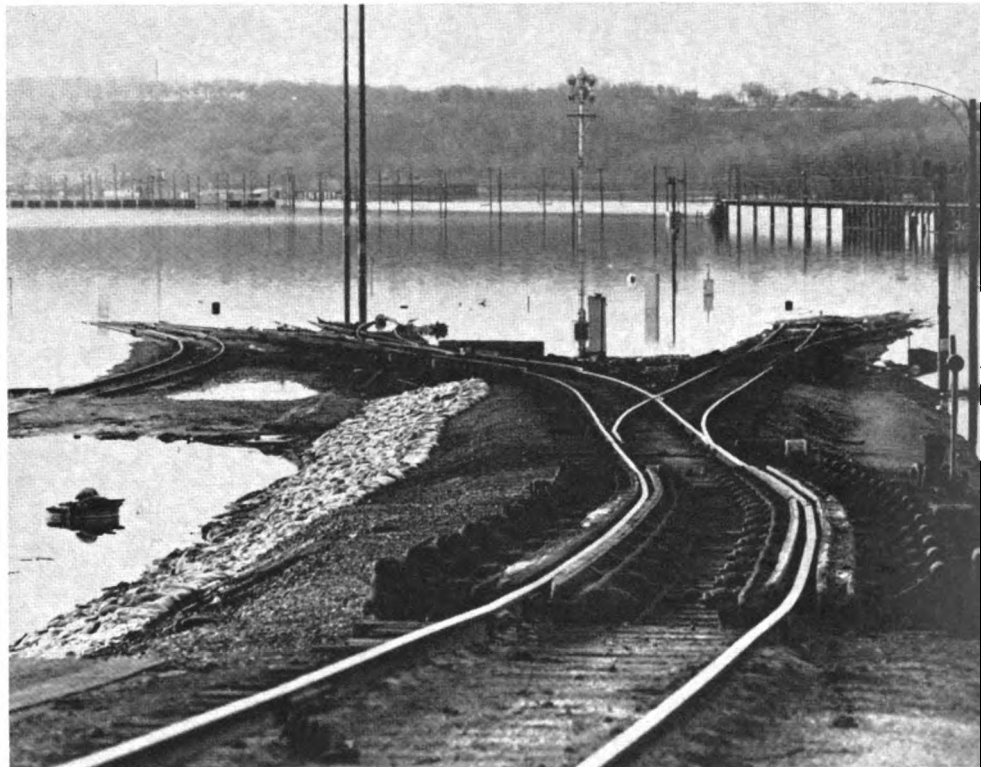
Water covered Milwaukee Road's St. Paul, Minn., classification yard to a depth of about 8 ft. This is view from hump looking northward.

Its St. Paul, Minn., automatic classification yard was under about 8 ft of water. In a major operation, the road's S&C forces worked 12-hr shifts about four days removing equipment to get it above flood waters. On April 12, the yard was completely out of service, after four days' work removing equipment and taking other preventive measures, such as placing sand bags to a height of 8 ft against the retarder tower's walls. On April 16, the flood crested at 26 ft, which was 12 ft above flood stage at St. Paul. By April 28, flood waters had receded to the point that S&C gangs were able to enter the yard. They replaced equipment, cleaned out debris

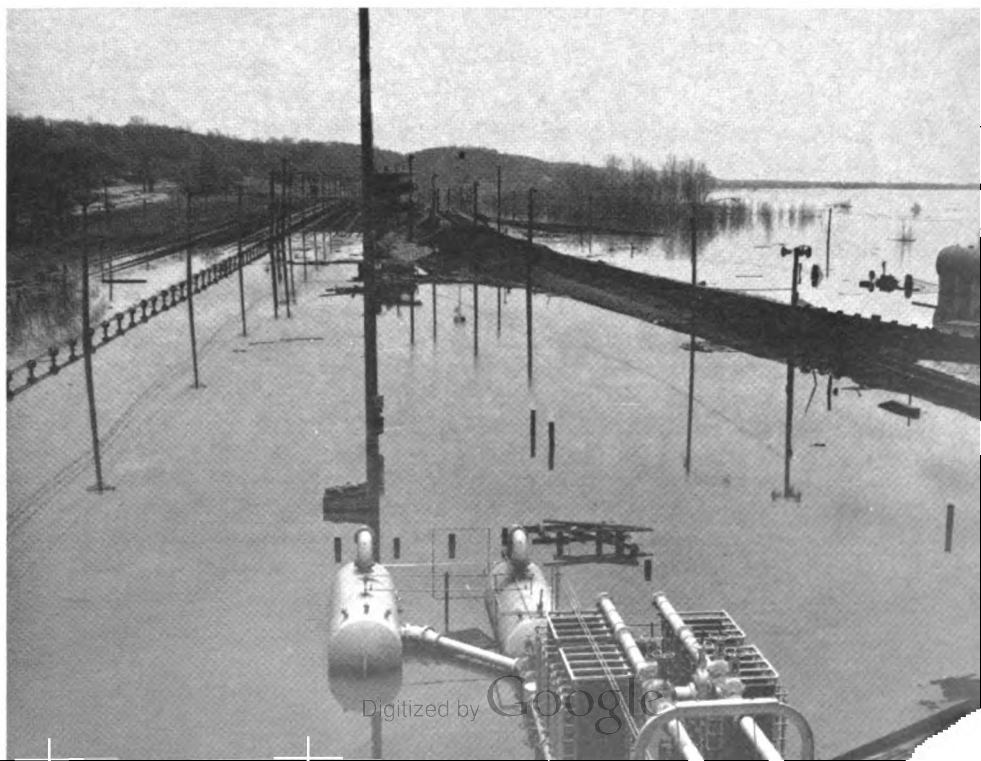
Storage tanks (below) were bled of air and filled with water to hold them down. Pneumatic tube line (far left) has sand bags at post positions for weighting.

filled with water to help hold them down. A similar practice was followed by MILW signal forces at St. Paul yard. The air storage tanks and pipe lines were bled of air and filled with water to help keep them in place.

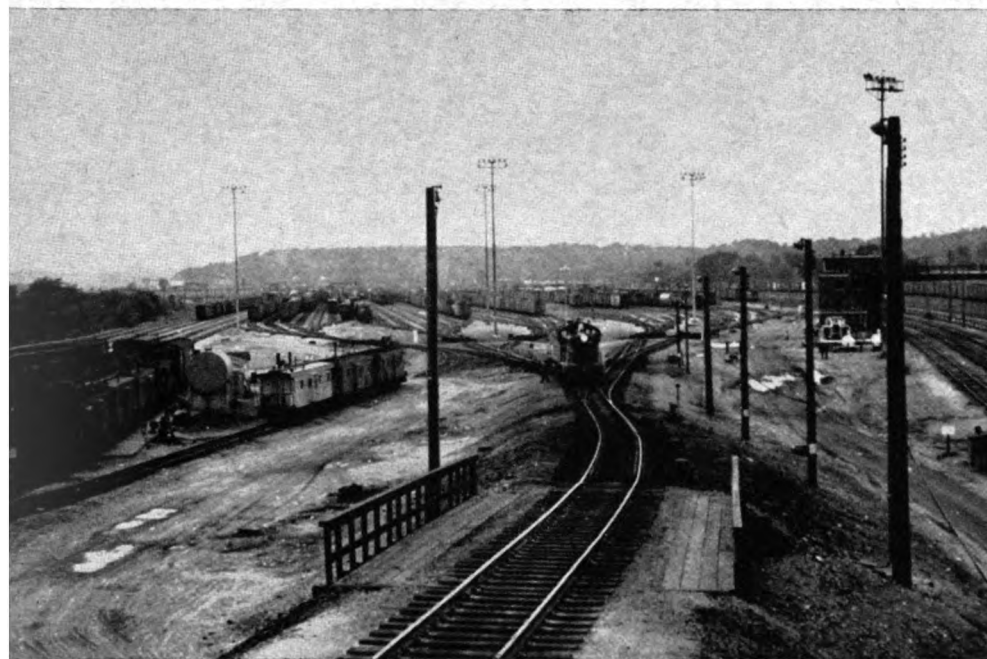
When restoring MILW yard to service, switch engine was run over class tracks several times to wear off rust and restore shunting sensitivity.

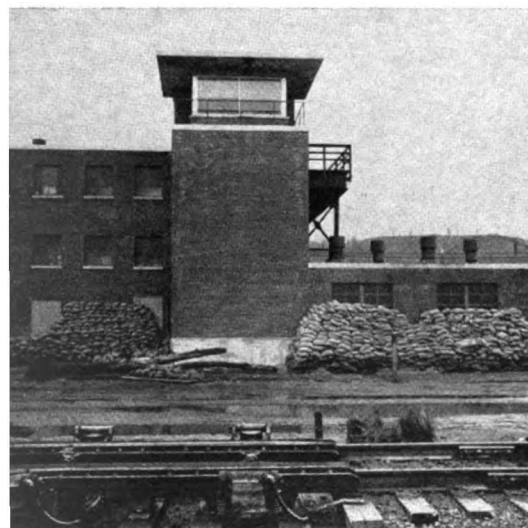
Retarder tower was sandbagged to prevent debris from damaging building.

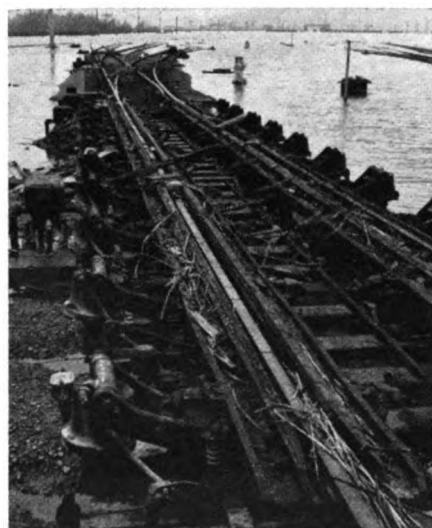
After water receded from retarders debris remained to be cleaned out.

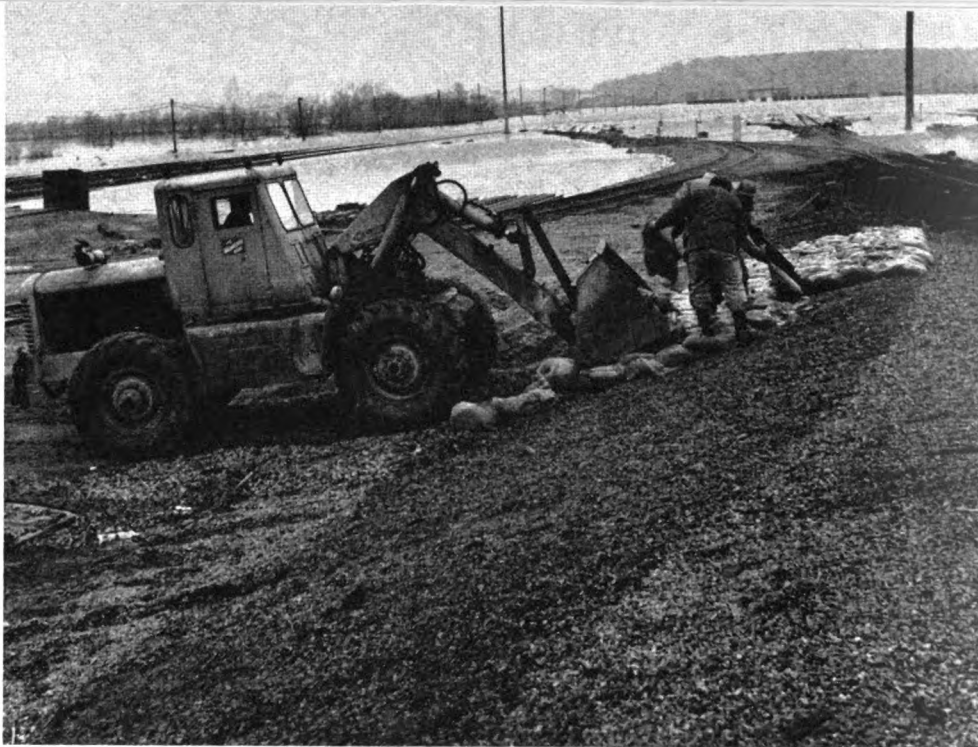
Sand bags were placed along side of the hump to prevent water from washing away soil and ballast. Here is removal of sandbags after water has receded.

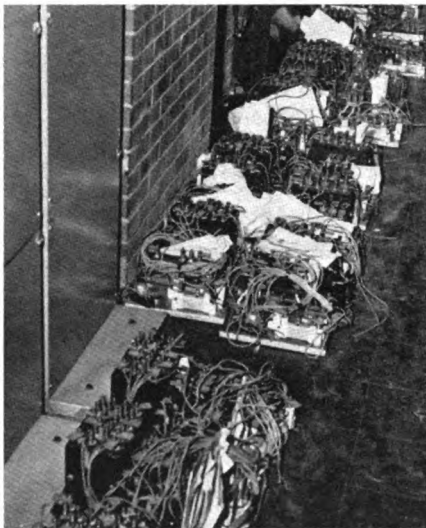
Electro-pneumatic switch control valves were stored in tower.

Out in the St. Paul classification yard, electrical equipment was removed where possible. For example, the relays and associated equipment in instrument cases near retarders and power switches were removed. Also, the electro-magnetic control valves for the retarders and electro-pneumatic power switches were removed and temporarily stored on the third floor of the retarder building. Talk-back speaker heads and some signal heads were removed to prevent them from being flooded.

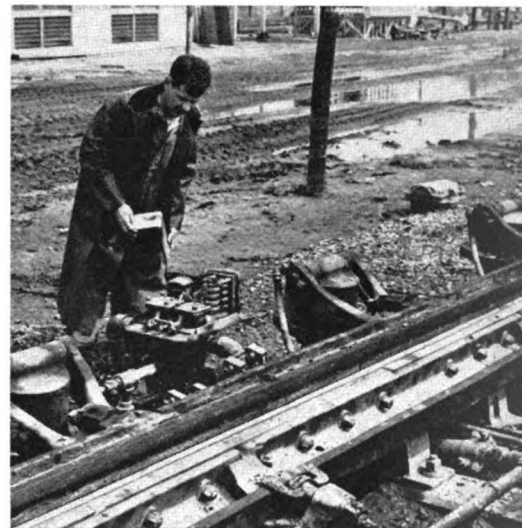
Retarder control valves are examined after water receded.

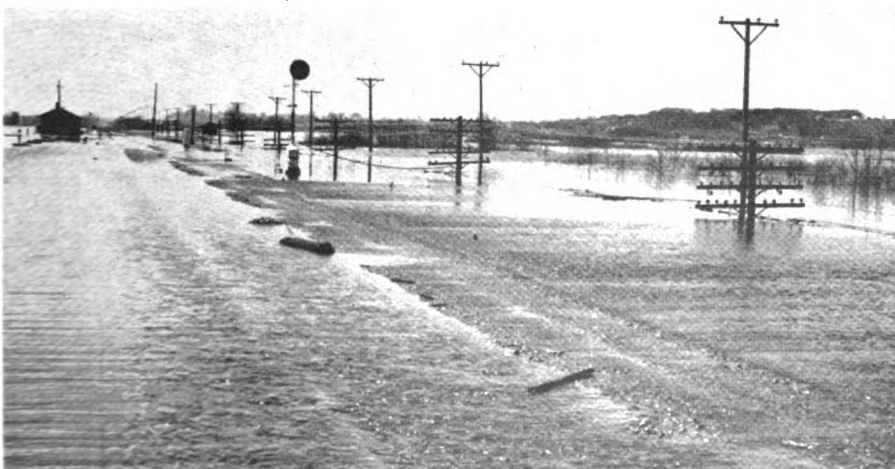
Rock Island line near Nahant, Ia., shows how pole lines may escape severe damage due to high water, unless there is a washout.

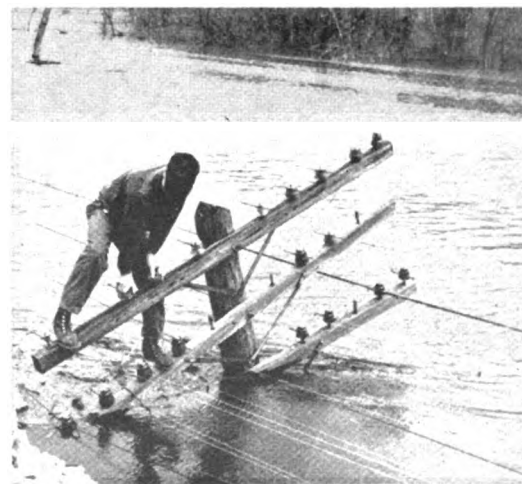
This pole line did not escape high flood waters.
