RAILWAY ACCIDENT

Report on the Accident that occurred on 4th July 1969 at Willesden

IN THE
LONDON MIDLAND REGION
BRITISH RAILWAYS

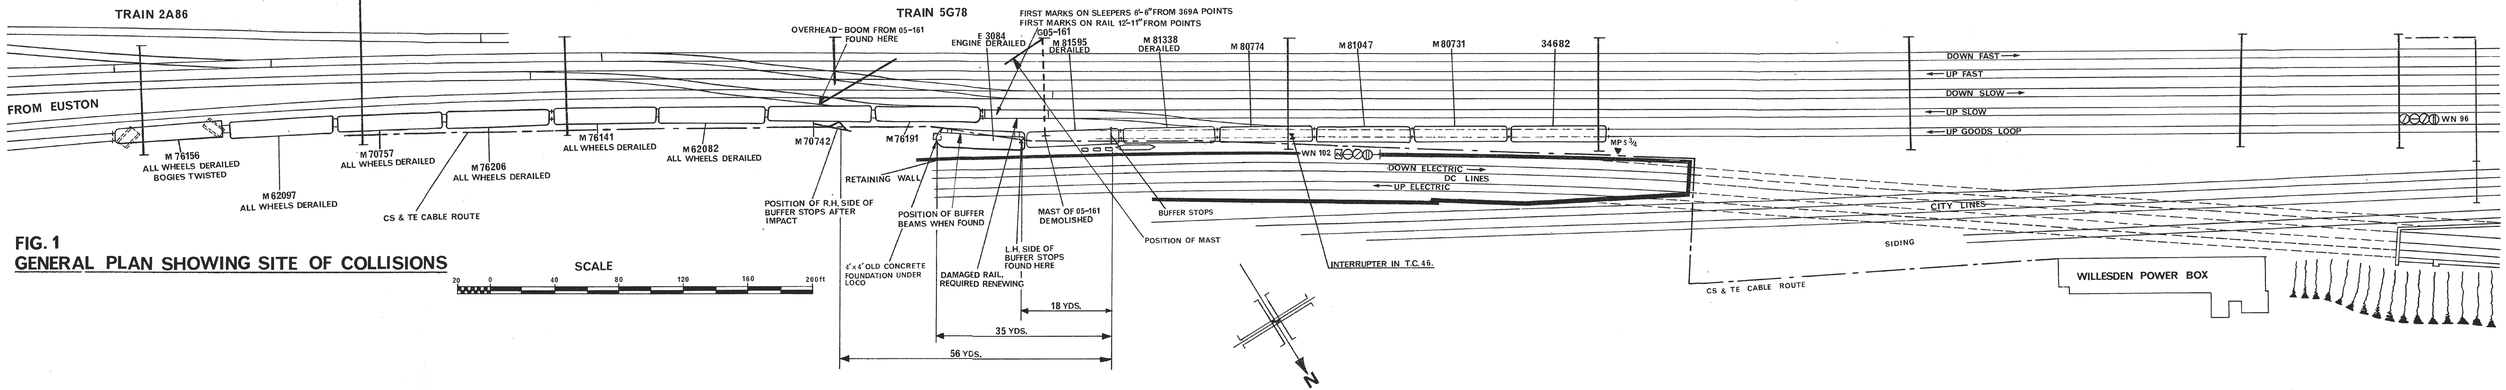
FIG. 1
GENERAL PLAN SHOWING SITE OF COLLISIONS

1. Figure 1 of the plan at the back of this report shows that at the site of the accident, the Main lines to Euston run East and West with the Slow lines on the north of the Fast lines. The 300 yards long Up Goods loop lies to the north of the Up Slow line. A few yards to its north and in a vertical sided cutting lie the DC third and fourth rail electrified lines, and to the north of these lie the City Lines which pass over the DC lines and connect with the Slow lines under a railway bridge and Acton Lane Road bridge. Finally, there is a siding entered from the Up City line just east of the railway bridge. Figure 2 shows diagrammatically the layout of the exit from the carriage sidings on the Up side of the Main lines, the Up departure line known as the Up Carriage line, and two crossovers over the Down City line the first leading to the Up Slow line, and the second leading to the Up Goods Loop. Trap points are provided at the exits to the goods loop with bent rail buffer stops 160 ft beyond the loop exit signal WN 102.

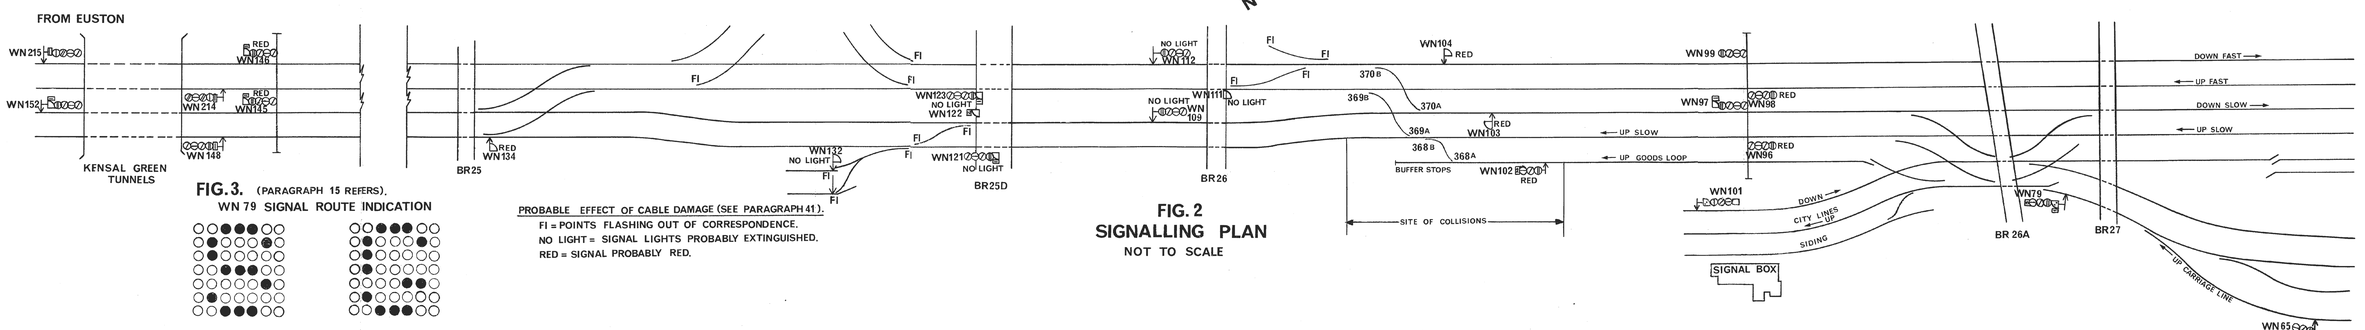
FIG. 3. (PARAGRAPH 15 REFERS).
WN 79 SIGNAL ROUTE INDICATION

15. I visited the site on the afternoon of 7th July and tested the route indicator at signal WN 79, and found that two of the lamps had failed as indicated in figure 3. On the night of 16th July I again visited the site and found one of the lamps, the left hand one, still failed. Mr. Humphrey told me that signal lamps are checked monthly and had last been checked on 17th June. When questioned about the failure of the two lamps he said that they had not been reported prior to the accident, but that on being told about them he had given instructions that they should be replaced, and had been told that this had been carried out. He added however that he did not think the absence of the two particular lamps affected the outline of the letter "G".

53. In view of the fact that there have been two almost identical accidents at this busy exit line, several modifications to the carriage line exit signal WN 79 were discussed. Firstly an approach control applied only when the signal reads to WN 102 on the goods loop was considered, holding WN 79 at danger until it was closely approached by a train. Secondly it was suggested that the letter "G" in the route indicator, which can be confused with the letter "C" (to the City line) and "S" (to the Up Slow line) should be replaced by the letter "L" reading to the loop. Thirdly, the provision of AWS at signal WN 79 was discussed. However, I am glad to be able to report that it has been decided that the goods loop shall be removed completely, which of all the solutions is the best.
