Collision Between Freight Train 9784 and Ballast Train 9795

RAIL INVESTIGATION REPORT

**Collision Between Freight Train 9784 and
Ballast Train 9795
Ararat, Victoria**

26 November 1999

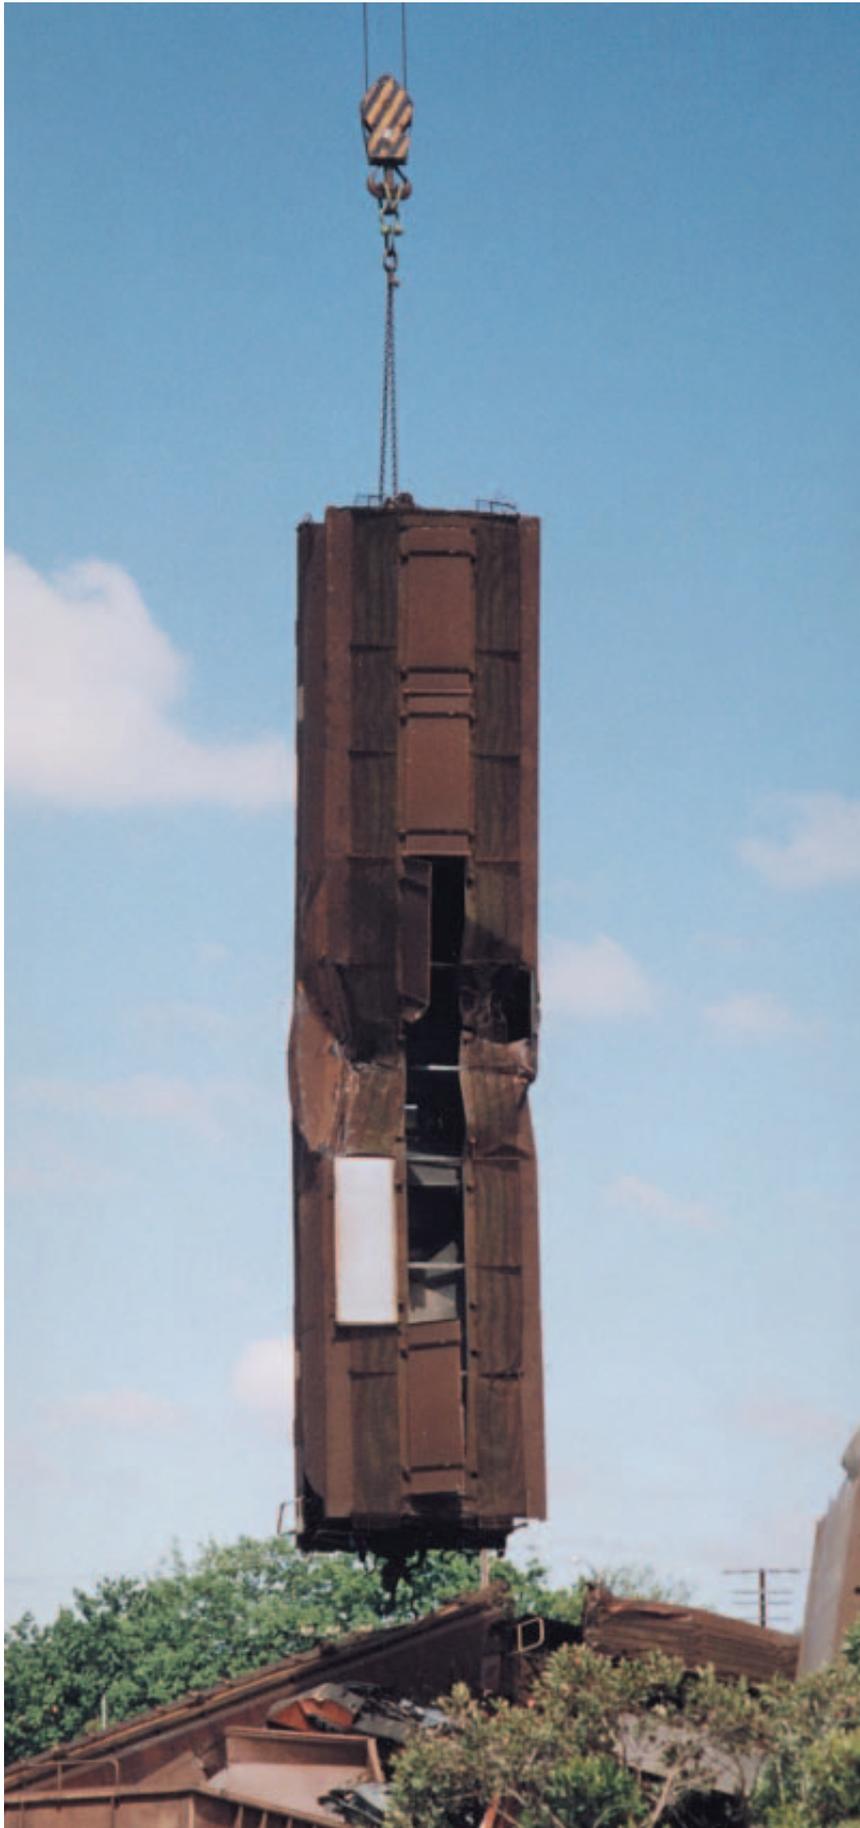
FIGURE 13.
Recovery operation in progress

The police declared the area a crime scene and worked with Freight Victoria to progressively release the area for recovery (fig 13). In addition, they provided crowd control until 1800 on Sunday 28 November.

A diesel fuel spill from the locomotive of 9784 was contained by personnel from a company contracted by Freight Victoria. The contractor acquired the services of the local council and other agencies to provide appropriate absorbent material. The final site clean up was handled by the contractor under the direction of the Environmental Protection Authority.
