RAIL SAFETY INVESTIGATION

2002/0003

**Level Crossing Collision Between
Steam Passenger Train 8382
and Loaded B-double Truck
Benalla, Victoria, 13 October 2002**

September 2004

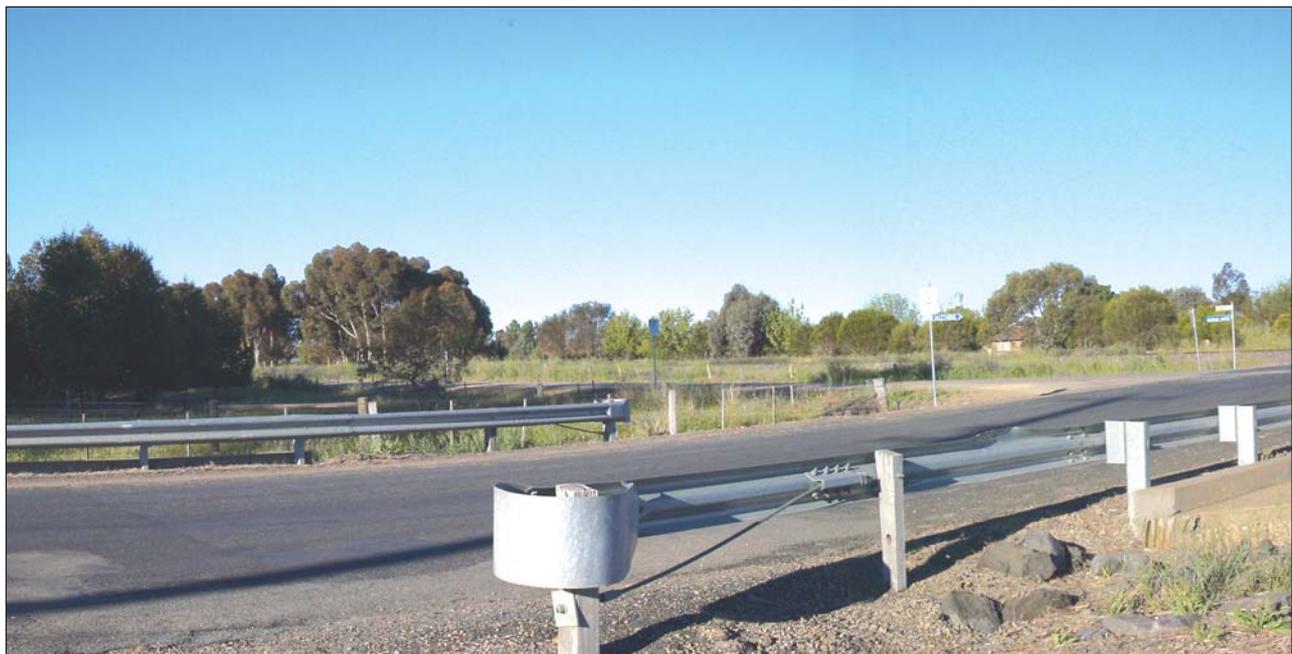
FIGURE 1:
Racecourse Road deviation into Gillies Street

At Gillies Road (670 m north of Saleyards level crossing) the truck would have to reduce speed and engage a low gear to turn through 90 degrees onto Gillies Road and start to travel in a southerly direction parallel to the rail track. The B-double having accelerated from the junction with Racecourse Road, would have had to reduce speed and changed down to a low gear to negotiate the turn into Saleyards Road level crossing.

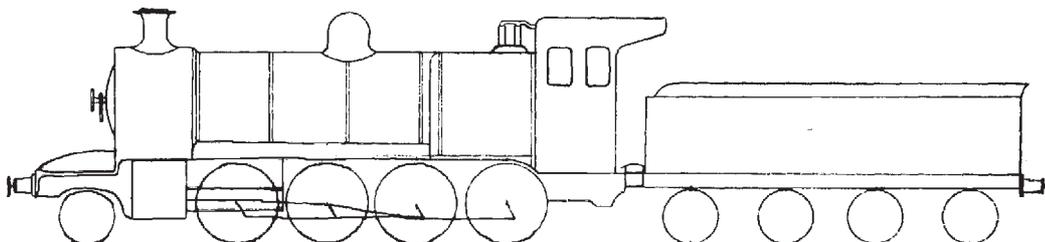
FIGURE 10:
Schematic of locomotive and tender

use of the engine. The most recent inspection conducted on 6 June 2002 certified the locomotive to operate at line speeds of up to 80km/h. The boiler of K183 was certified to operate at its designed pressure of 175PSI⁷. All wheels of the locomotive had been re-profiled during June 2000 and had travelled less than 5000 km since that date.

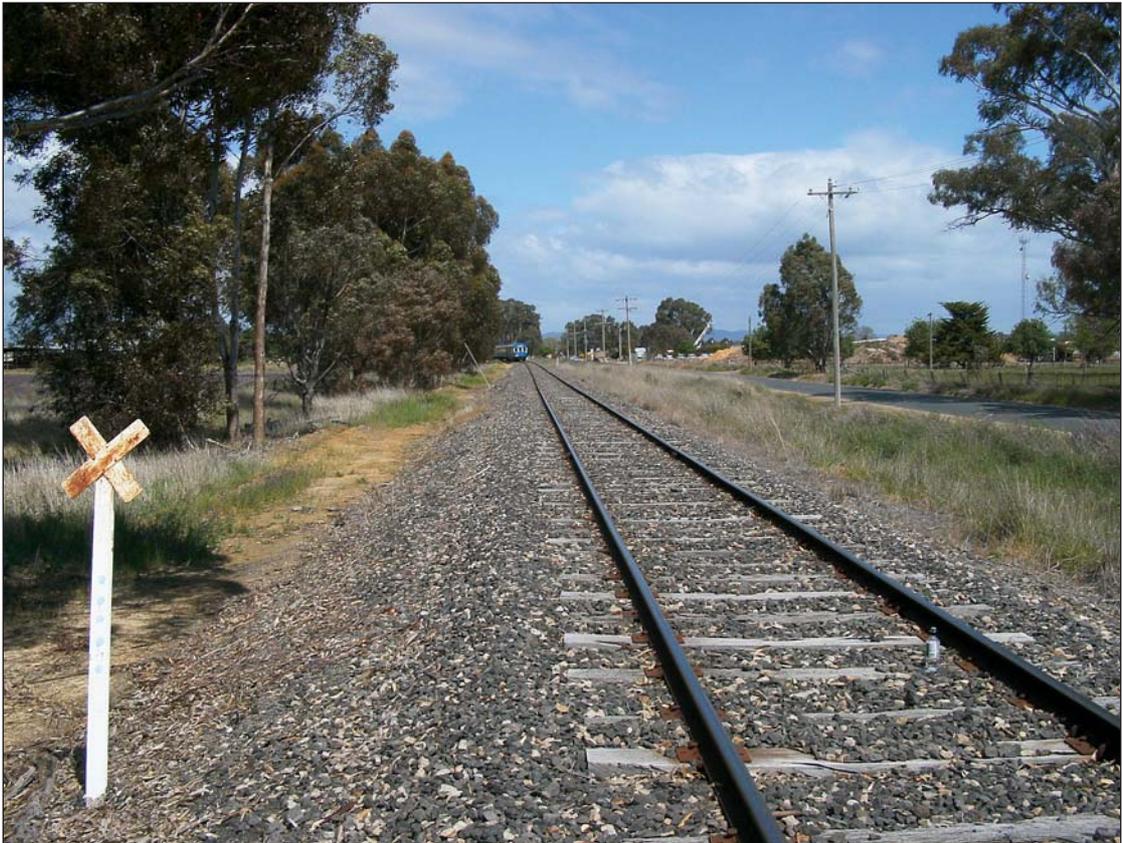
FIGURE 13:
Picture of whistle board in situ on approach to Saleyards Rd level crossing

Train drivers are required to sound the train whistle when approaching level crossings. A whistle board (white post with white 'X') was provided 400 m on the approach to each level crossing. When the train passes the whistle board the driver is required to sound the train whistle and again when the train is closer to the level crossing.

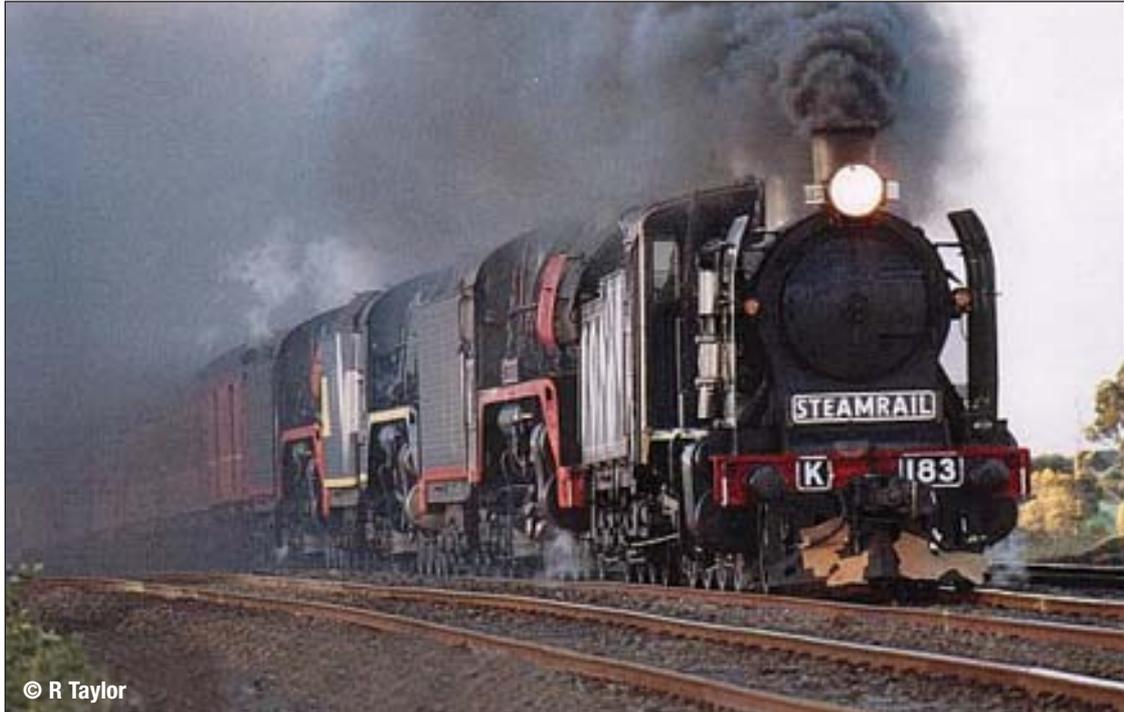
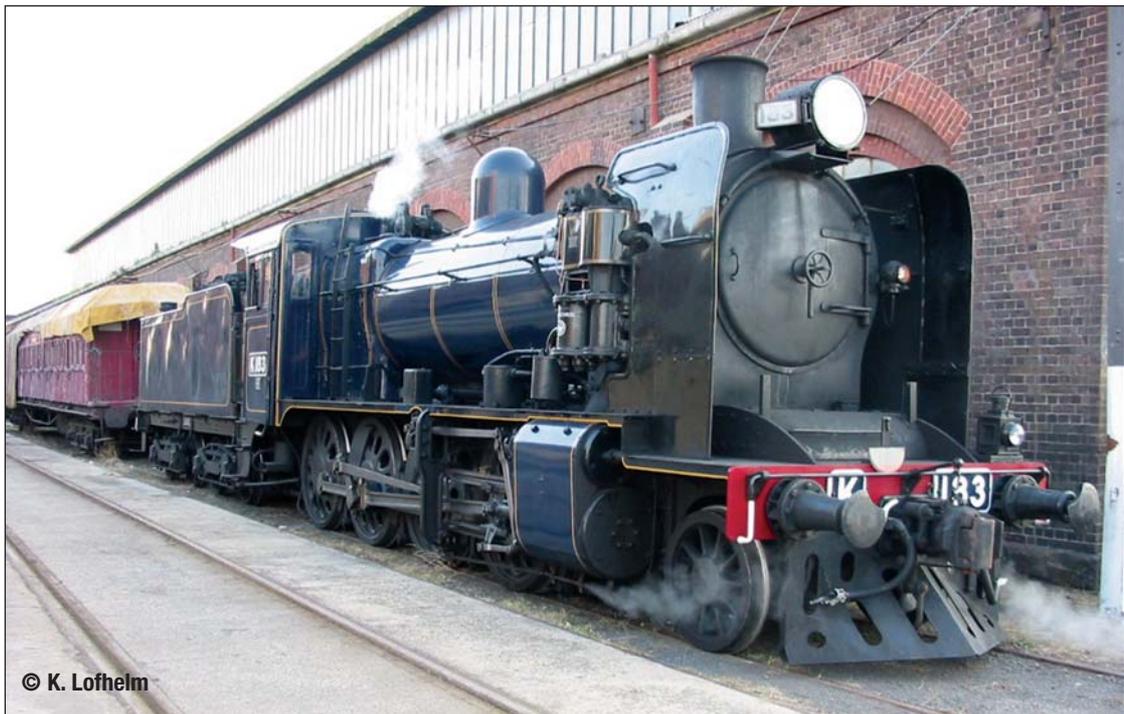
FIGURE 14:
Enthusiast photographs of locomotive K183

Given the locomotive's speed and steady acceleration, together with the position of the controls, it is probable that the locomotive would have been exhausting steam and smoke from the funnel. Both would add to the conspicuity of the train.
