ATSB TRANSPORT SAFETY INVESTIGATION REPORT
Rail Occurrence Investigation 2005001
Final

Collision Between Freight Wagons (for train 4MP5) and Passenger Train 8622

Moonee Ponds Creek Junction, South Dynon, Victoria

19 January 2005

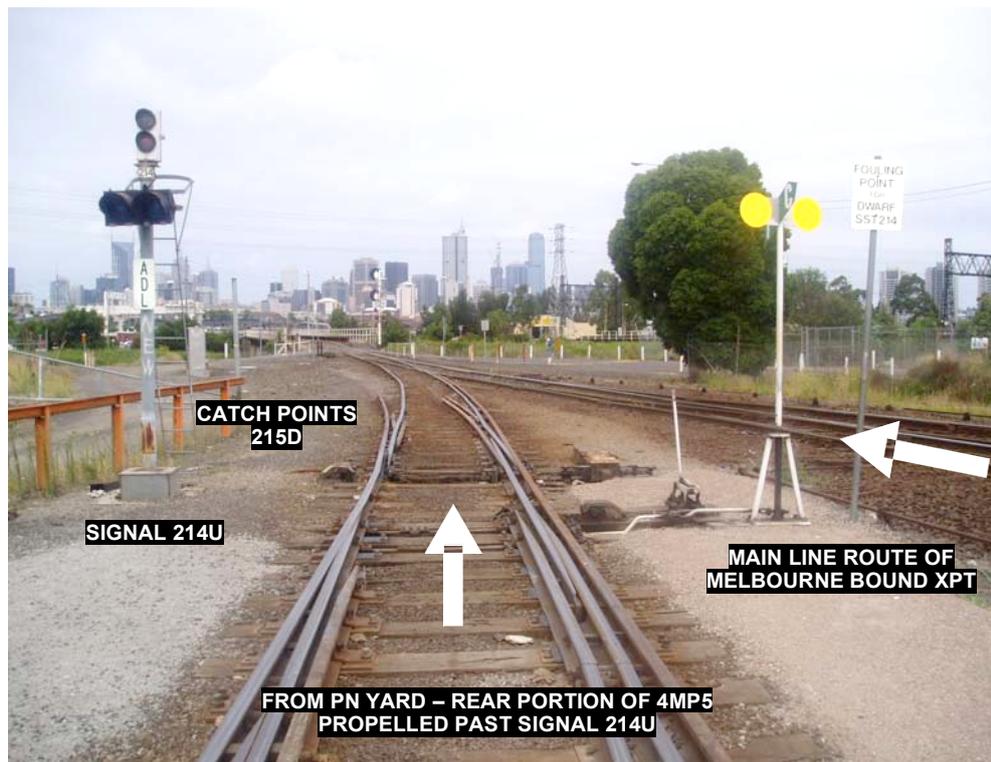
Figure 1: Moonee Ponds Creek Junction. The operational interface between the main line to Spencer Street Station and the *Pacific National Yard* and *Coke Road* is marked by 'dwarf' signal 214U.

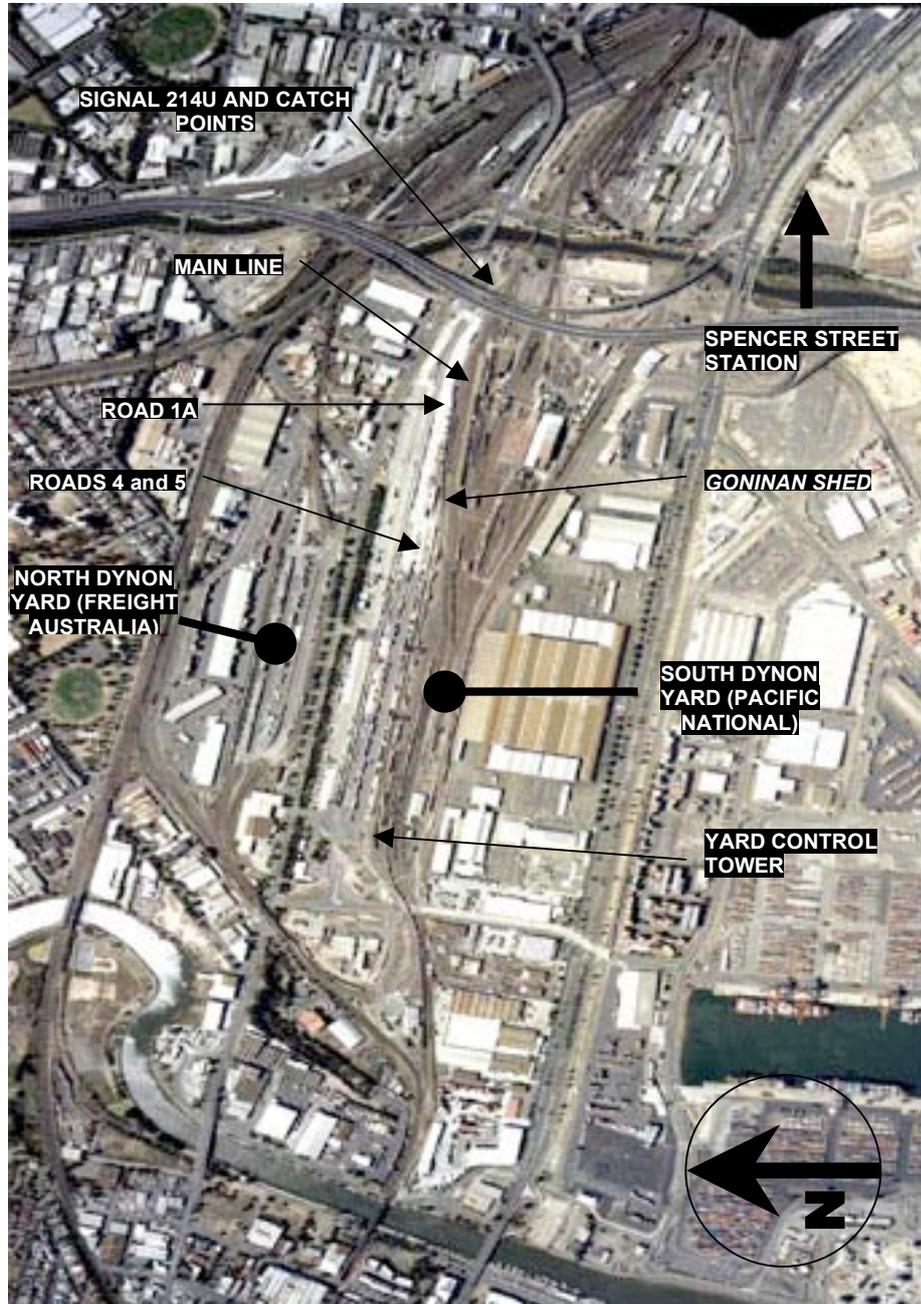
Figure 2: Aerial photograph of Melbourne's Dynon complex. The occurrence site is S37°48.286' E144° 56 102' at signal 214U.

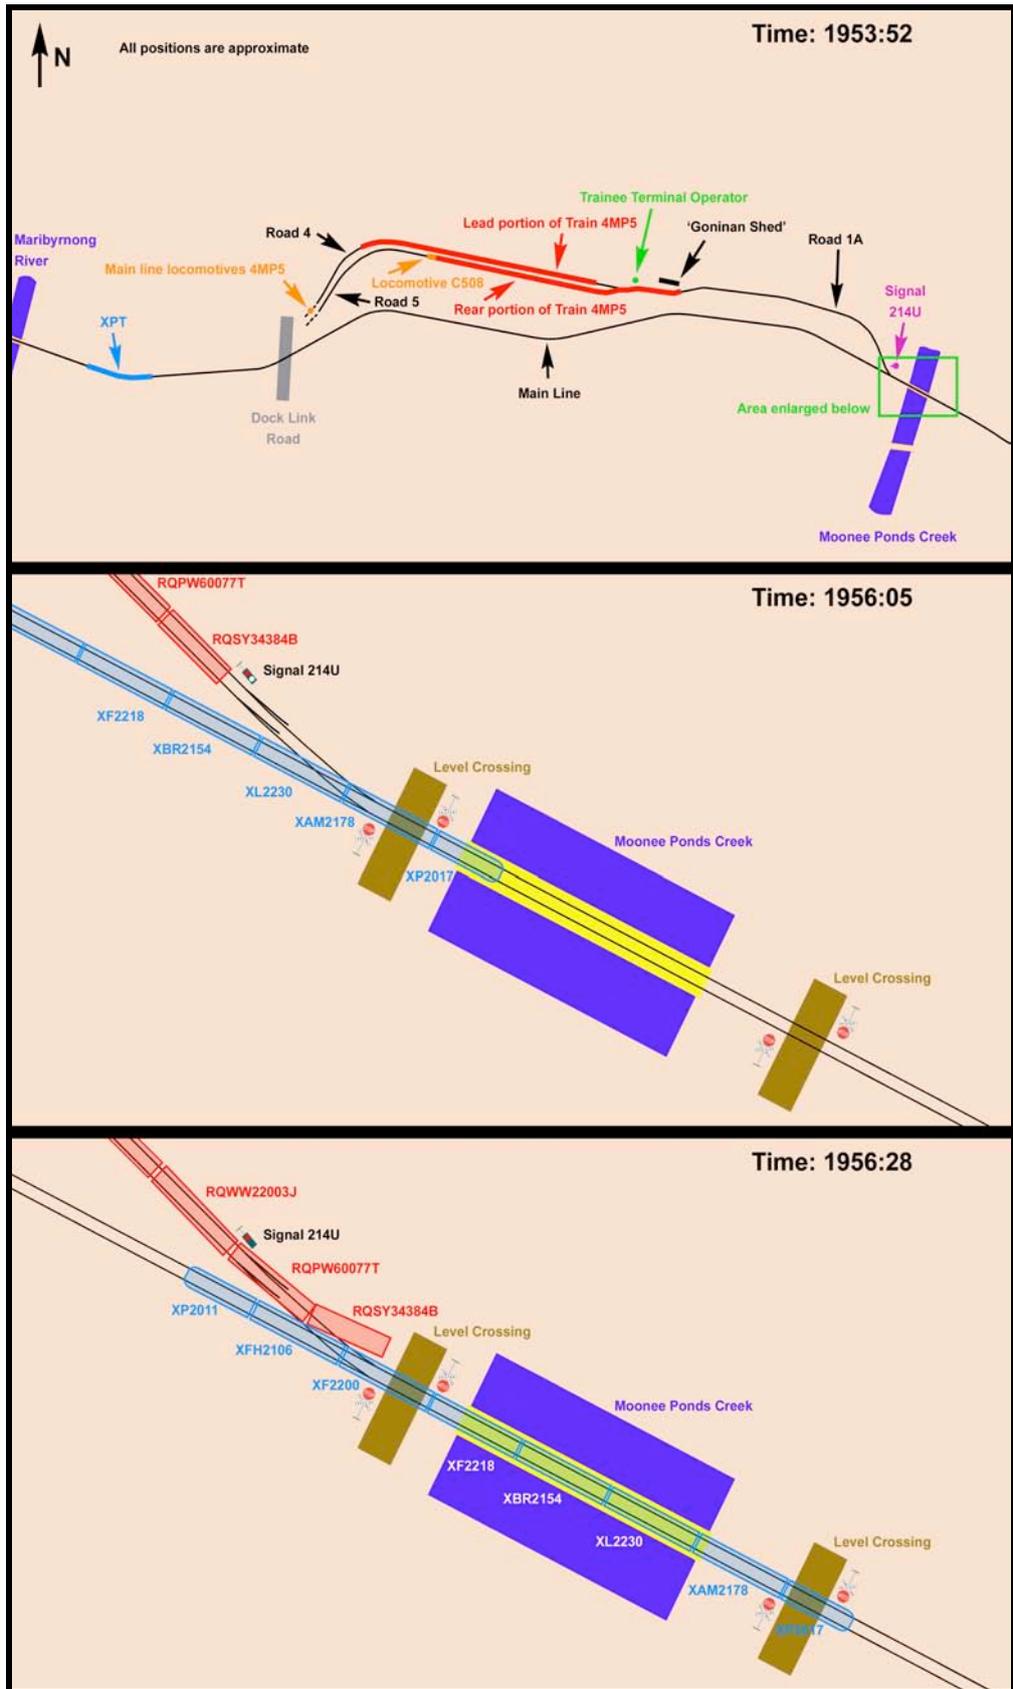
Figure 3: The development of the occurrence. (Relevant details shown only).
