ATSB TRANSPORT SAFETY INVESTIGATION REPORT
Rail Occurrence Investigation 2005/005
Final

Collision between Freight Train 5BS7 and Track Vehicle Greenbank, Queensland

25 August 2005

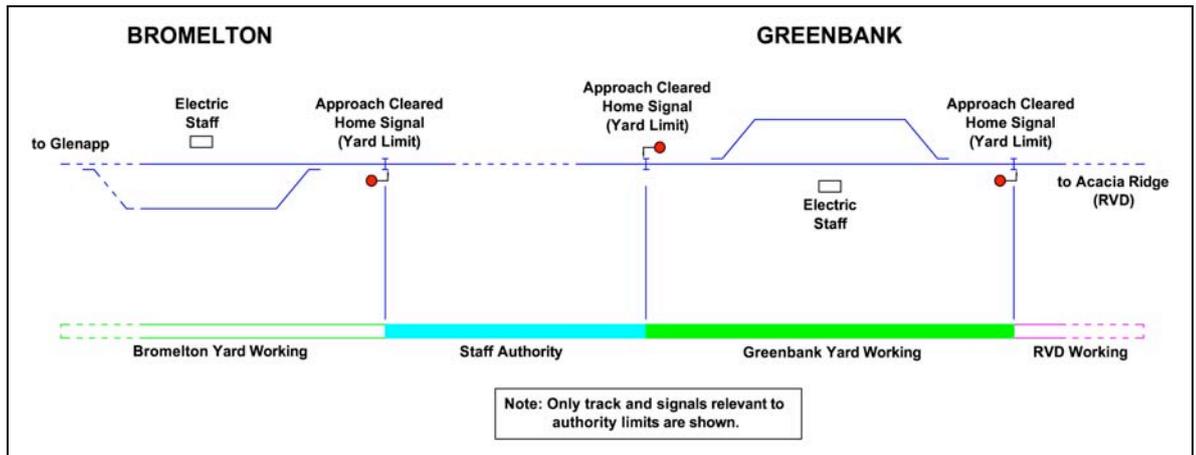
Figure 9: Authority limits Bromelton to Greenbank

An electric staff gives authority to occupy the section of track between staff stations only. That is, between the departure end yard limit of one station to the arrival end yard limit of another station (refer figure 9). In accordance with NWT 304 a verbal TOA to access yard limits at an unattended station is not permitted. Under TOA
