ATSB TRANSPORT SAFETY INVESTIGATION REPORT
Rail Occurrence Investigation 2006/003
Final

Signal 161 Passed at Danger TransAdelaide Passenger Train H307

Adelaide, South Australia

28 March 2006

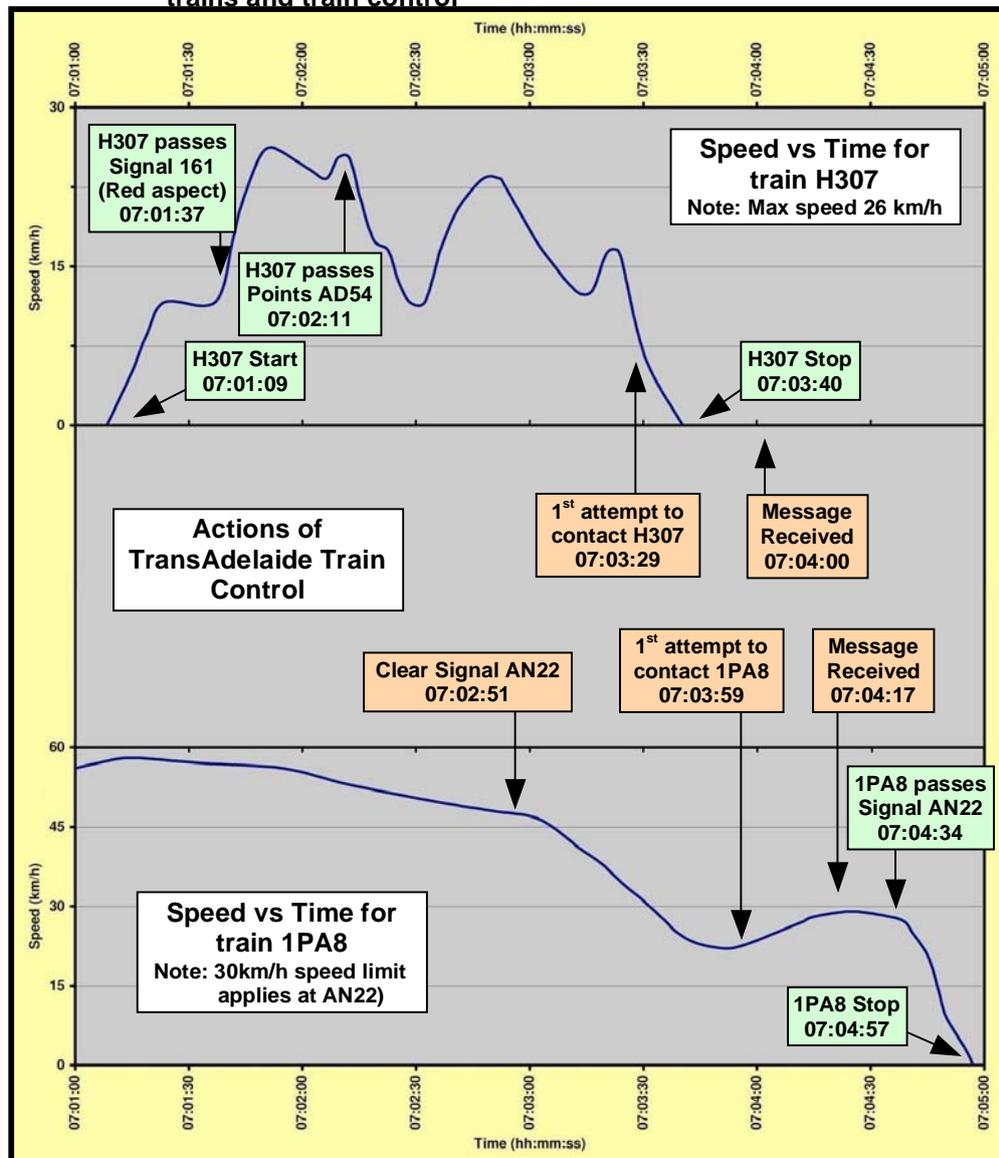
Figure 3: Sequence of events based on recorded information from both trains and train control

Examination of all recorded data allowed reconstruction of the sequence of events leading up to, including and following this incident (illustrated in Figure 3)⁸.

Recorded data (Figure 3) and statements from TransAdelaide personnel were analysed in an attempt to understand why train H307 had been allowed to travel approximately 600 m past signal 161.

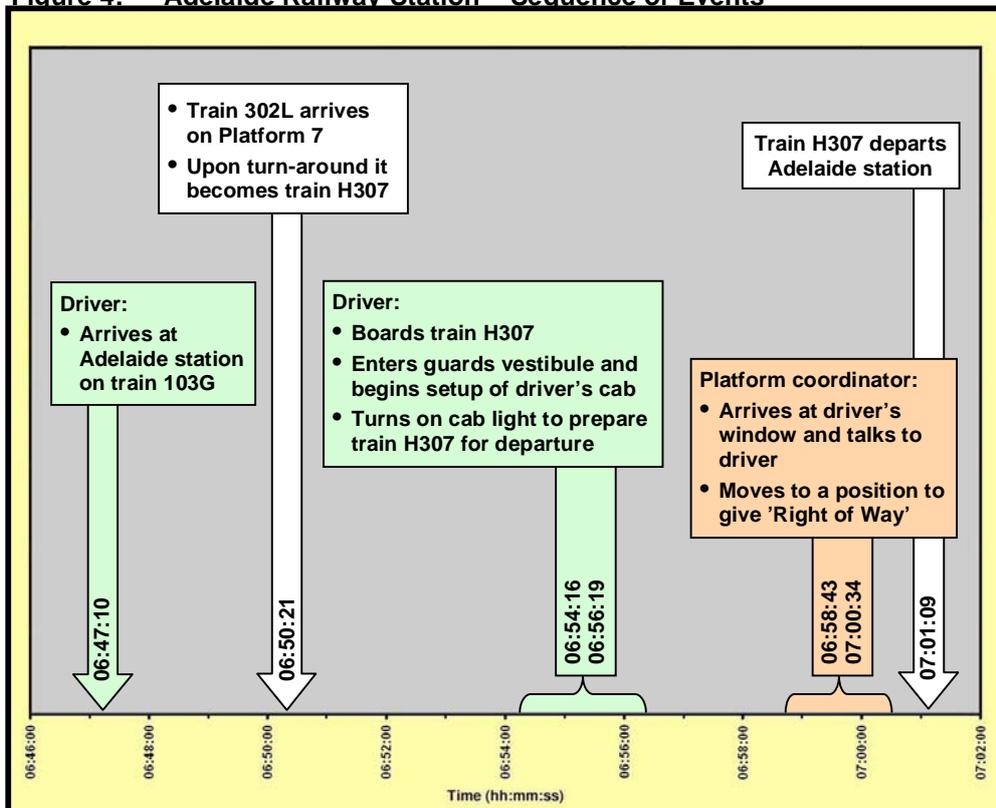
Figure 4: Adelaide Railway Station – Sequence of Events

There was about a seven minute period between the arrival of train 103G (06:47:10) and the time that the driver was observed boarding train H307 (06:54:16). The driver advised that upon arrival at Adelaide, he isolated the cabin of train 103G before going for a toilet break. Considering a number of factors, it would appear consistent that seven minutes would be a reasonable time to isolate the cabin, pack and collect his kit bag, go to the toilet then to board train H307.

At the time the driver boarded train H307, there was still approximately six minutes before the scheduled departure time. This would normally be sufficient time to prepare a train for departure. Indeed, video evidence from the platform camera indicated that the driver did not appear to be in a rush. The video shows the driver entering the guard's vestibule and driver's cab, securing the doors, turning on the cab light and beginning the preparations for departure. Approximately two minutes passed during these actions.

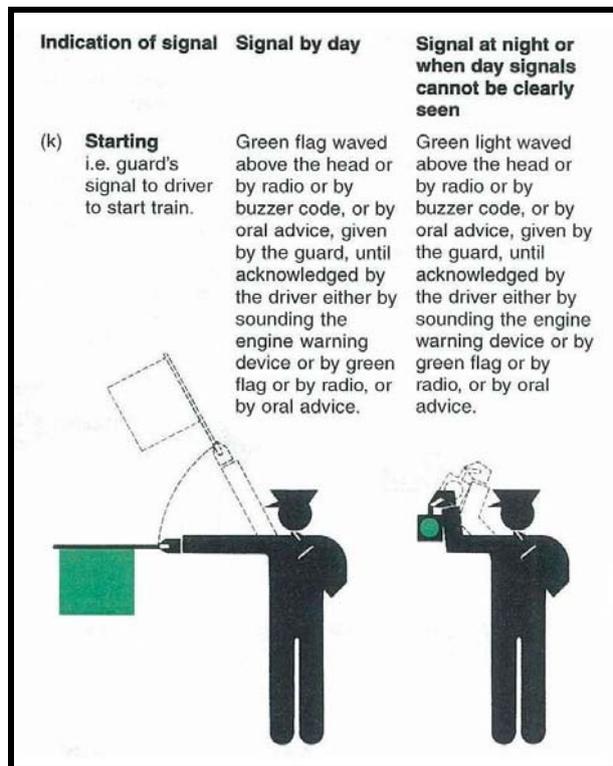
Figure 7: Rule 43(k) – 'Starting' hand signal

Rule 43(k) defines the 'Starting' signal and is illustrated in Figure 7.

One of the functions performed by a PSA who is travelling on a TransAdelaide train is to provide RoW on departure from Adelaide Railway Station. This function is equivalent to the role of the Guard referenced in the addenda dated 9 June 1991. The hand signal specified in this document is the 'Starting' signal (Figure 7 on page 40).

These requirements have carried over to TransAdelaide’s draft version of the *General Instruction and Addenda to the Working Timetable*. However, the draft addenda February 1999 is inconsistent by making reference to both the ‘Starting’ signal (Figure 7 on page 40) and the ‘All clear or proceed’ signal (Figure 9 on page 42) when RoW is provided by the PC. When RoW is provided by the PSA, the ‘Starting’ signal (Figure 7) is specified as the required hand signal to give RoW to a driver.

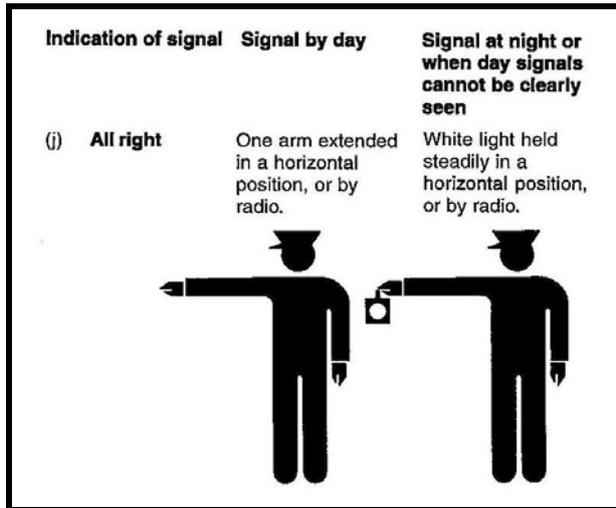
Figure 8: Rule 43(j) – ‘All Right’ hand signal

One function of a PC is to provide RoW to DOO trains departing from Adelaide Railway Station. This function is equivalent to the role of the Station Supervisor referenced in the addenda dated 9 June 1991. The hand signal specified in this document is the 'All Right' signal as defined in rule 43(j) (illustrated in Figure 8). This differs when referring to the draft addenda dated February 1999. Here the function of the PC is defined as that of a Qualified Worker on a DOO movement. The hand signal specified is the Starting signal (Figure 7 on page 40).

While examining the actual work practices of the PC, the investigation team observed inconsistencies in the execution of hand signals intended to provide the driver with RoW. In some cases RoW was provided using the 'All clear or proceed' signal (Figure 9). However, in many cases the investigation team observed the PC giving RoW using a steady green flag or light held in front of the body which is not a valid hand signal as defined in the operating rules. In other cases, RoW was observed using an outreached arm with no flag or light which is the 'All right' signal (Figure 8 on page 41).

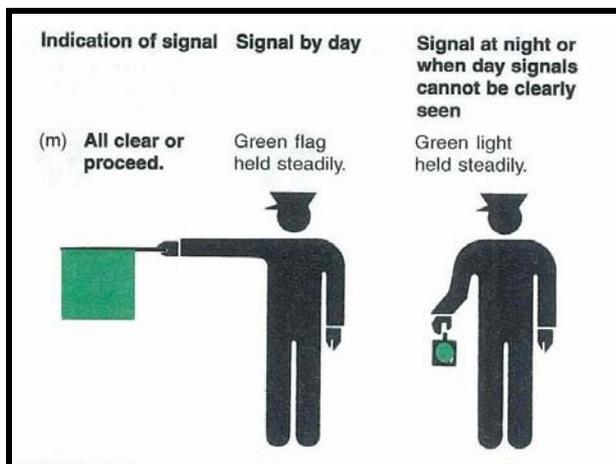
Figure 9: Rule 43(m) – ‘All clear or proceed’ hand signal

However, TransAdelaide advised that the current practice for the PC was to give the ‘All clear or proceed’ signal as defined in rule 43(m), to provide RoW to the driver. Rule 43(m) is illustrated in Figure 9 on page 42. This practice differs from the functions defined in both versions of TransAdelaide’s *General Instruction and Addenda to the Working Timetable*. Only in the draft addenda dated February 1999, under the section documenting the roles of a Suburban Train Driver when operating a driver-only train, is there reference to a Qualified Worker giving “...the ‘ALL CLEAR’ signal...”. (Noting that subsequent paragraphs continue to make inconsistent reference to the ‘Start’ signal.)

It is an acknowledged principle of railway operations that a steady green lamp/light indicates to a train driver that the track/line ahead is safe and clear for his/her train movement. To use a steady green lamp/light to indicate any other meaning exposes the system to risk. The original Rule Book of the South Australian Railways (1947) recognises this risk as there is no valid hand signal defined that displays a steady green lamp/light. The *Common General Operating Rules* were derived from the original rule book; however, a hand signal in the form of a steady green lamp/light was included, most likely to reflect the operations of the Commonwealth Railways²¹. This hand signal was defined as 'All clear or proceed', illustrated in Figure 9 on page 42.
