Collision between freight trains 2MP9 and 2MP1

Mile End, South Australia | 31 March 2015

ATSB Transport Safety Report
Rail Occurrence Investigation
RO-2015-007
Final – 16 December 2015

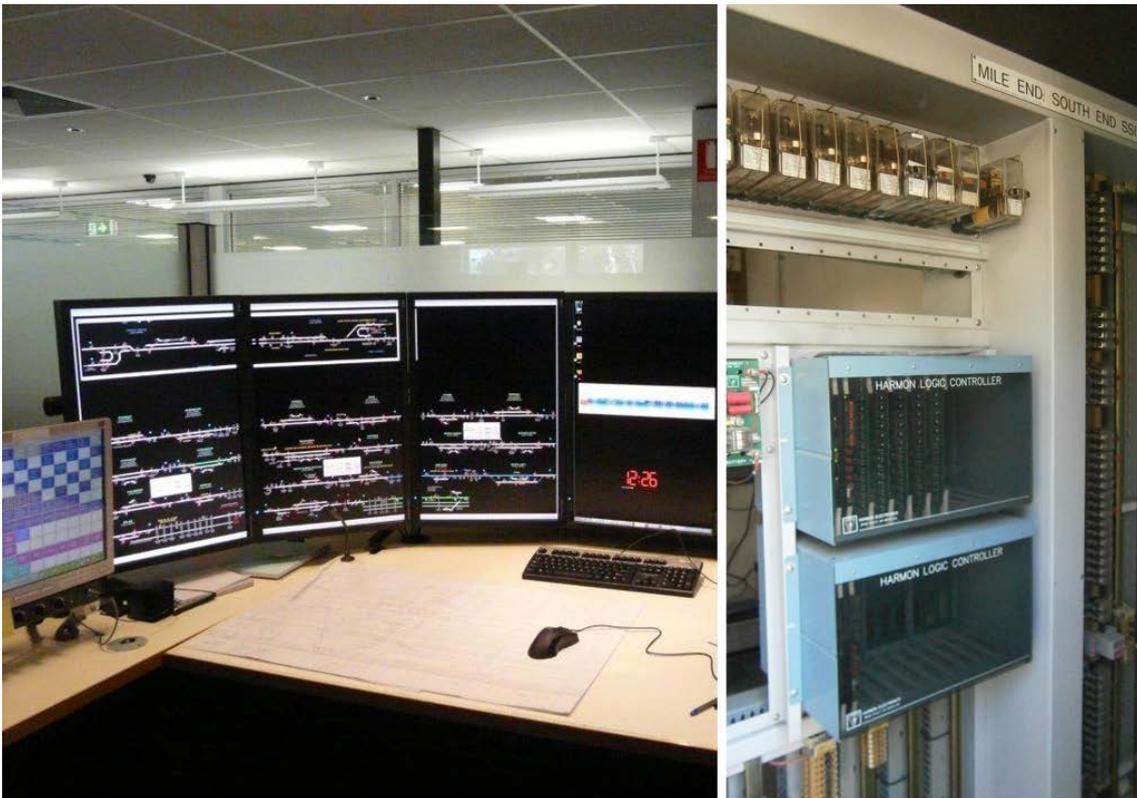
Figure 11: Adelaide metro network control board (left photo) and Harmon vital logic controller (right photo)

Signals and points at Mile End were remotely operated from a network control centre located at Mile End in South Australia, using the ARTC's Phoenix control system (Figure 11, left photo – Adelaide metro network control board). The Phoenix system is a non-vital⁵ CTC⁶ system that provides real time monitoring and control of field hardware including signals, points, track circuits and the associated management of train movements. The system also includes an event logger to capture signal, points, track and train movement data.

The fail-safe⁷ interlocking functions for the Mile End crossing loop were achieved using a vital logic controller (VLC). The Harmon VLC (Figure 11, right photo) was programmed to facilitate the safe movement of trains and incorporates two distinct levels of computer coding:
