ATSB TRANSPORT SAFETY REPORT
Rail Occurrence Investigation RO-2009-009
Final

Reported signal irregularity at Cootamundra NSW involving trains ST22 and 4MB7

12 November 2009

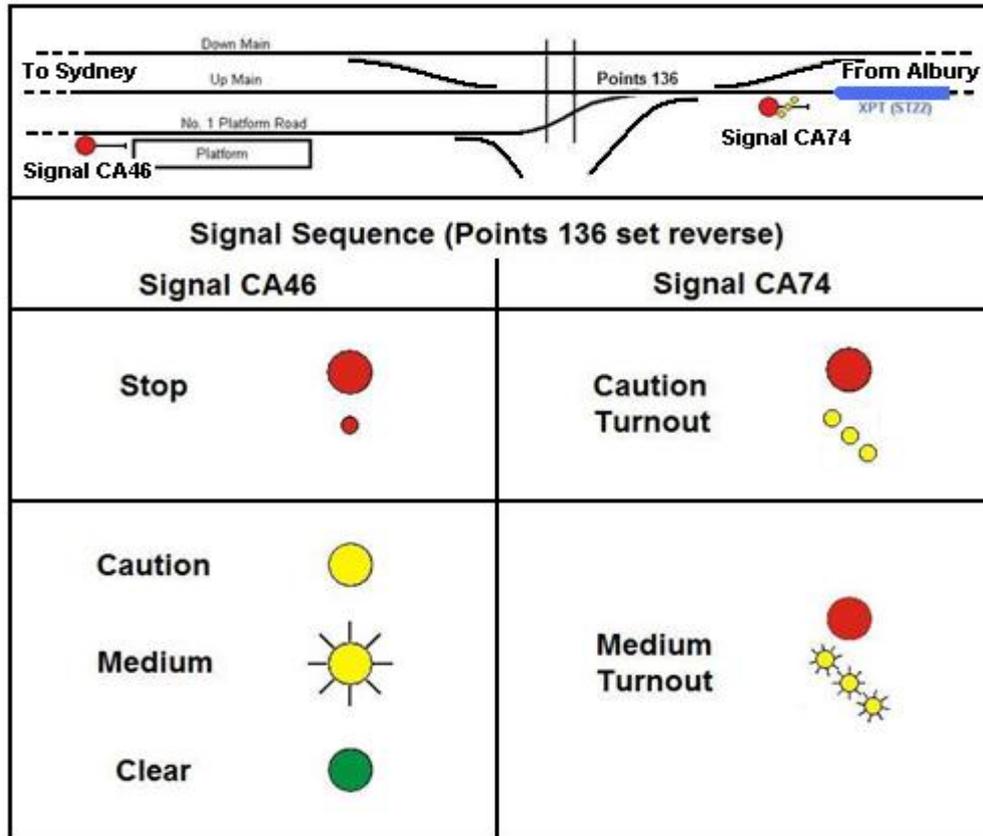
Figure 8: Signal sequence for signals CA74 and CA46

Figure 8 shows the signal sequence displayed to a train driver travelling from signal CA74 up to signal CA46 on No.1 Platform Road (points 136 set reverse). A Caution Turnout indication is displayed on signal CA74 when signal CA46 is at stop. A Medium Turnout indication is displayed on signal CA74 when signal CA46 displays a proceed indication (Caution, Medium or Clear). In each case, displaying a proceed indication on signal CA74 implies that the route up to signal CA46 will be unobstructed.

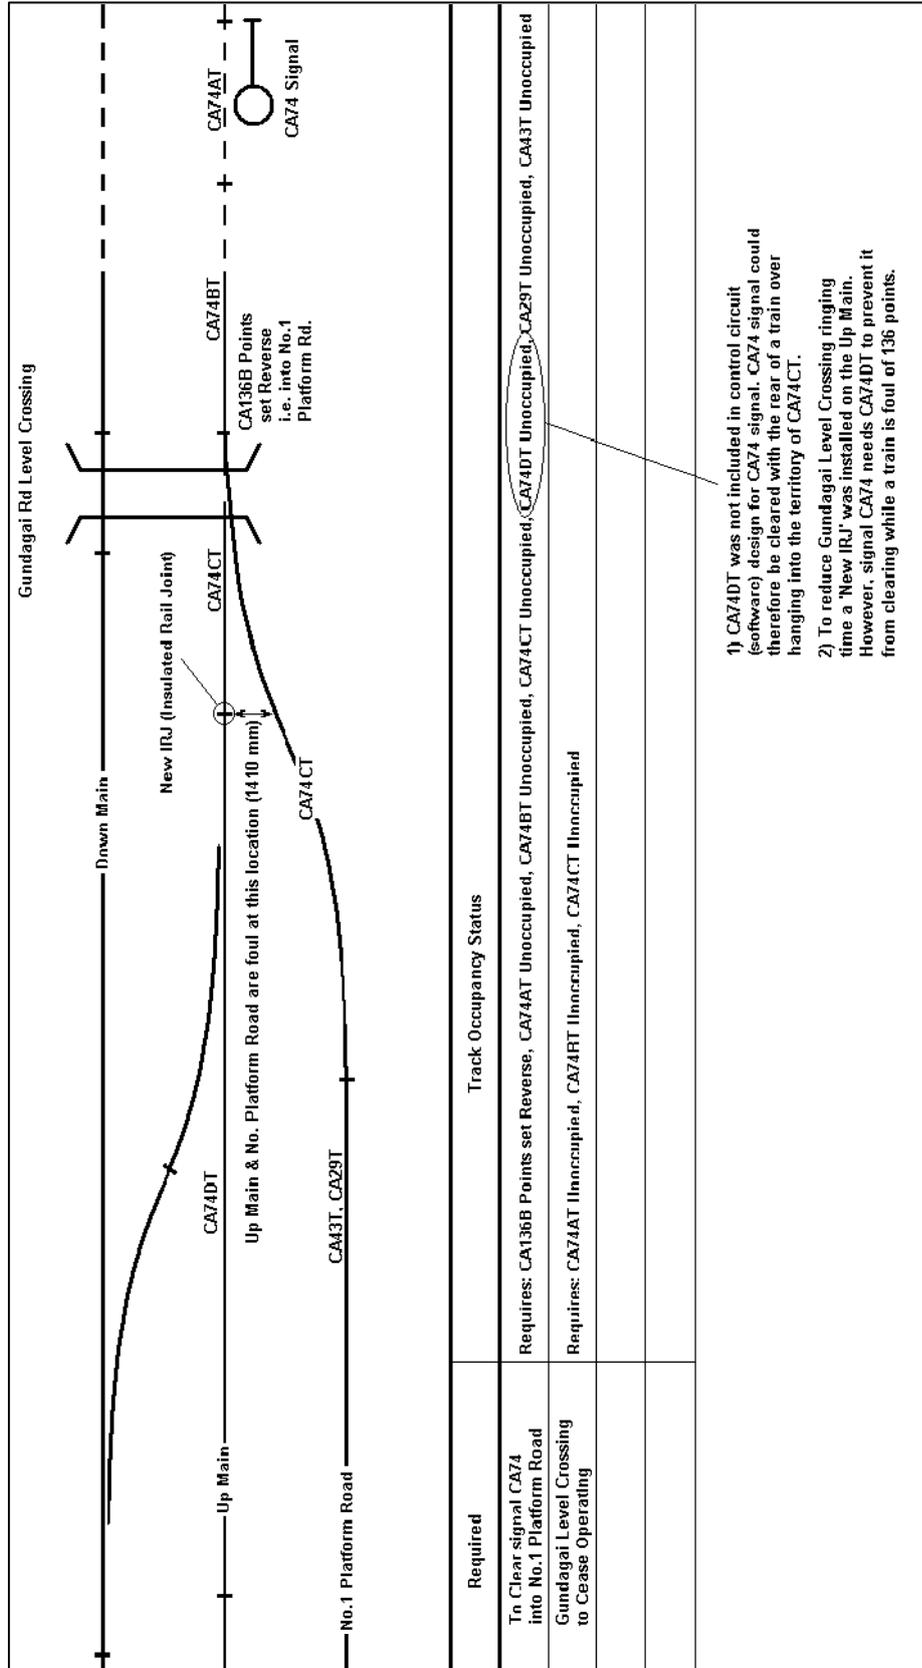
Figure 24: Cootamundra - Simplified signalling arrangement plan and control table

With the introduction of automatic level crossing operation at Gundagai Road, the original track circuit over CA133 points to CA136 points was split into two and became CA74C and CA74D tracks. This was done to minimise the level crossing ringing time. With no information shown on the signalling arrangement plan¹⁵ the joint between CA74C track and CA74D track was incorrectly used as the clearance point for signalled moves from CA74 signal into No.1 Platform Road. Figure 24, shows a simplified control table and signalling arrangement plan at the point of interest. It can be noted that the inclusion of CA74D track into the logic code for signal CA74 prevents it from clearing until CA74D track section is unobstructed.
