**ATSB TRANSPORT SAFETY REPORT**  
Rail Occurrence Investigation  
RO-2010-002  
Final

**Safeworking irregularity involving a  
freight train and an empty passenger train  
at Manildra, NSW  
10 February 2010**

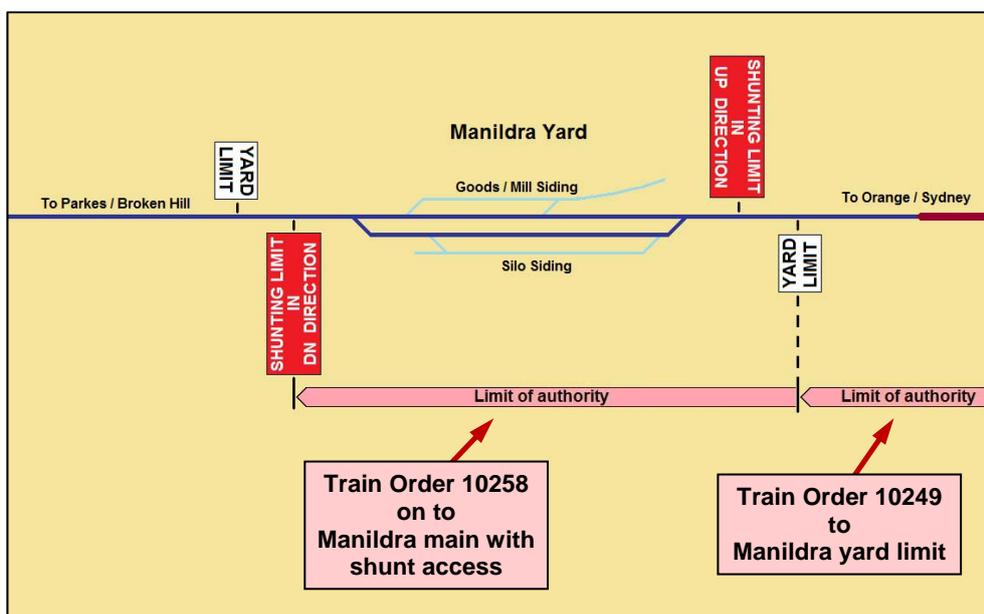
**Figure 4: Train 9837**

At 0845 on Wednesday 10 February 2010, a Pacific National train crew (one driver, one acting driver trainer and one trainee assistant driver) signed on duty at Parkes before travelling by car to Orange East Fork to relieve the crew of Pacific National freight train 9837. The train travelled to Manildra under the authorisation of train order 10249 and arrived at the yard limit board at about 1150. The crew received train order 10258 (with shunt access) at 1205, authorising them to enter the yard and undertake shunt operations within the yard. They continued shunting until about 1250 at which time the locomotives and wagons were positioned clear of the main line to allow train 8134 to pass through the yard. Figure 4 illustrates the limits of authority given to freight train 9837.

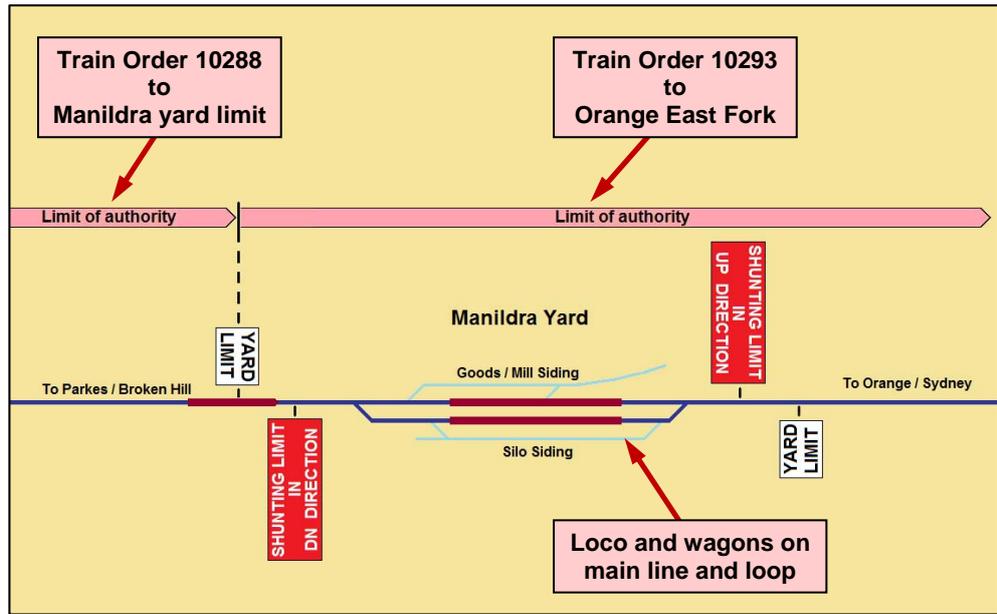
Figure 6: Train WP46

Train WP46 (an empty Xplorer passenger train) was travelling from Parkes, having received train order 10288 at 1554 authorising them to travel up to the Manildra yard limit board. At about 1630, the crew of train WP46 reported in at Bumberry (about 22 km before Manildra) and received new train order 10293 authorising them to pass through Manildra and continue to Orange East Fork. About 10 minutes later, while approaching the Manildra yard limit, the driver could hear radio chatter relating to preparation of train 8938 at Manildra. The driver broadcast, over the local radio<sup>6</sup>, an announcement that he had a train order for the main line at Manildra and was passing the yard limit board. The driver of the freight train immediately told him to 'Red Light' (stop) because their train was occupying the main line. Train WP46 had already passed the yard limit board, but the driver had also sighted and reacted to a main line indicator located more than 530 m before the track occupied by freight train. The MLI was showing a red (stop) indication and the driver brought train WP46 to a stop before passing the MLI. Figure 6 illustrates the limits of authority given to train WP46, even though the freight train was occupying the main line and there were wagons on the loop in Manildra Yard.
