Signal passed at danger by XPT ST24

Henty, New South Wales
5 February 2011

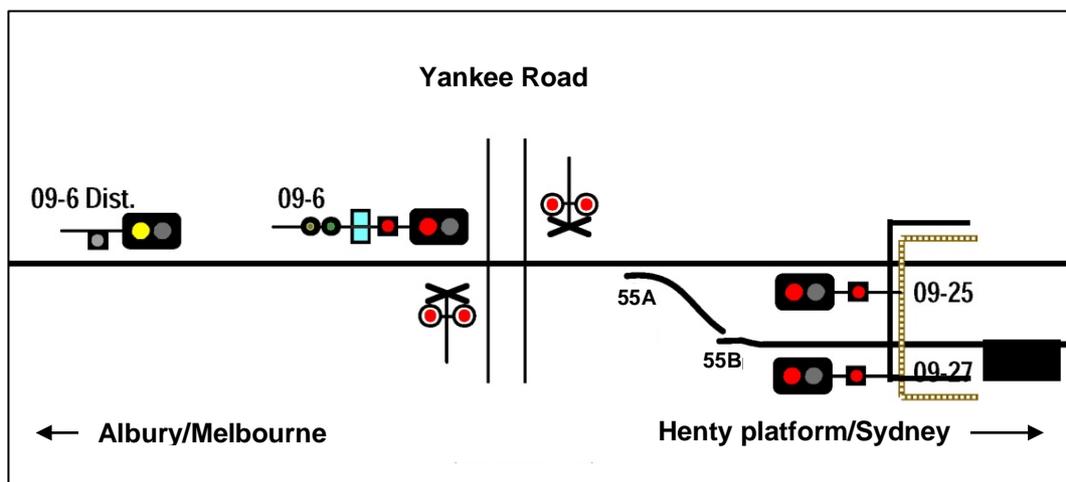
Figure 1: Henty signalling layout

The rail line from Melbourne to Henty and Henty to Junee⁴ comprised a single line bi-directional track, controlled by fixed colour light signals using Rail Vehicle Detection (RVD)⁵, remotely operated from the Junee Network Control Centre. The boundaries of Henty station yard were defined by Up home and Down outer home signals. Trains travelling in the Up direction, approaching Henty from the south, (the direction ST24 was travelling) encounter a location sign that indicates the approach to Henty station. About 500 m beyond the location sign was a two aspect colour light distant signal (09-6 Dist - Figure 1) that was capable of displaying either a Caution (yellow) or Clear (green) indication.

If the home signal displays a Stop or restricted indication the distant signal displays Caution. In this instance, the driver should slow the train, enabling it to be stopped at the home signal (09-6) as necessary. At Henty, the Up home signal was located about 2 km from the Up distant signal.
