Safeworking breach – Track machine BC7

Bogan Gate, New South Wales | 15 August 2011

ATSB Transport Safety Report
Rail Occurrence Investigation
RO-2011-013
Final

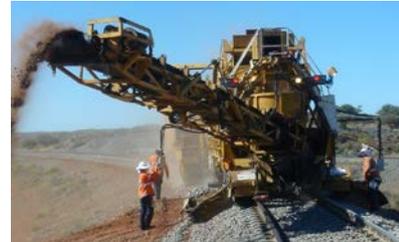
Track machine BC7 was a shoulder ballast cleaner which comprised 12 axles, had a total length of 62 m, weighed 176 t and had an allowable maximum speed of 50 km/h. Track machine BC7 was being operated by the rail division of John Holland Group (JHG) under contract to the Australian Rail Track Corporation (ARTC) at the time of the incident.
