# Safeworking breaches involving Absolute Signal Blocking

Blackheath, NSW, 13 June 2013  
Newcastle, NSW, 13 July 2013  
Wollstonecraft, NSW, 17 July 2013

**ATSB Transport Safety Report**  
Rail Occurrence Investigation  
RO-2013-018  
Final – 2 March 2015

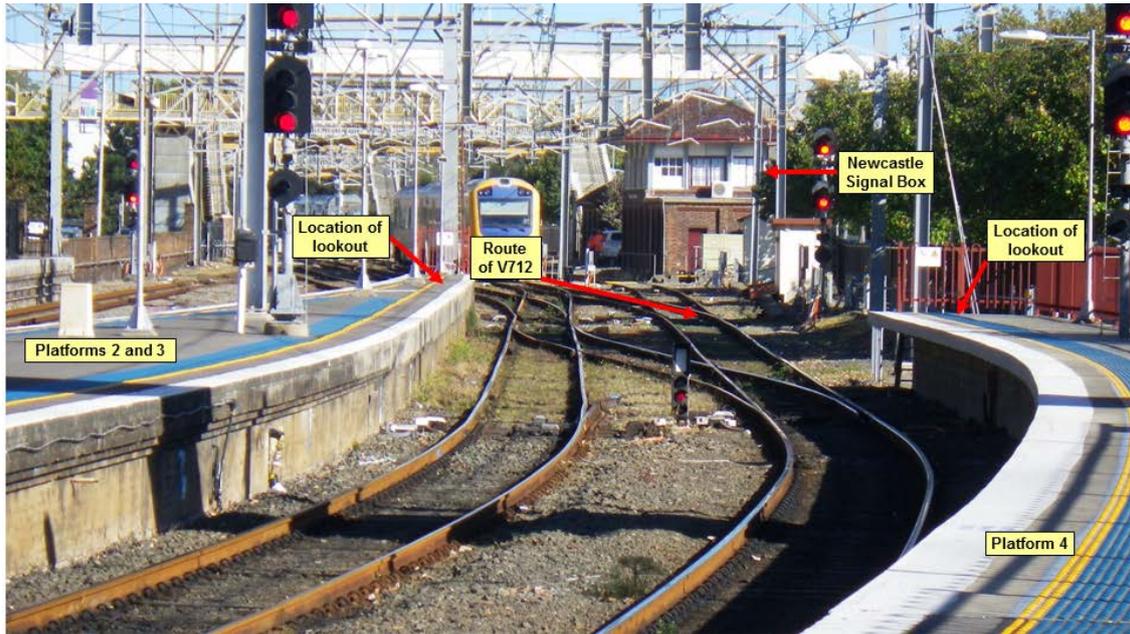
**Figure 3: Worksite at Newcastle**

At about 0800, the PO for a contractor workgroup comprising of six workers commenced a pre-work briefing for the planned litter reduction on track between the platforms at Newcastle Station (Figure 1).

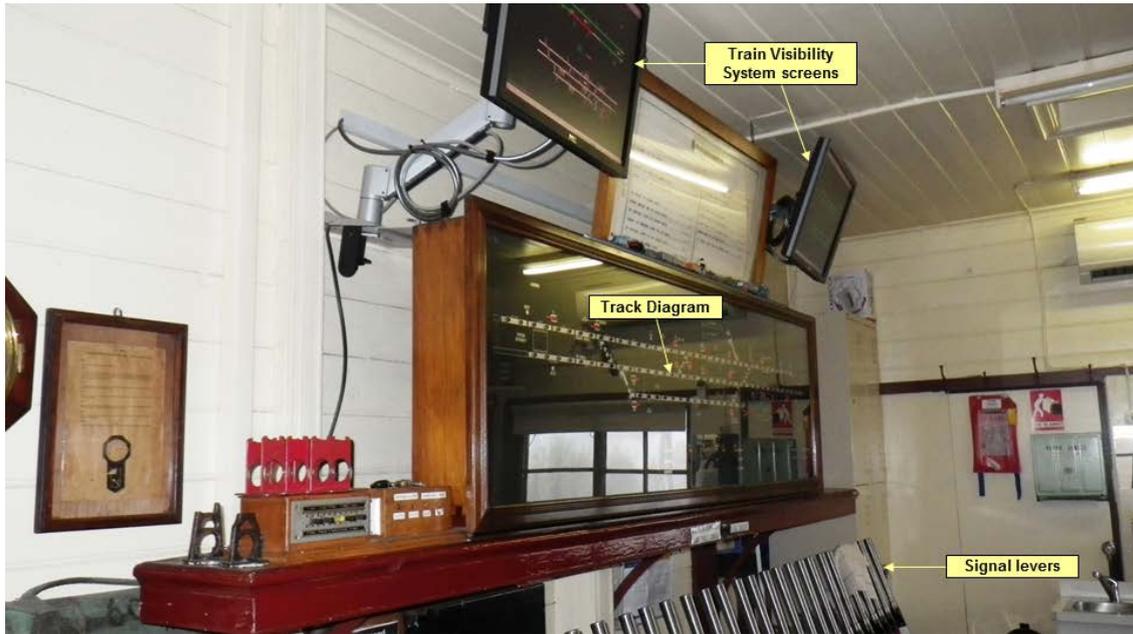
**Figure 5: Katoomba signal box**

The Signaller at Katoomba monitored train movements in his area of control using the signal diagram and a TVS screen mounted each side of the diagram (Figure 5). However, as the TVS screens are non-vital equipment, Sydney Trains directives do not permit their use to ascertain the location of trains for safeworking purposes e.g., the granting of ASB.

Having departed Katoomba, W521, at best, would have only been displayed on the last two indication lights of the track diagram and/or the first couple of track circuits depicted on the top left corner of the right hand TVS screen for the Katoomba to Mt Victoria section (Figure 5). As such, it was at this stage that the Signaller had the least visibility of W521 and he did not establish its precise location directly from either the driver or the Signaller at Mt Victoria. It was also at this stage that the Signaller commenced the most active period of the ASB; when he was required to set signals and points, apply blocking facilities, telephone various parties and record information in the Train Register Book (TRB). Although a guide only, it should be noted that the TVS screen for the Katoomba to Mt Victoria section also faced slightly away from the view of the Signaller and was not positioned for clear visibility from near the TRB and the telephone in the box.

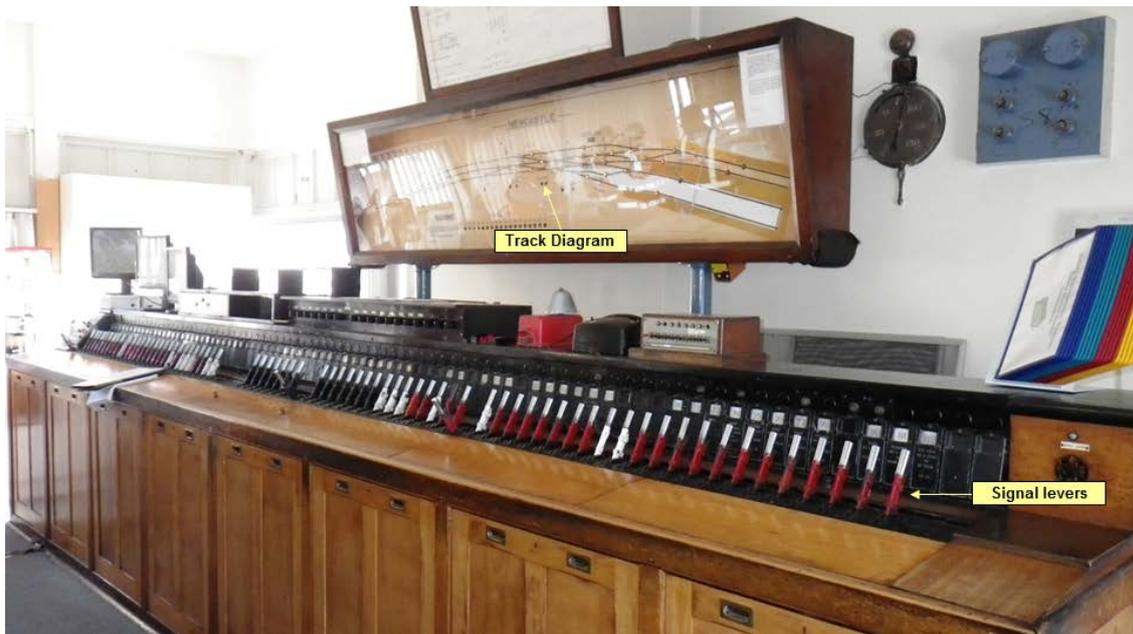
**Figure 6: Newcastle Signal Box**

Both Katoomba and Newcastle Signal Boxes (Figure 6) are equipped with track diagrams to provide signallers with information regarding the location of trains and the status of track circuits, absolute signals and points in their area of control. Although the diagrams are simplistic, they are permitted for use in safeworking as they indicate the actual location of trains and the state of the equipment controlled by the signal box.

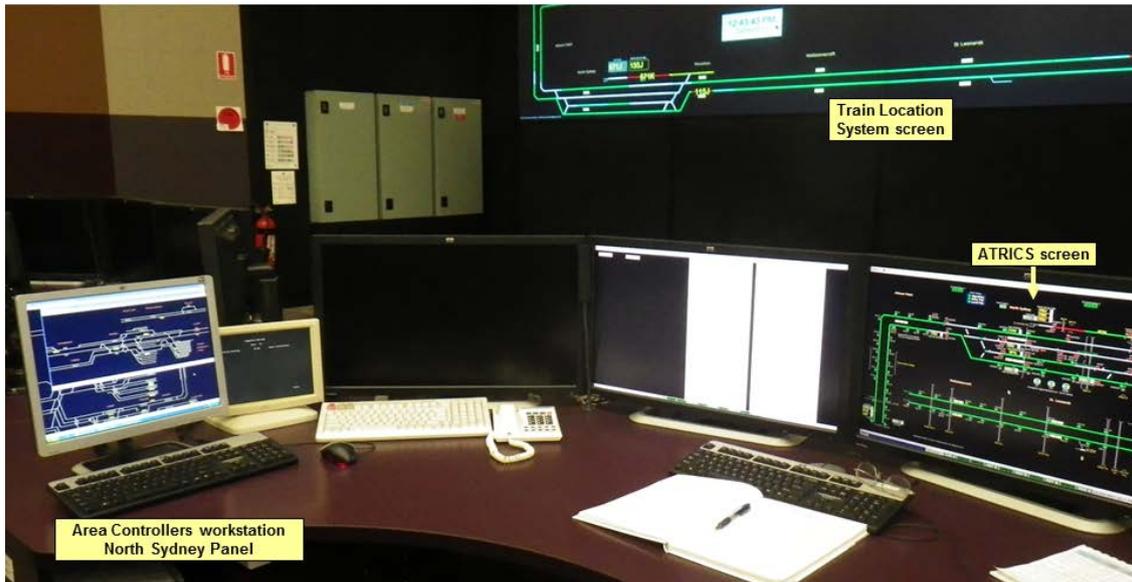
**Figure 7: Homebush signal complex – North Sydney control panel**

The area controller's area of responsibility is displayed over multiple computer monitors. The North Sydney control panel is shown in Figure 7.
