RAILWAY ACCIDENT INVESTIGATION UNIT IRELAND

INVESTIGATION REPORT

Investigation into SPADs on IÉ Network, from January 2012 to June 2015

RAIU Report No: R2016 – R001

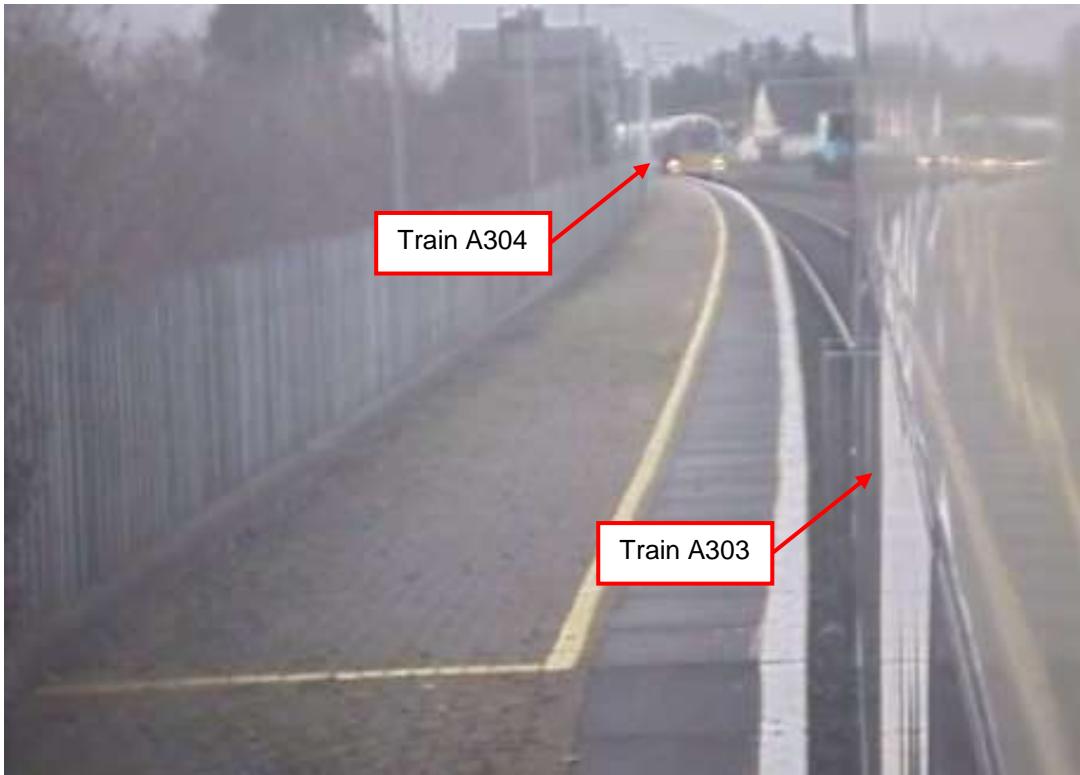
165 The drivers of Train A303 and Train A304 both responded with brake applications with the trains coming to a stop 175m apart, facing one another, on Millstreet Station Platform. Train A303 had passed Signal TL223 by 384m and was 56m along the length of Millstreet Station Platform, see Figure 19.

Figure 19 – Train A303 & Train A304 stopped 175 m apart on Millstreet Station Platform after the SPAD

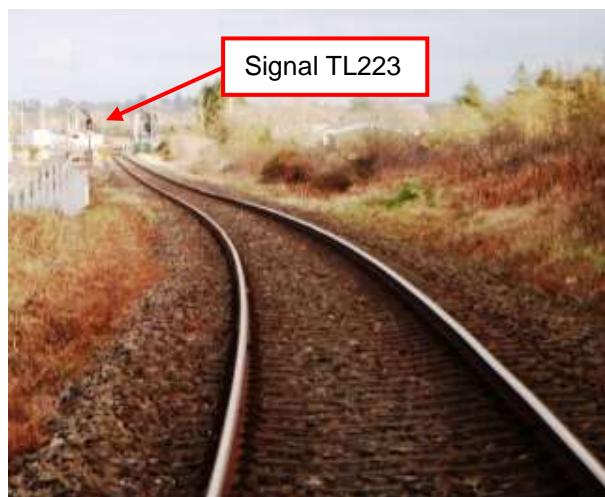
191 On the driver's approach of Signal TL223, the signal comes into view, across a curve, from a distance of 435 m, Figure 23. There is then a clear view of Signal TL223 on the straight line from a distance of 370 m. The minimum required sighting distance for a line speed of 80 mph (128 km/h), as set out in I-SIG-2043 (discussed in paragraphs 30 - 34), is 286 m; therefore the actual sighting distance of 370 m exceeds the requirements set out in the standard.

Figure 23 – View of Signal TL223 on curve

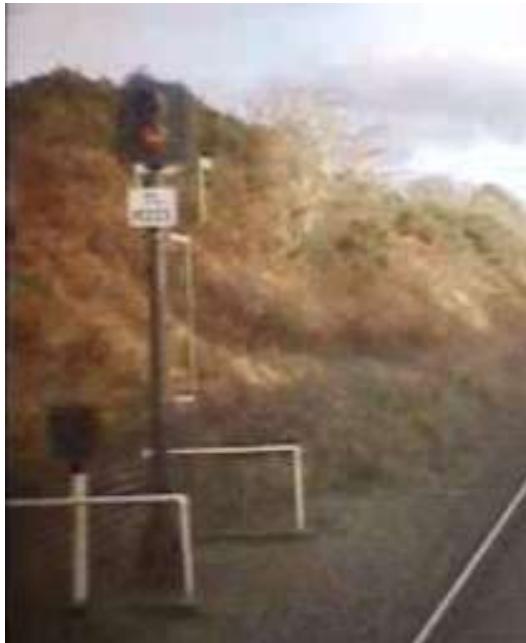
193 The aspects displayed on the day of the incident, as outlined in the sequence of events, was confirmed by forward facing CCTV on board Train A303 i.e. that Signal TLR223 was displaying a yellow aspect (see Figure 25), and Signal TL223 was displaying a red aspect as Train A303 approached the signals (see Figure 26).

Figure 25 – Train A303 CCTV download, showing Signal TLR223 displaying a yellow aspect

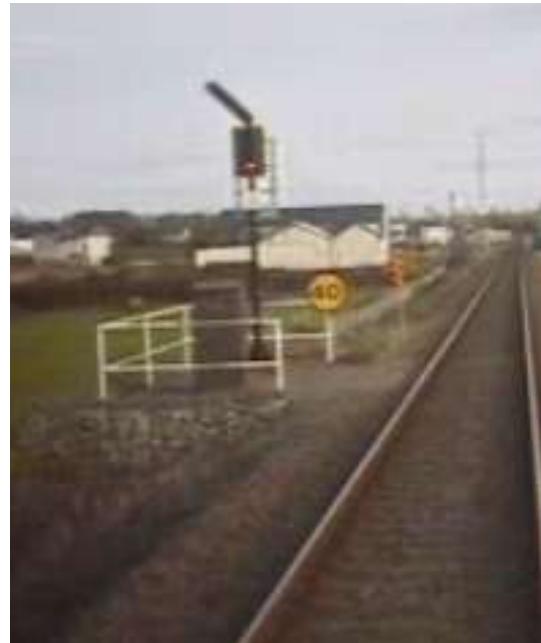
Figure 26 – Train A303 CCTV download, showing Signal TL223 displaying a red aspect and speed board

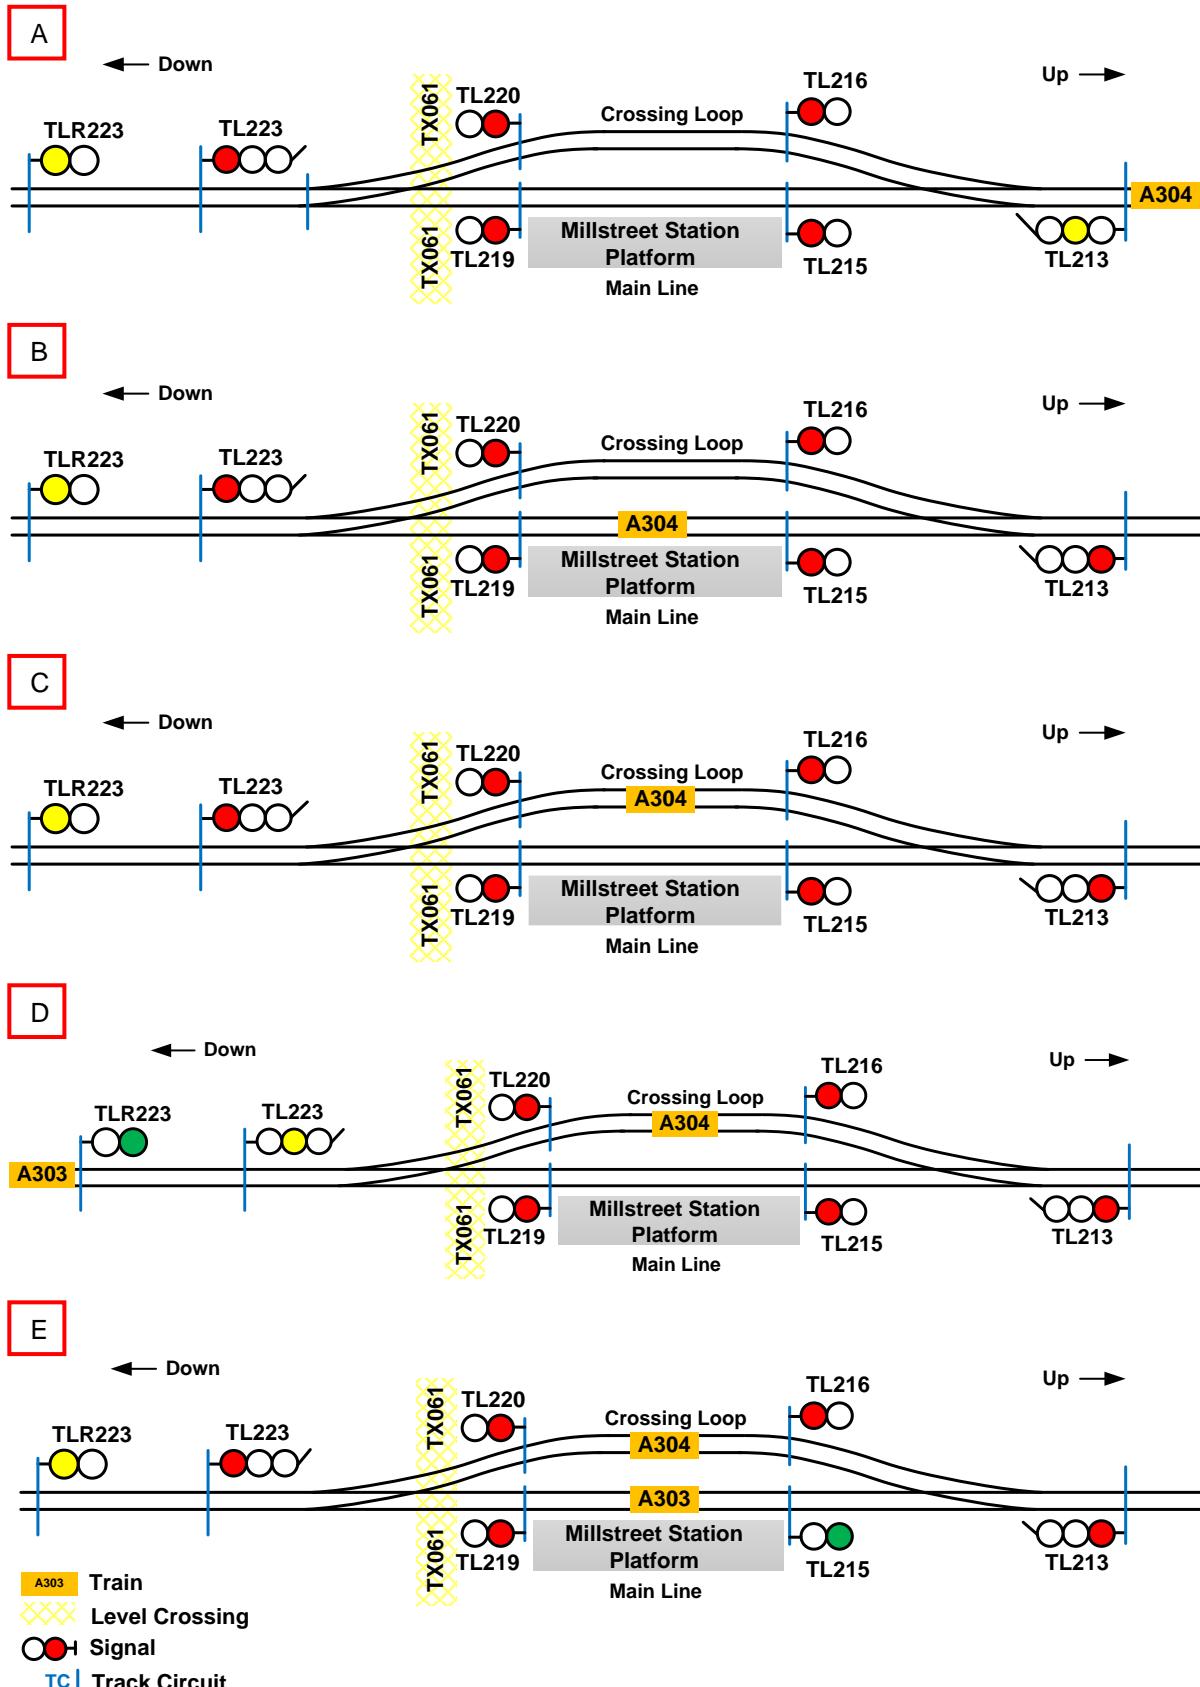
219 As a result, the Traffic Regulator and the CTC Signalman decided not to leave Train A304 waiting in Banteer Station for Train A303. Instead, they decided that they would send and accept Train A304 into Millstreet Station Platform, disembark passengers (Figure 29A) and then shunt the train into the crossing loop (Figure 29B) to wait for Train A303.

220 Train A303 would then be accepted into Millstreet Station Platform (Figure 29C&D), where it would disembark passengers and continue towards Heuston; and Train A304 would then continue towards Tralee.

Figure 29 – Traffic Regulator's planned sequence of movements for Train A303 and Train A304

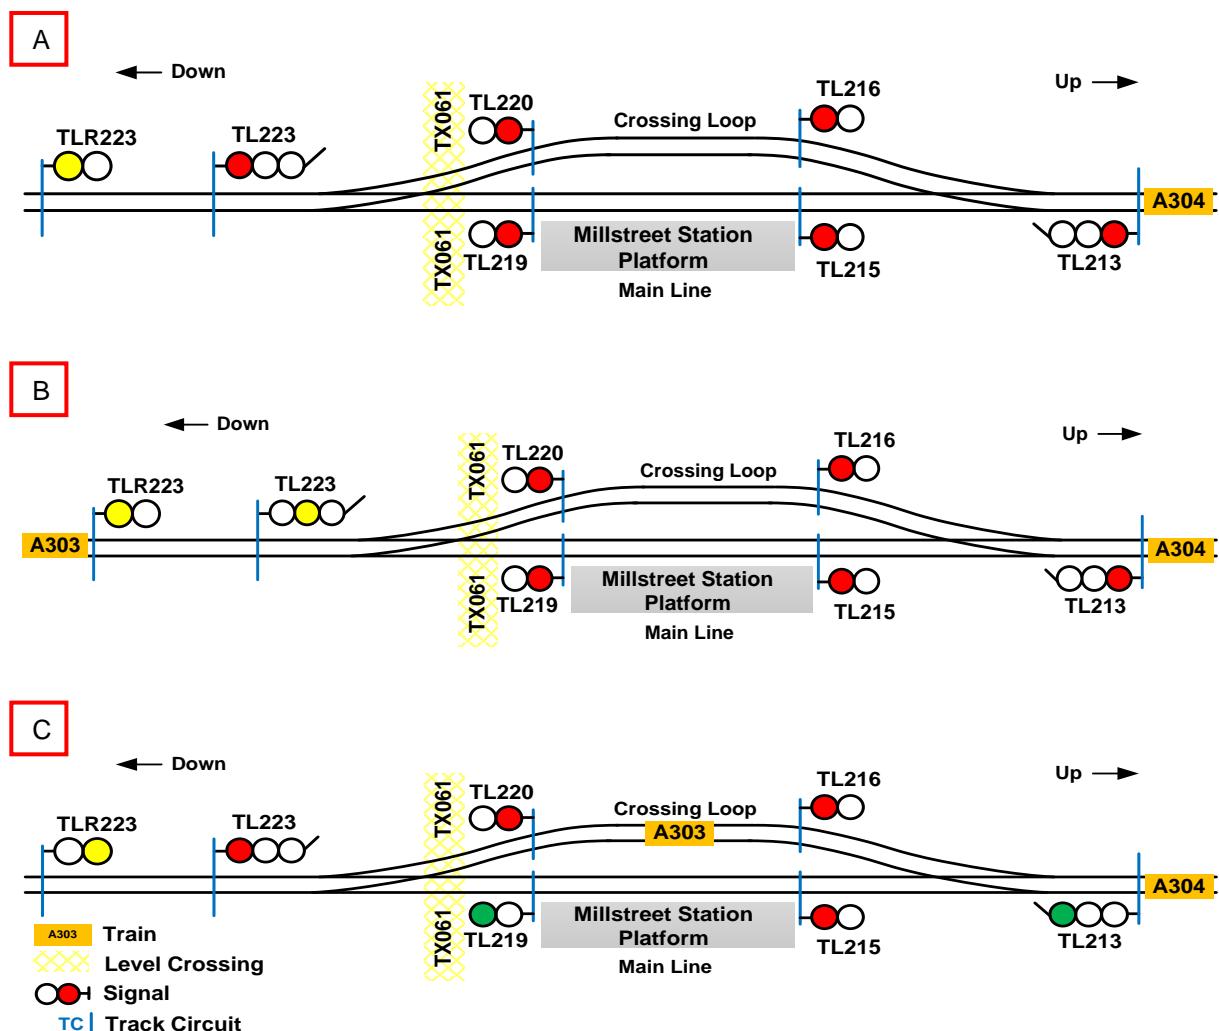
222 IÉ calculated, given the timings on the day of the incident, that the delay to Train A304 would have been reduced if Train A304 had been held at Signal TL213 (see Figure 30 A) the signal protecting the platform; to wait for the arrival of Train A303.

223 On the arrival of Train A303, it would be given the route directly into the crossing loop, while still holding Train A304 at Signal TL213 (see Figure 30 B&C). Once on the crossing loop, Train A304 could be routed onto Millstreet Station Platform and continue towards Tralee; Train A303 could carry out a shunt movement onto Millstreet Station Platform and continue towards Heuston.

Figure 30 – Alternative sequence

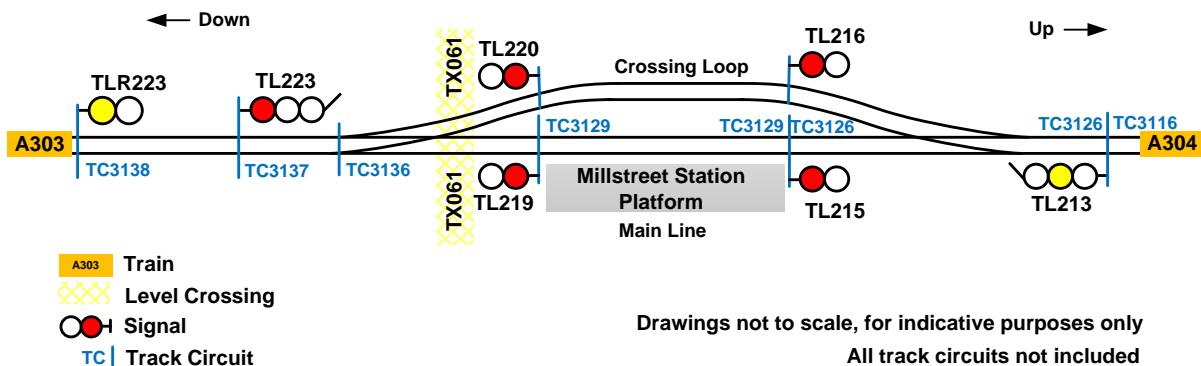
246 At approximately 13:11 hrs, Train A303 approaches Signal TLR223 in the up direction at the permitted line speed. Signal TLR223 is displaying a single yellow aspect (this is a cautionary proceed aspect, meaning the driver should be prepared to stop at the next signal, Signal TL223, which is displaying a red aspect). Train A303 was travelling at 68 mph (108 km/h) as it approached Signal TLR223. Signal TLR223 and TL223 are displaying yellow and red aspects, respectively, as Signal TL213 is displaying a yellow aspect, to allow Train A304 proceed into Millstreet Station Platform, see Figure 32.

Figure 32 – TLR223 displaying a cautionary aspect & TL213 displaying a cautionary aspect

247 Driver A303 did not have CAWS in cab and did not use any form EPT, such as RTC, to remind himself that the next signal, Signal TL223, would be displaying a red aspect.

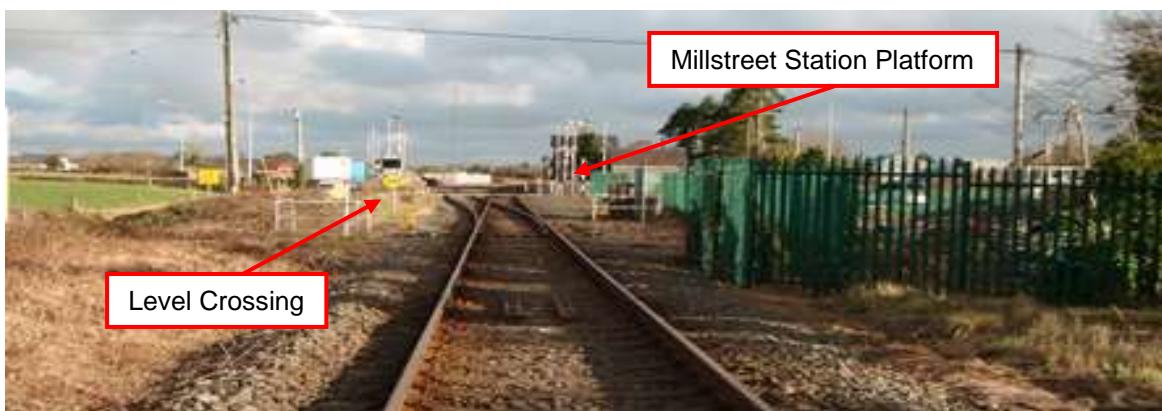
Figure 33 – Driver's view of approach into Millstreet Station

248 As Driver A303 approaches the level crossing, he sees that the barriers lowered and also sees the passengers waiting on Millstreet Station Platform, see Figure 33 for a driver's view into Millstreet Station. (Driver A303 assumes the barriers are lowered for his train, however, it was Train A304 who had initiated the lowering of the barriers).

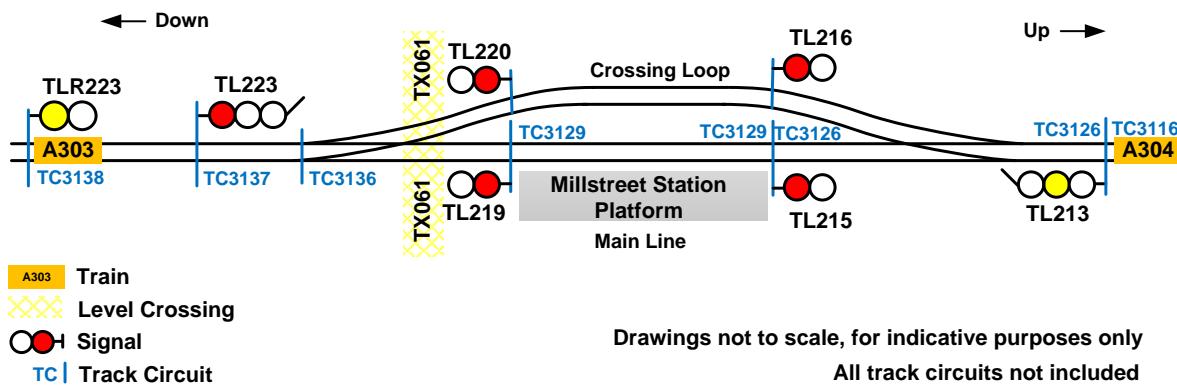
Figure 34 – Train A303 travelling past Signal TLR223 displaying a cautionary aspect

249 At 13:11:30 hrs Train A303, travels past Signal TLR223 displaying a single yellow aspect (cautionary), see Figure 34. An initial brake application is made by Driver A303 with the train reducing to 62 mph (99 km/h).

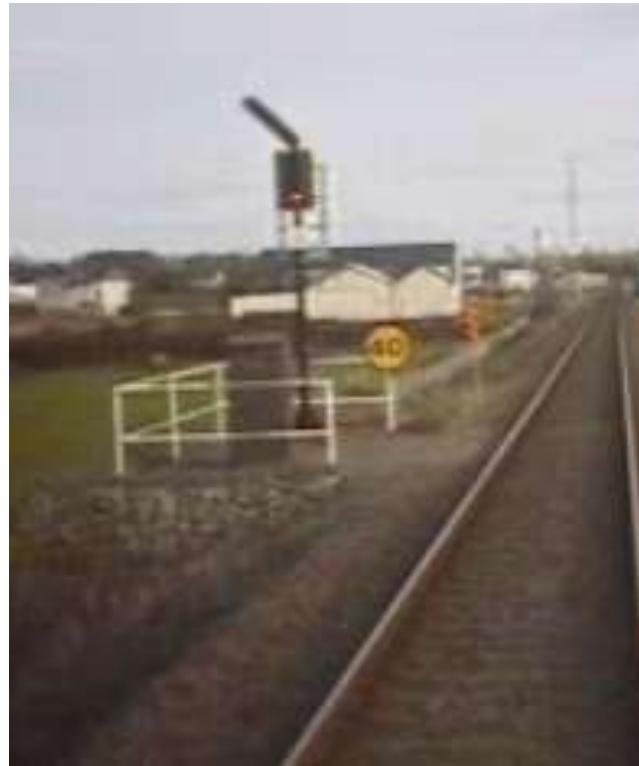
Figure 36 – Signal TL223 & speed board

253 Driver A303 applied the brake 12 m before Signal TL223, to adhere to the speed board located behind Signal TL223, see Figure 36.

278 Both Signal TLR223 and Signal TL223 met the sighting requirements set out in I-SIG-2043 (paragraphs 190 - 192). However, it is noted, although I-SIG-2043 addresses PSR boards ahead of signals, it does not appear to address TSR boards or distractions positioned directly behind signals. As a result, it appears that the positioning of a speed board placed behind Signal TL223 is not regarded as a risk, in terms of I-SIG-2043, this will be further discussed in Part 12 of this report.

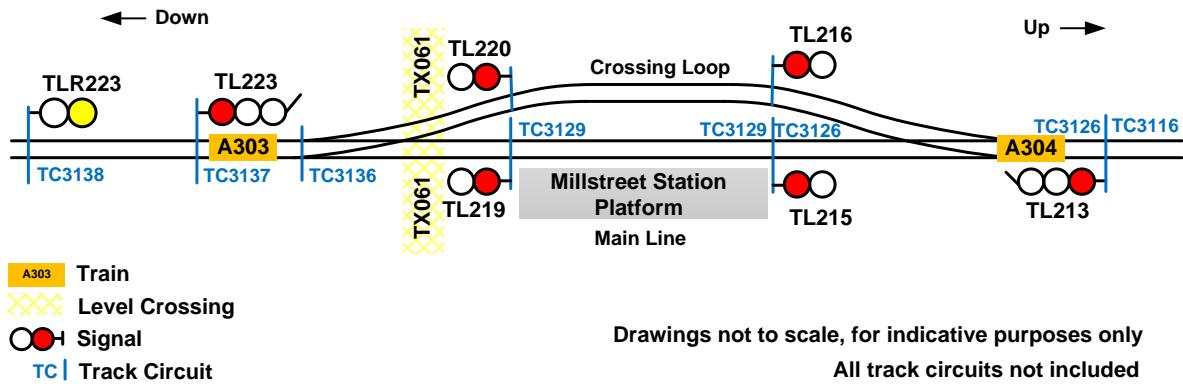
Figure 37 – Train A303 passing Signal TL223 displaying a red (danger) aspect

254 At 13:14 hrs Train A303 passes Signal TL223 at danger (red aspect); entering TC3137, see Figure 37. Train A303 is travelling at 39 mph (62 km/h) as it passes Signal TL223. Driver A303 reduces the speed to 26 mph (42 km/h) at the platform ramp.

313 The immediate cause of the SPAD was that Driver A303 did not see that Signal TL223 was displaying a stop aspect and continued driving towards Millstreet Station as if Signal TL223 was displaying a proceed aspect.

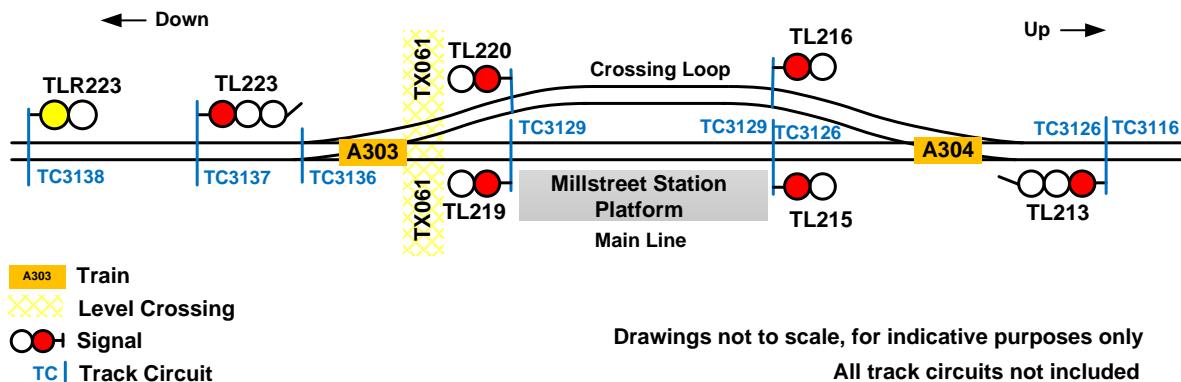
Figure 38 – Train A303 entering TC3136 section

255 At 13:13:00 hrs, the SPAD alarm activated at CTC for Millstreet Station, and is acknowledged by the CTC Signalman at 13:13:05 hrs. At 13:13:12 hrs the CTC Signalman makes a general call for both trains to stop. However when he initiated the call, he used the instructions "General call to Up Tralee – stop your train immediately!" and "Down train also stop immediately!". As the call is being made Train A303 enters TC3136, see Figure 38.

256 The PIC Millstreet, who was on the Millstreet Station Platform sees both Train A303 and Train A304 approaching the platform and immediately hand signals Train A303 to stop. Driver A303 does not see that the PIC Millstreet is trying to stop the train, but thinks that he is waving him into the platform.

307 The communications of the CTC Signalman were calm and direct (paragraph 255), where he made a general call to both drivers to immediately stop the trains; and the drivers immediately applied the brakes. However, it was noted, that some of the communications were not in line with safety critical communication requirements, e.g. he identified the trains as up and down trains instead of using the required ID numbers (paragraph 255).

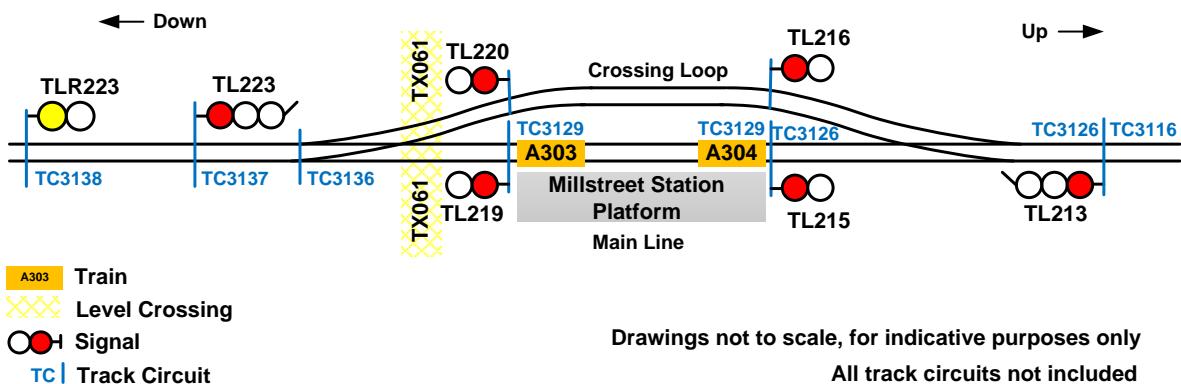
Figure 39 – Train A303 and Train A304 occupying TC3129 on Millstreet Station Platform

257 Driver A303 and Driver A304 apply the emergency brakes and the trains begin to come to a stop while occupying TC3129. Train A304 comes to a stop three seconds before Train A303. Train A303 and Train A304 are positioned 175 m apart after both coming to a stop on Millstreet Station Platform, see Figure 39.

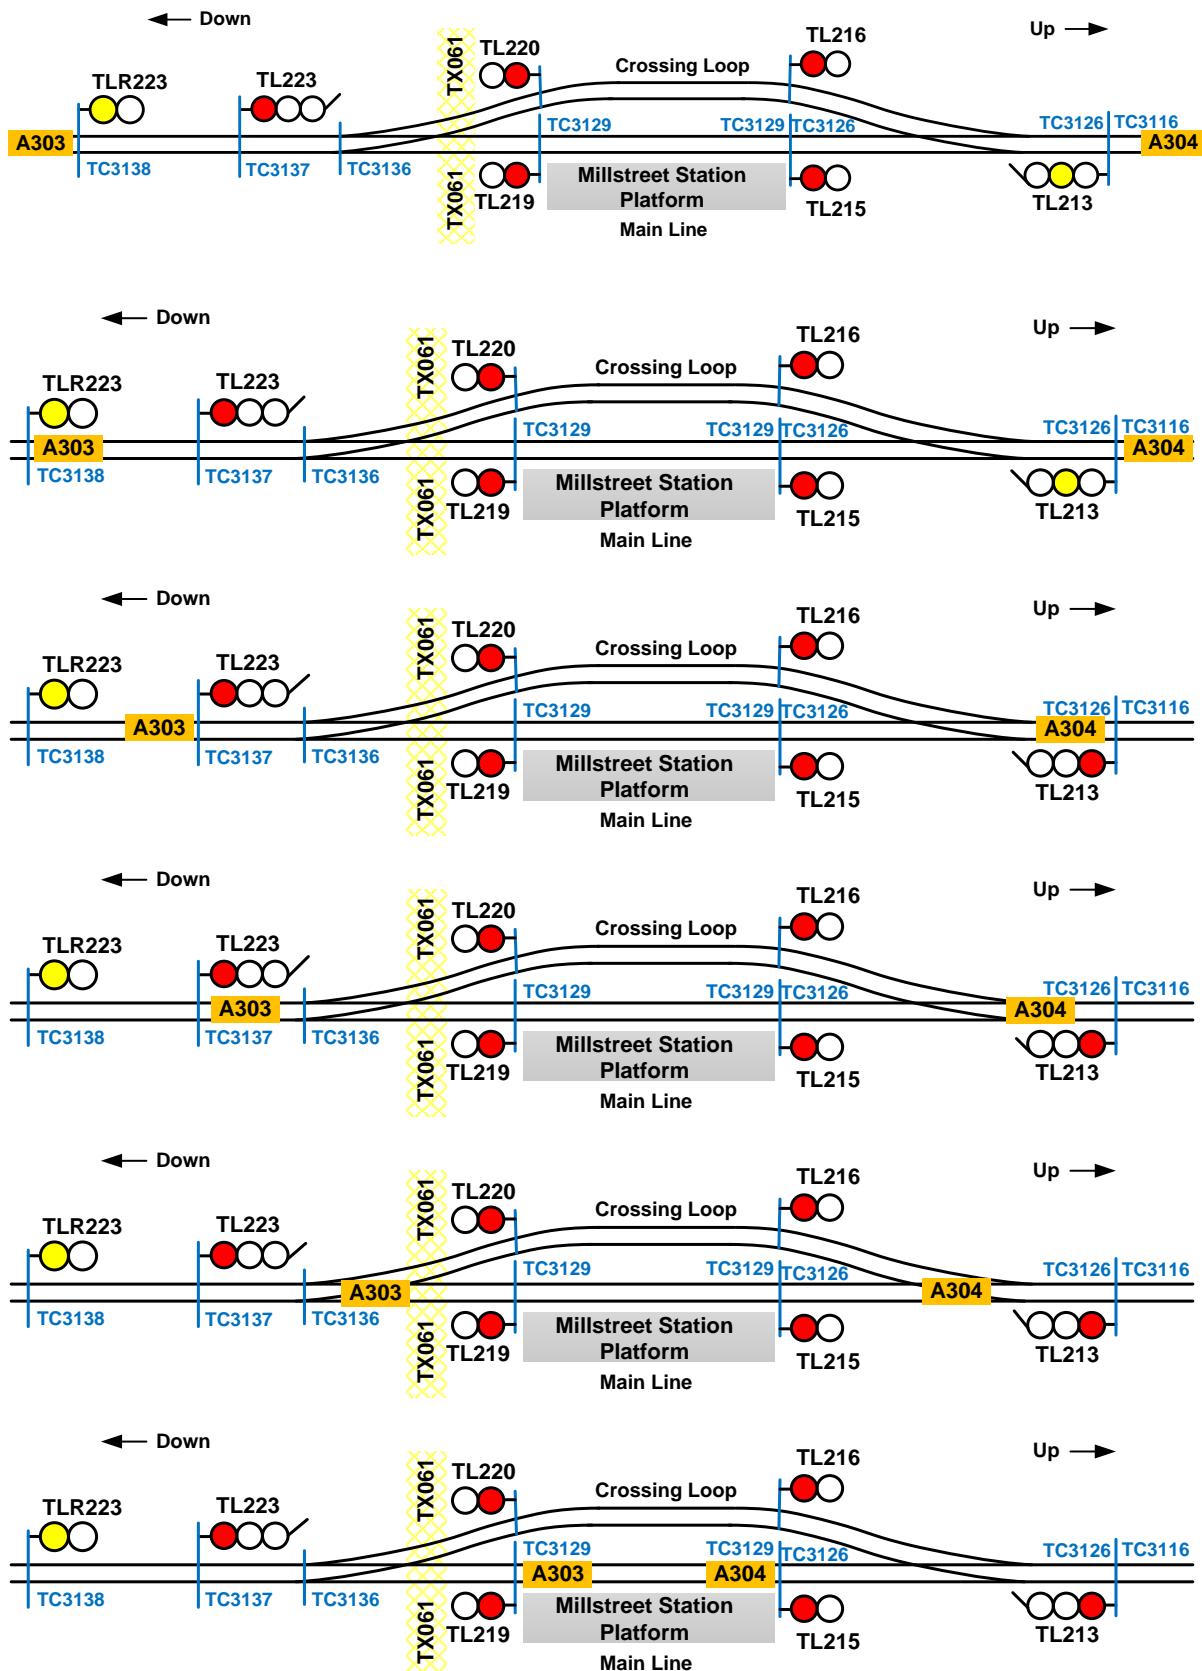
Figure 40 – Sequence of events during the incident

259 See Figure 40 for the diagrammatical summary of events.

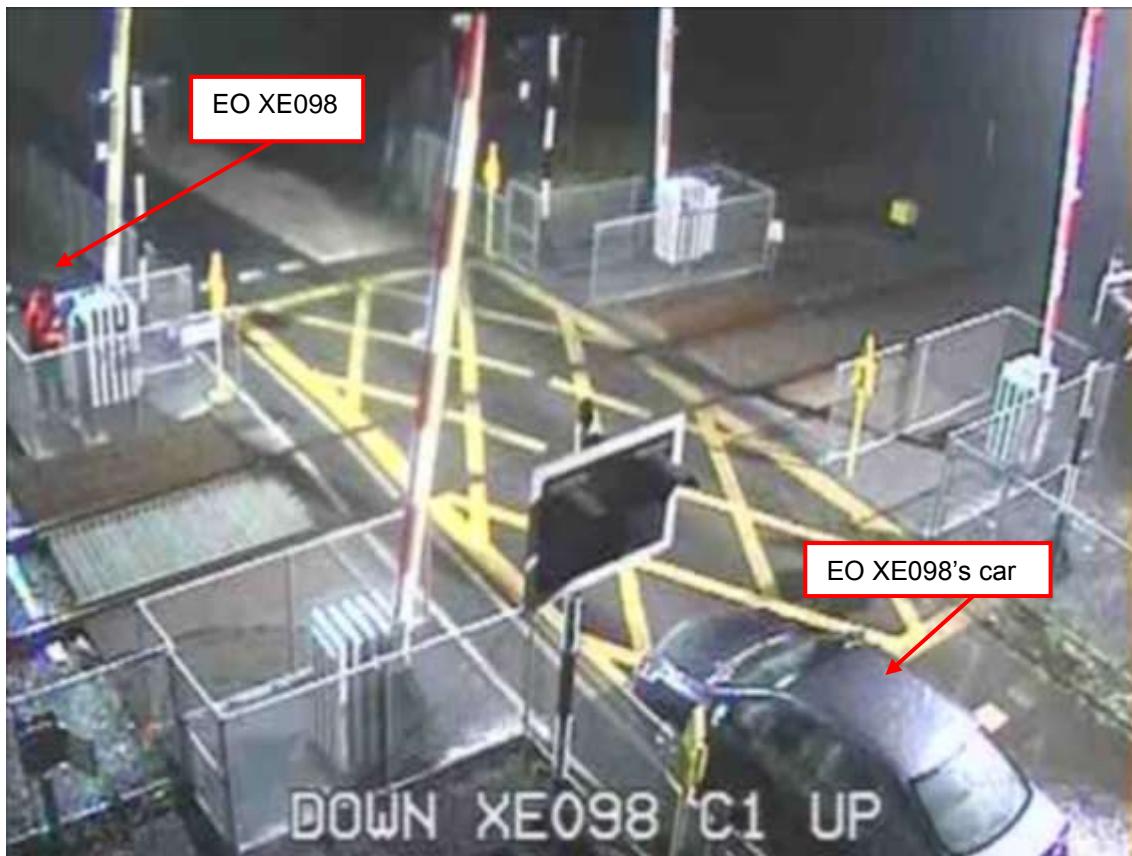
Figure 41 – EO XE098 at Level Crossing XE098

323 The EO at Level Crossing XE098 (EO098) was in the process of taking manual control of Level Crossing XE098, see Figure 41.

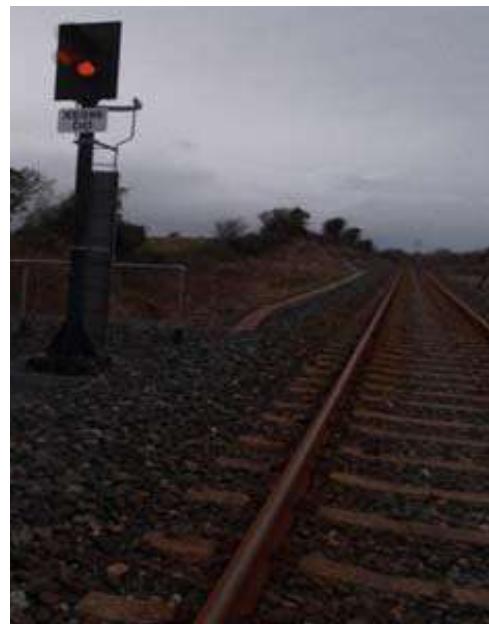
Figure 46 – Signal XE098DD

351 The signal in rear of Signal XE098DS is Signal XE098DD. It is a two aspect signal mounted on a standard height pole and situated on the left hand side of the line at 35 miles 461yds. It is capable of displaying single yellow and green aspects, see Figure 46. It is located 1,188 m before Signal XE098DS.

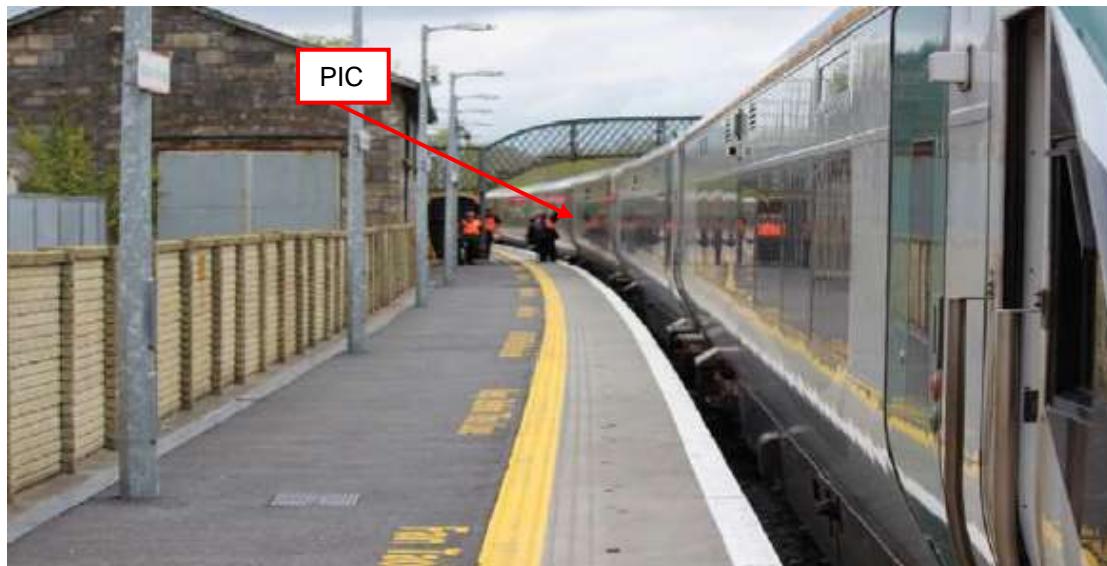
Figure 61 – Curved platform & driver's view of PIC

454 The driver should also be able to acknowledge the ‘Station Work Complete’ and ‘Ready to Start’ signals given by the PIC, see Figure 61, for a view of the PIC taken adjacent to the driving cab. The ‘Station Work Complete’ and ‘Ready to Start’ indications will be discussed in paragraphs 457 - 463.

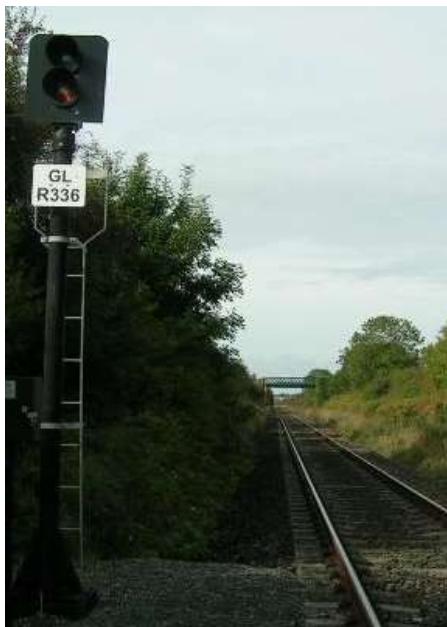
Figure 67 – Signal GLR336

530 The driver (Driver A708) booked on duty at 16:00 hrs and read his notices for the day. He then worked the 17:07 hrs passenger service from Athlone to Galway (Train A708). Driver A708 approached Signal GLR336 (see Figure 67) on a yellow aspect which indicated that the next signal, Signal GL336 (see Figure 68), would be at danger. The driver applied the train brakes to reduce speed with the intention of stopping at Signal GL336, however, due to the strong sunlight he did not see Signal GL336 until he was too close to stop at the signal, and past Signal GL336 at danger by approximately 66 yards (60 m).

532 IÉ assigned an SRR of 16 to the SPAD. IÉ's internal investigation 'Report of the Investigation into the Signal GL336 passed at danger, 26th October 2012' published on the 23rd December 2012 found that the sunlight (from the setting sun, which was low in the sky) was very strong and the windscreen was smudged and that these together affected Driver A708's view of Signal GL336. IÉ internal investigation report (Synergi Ref – 18209) published on the 23rd December 2012 identified the immediate cause as Driver A708 failing to control his train in accordance with the restrictive aspect (yellow signal) in Signal GLR336 and passed GL336 at danger. Underlying causes were identified as: the very strong sunlight at the time (with the sun shade on the 2800 DMU driving cars not being able to be lowered enough to block out strong sunlight) and the windscreen of the cab being smudged, which both this affected his view of Signal GL336; and Driver A708 failing to react to the yellow aspect in Signal GLR336 and applying the train brakes accordingly.

533 As a result of the incident, Driver A708 was reclassified as a Category A driver and placed on a DD&SS with special emphasis on human factors and defensive driving (there were instances of over-speeding identified on the day of the SPAD during the investigation). Two recommendation resulted from this investigation, which included for the introduction of a more robust system to be put in place to deal with driving in strong sunlight (by adding to defensive driving presentation

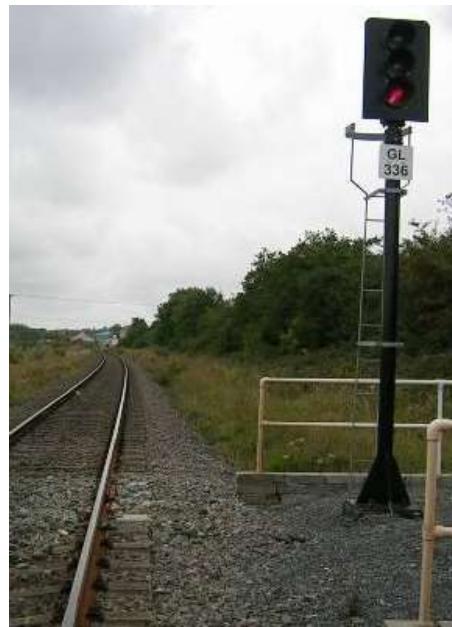
Figure 68 – Signal GL336

534 In addition to the IÉ findings, the RAIU review of the incident found that Driver A708 may have become distracted by a passenger taken ill earlier in the service, which is an unusual occurrence for a driver; and that Driver A708 had lost situational awareness in terms of the location of the signal due to the distraction of the strong sunlight.

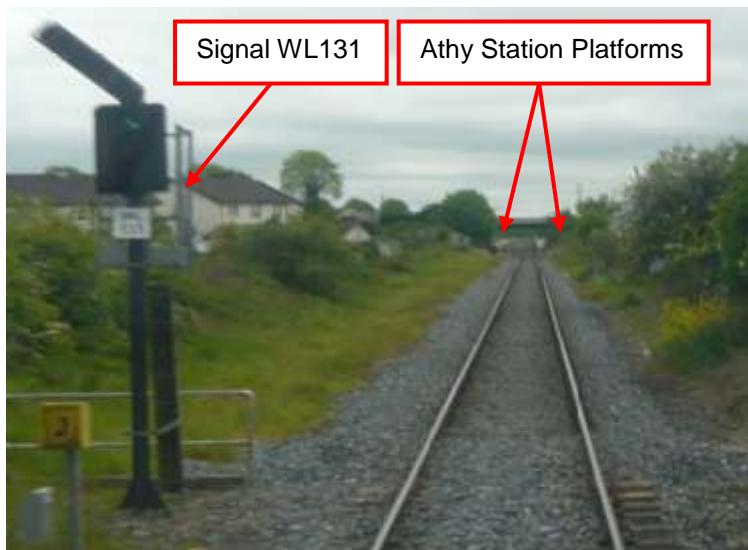
Figure 69 – Signal WL131 with Athy Station in the distance

540 Driver A500 then noticed that there was no train travelling in the opposite direction at Athy Station (see Figure 69); as he was expecting to see the 07:10 hrs passenger service from Waterford to Heuston, which was scheduled to cross his train in Athy. This prompted Driver A500 to check the scheduled running time for his train and he picked up his Working Time Table (WTT) which was open on the driving console. However, to read the WTT he needed to put on his reading glasses.

543 IÉ assigned an SRR of 18 to this SPAD. The internal IÉ investigation report determined that the immediate cause was that “the driver of A500 passed Signal WL131 at danger as he did not have his train under sufficient control approaching a red (stop) aspect” and that the underlying causes were that “The driver was consulting his WTT approaching Signal WL131 instead of giving his full attention to bringing his train under control” and that the “driver failed to prioritise his actions, instead of concentrating on Signal WL131 he was looking beyond the signal and querying why the train was not on the platform”.

545 The RAIU review of the incident found that Driver A500 had initially become distracted by the Patrolman, as it was the Patrolman who first mentioned the crossing point. He became further distracted when he could not see the other train and consulted with the WTT. Driver A500 had also lost situational awareness due to operating services where CAWS was in operation in the weeks previous to the day of the SPAD and this was the first day Driver A500 was driving in a non-CAWS area after a number of weeks of driving in a CAWS area, which contributed in him not responding to the cautionary aspect as required.

544 As a result of the incident Driver A500 was reclassified as a Category B Driver and placed on a DD&SS for a period of two years. In addition, the internal report recommended that the IÉ-RU Safety Manager was to publish a weekly circular notice reminding all staff whose duties require them to travel in the footplate should comply with driving cab protocol; and that IÉ-RU review the Professional Driving Handbook to ensure train operations in non-CAWS areas is adequately covered.

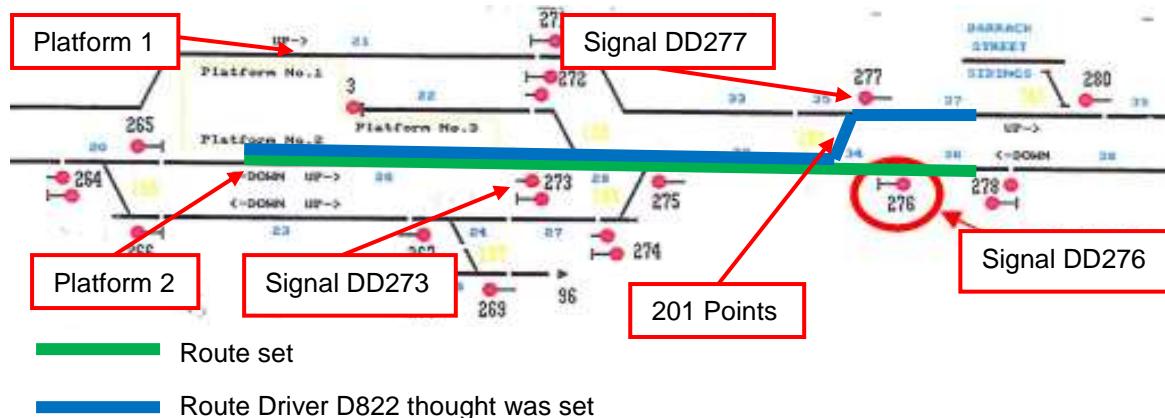
Figure 70 – Set and assumed manoeuvres

548 Driver D822 returned to his train on Platform 2. He thought that he was required to shunt over 201 Points and behind Signal DD277 to stable the train on Platform 1 (see blue line Figure 70), he had forgotten about the possession on Platform 1.

549 As a result, when Signal DD273 cleared, Driver D822 began the manoeuvre. As he approached Signal DD276, it was displaying two white lights in the vertical position, which means that the route is set to proceed to Signal DD276, (green line Figure 70). Driver A822 was not aware of this and still thought that he was about to traverse 201 Points and travel towards Signal DD277.

550 When Driver D822 past Points 201 without traversing them, he realised he was travelling towards Signal DD276, which was displaying a red aspect, the train was travelling at 35 mph (56.55 km/h). Driver D822 applied the full service and emergency brakes, but continued past Signal DD276 at danger by 75 m (it is noted in the report that Driver D822 stated that he only past Signal DD276 by a few inches).

552 IÉ assigned an SRR of 14 to this SPAD. IÉ internal investigation report, (Report No. R0303-2014-17) published in March 2014, identified the immediate cause as Driver D822 not having his train under sufficient control. Causal factors to the incident included that Driver D822: made the wrong assumption about the manoeuvre required; was speeding; misread Signal DD273; and failed to see that Points 201 was in the reverse position. Underlying causes to the incident were the lack of out-of-hours monitoring of shunting in Dundalk and the known risk issues with Driver D822 (which were managed by a driving development plan).

554 The RAIU investigation found that Driver D822 had lost situational awareness as he had forgotten about the possession and he had not gained a clear understanding of the manoeuvre he was required to undertake, which resulted in him reverting to carrying out his normal manoeuvre, thus having an incorrect expectation of the signals.

553 As a result of this incident, Driver D822 was removed from driving duties. In addition, a review commenced related to the DD&SS (specifically the categorisation of drivers). The report made two other safety recommendations related to out-of-hours monitoring and DD&SSs.

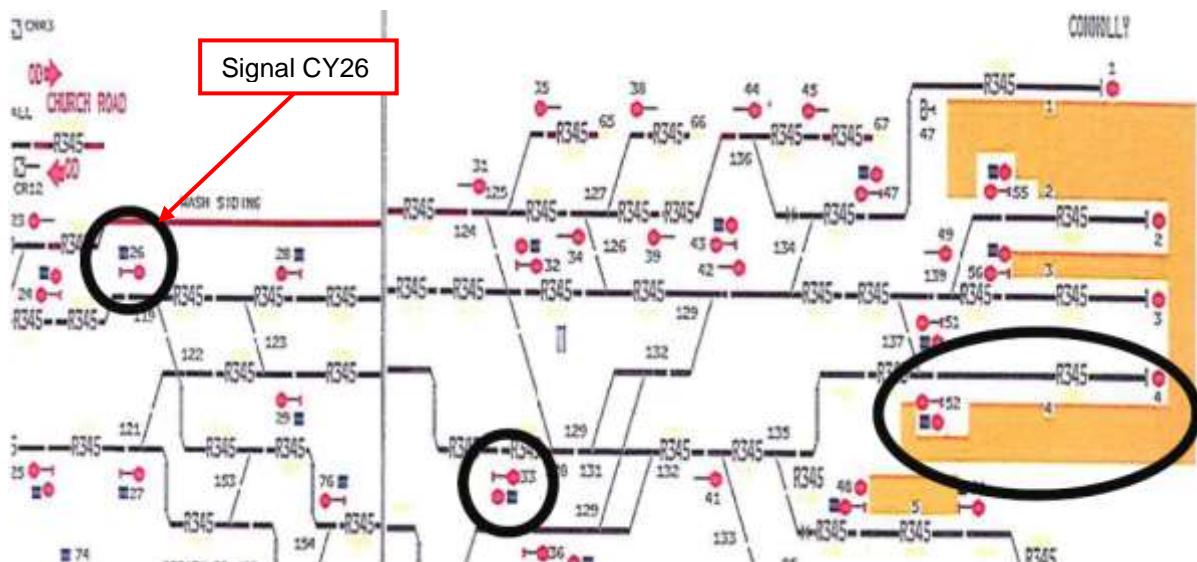
Figure 71 – Layout at Connolly Station

555 On the 3rd April 2014, Driver P709, signed on for duty fit and well rested at 17:30 hrs and operated services without incident. As Driver P709 approached Connolly Station, while operating the 22:05 hrs service from Drogheda to Connolly, he approached Signal CY18 which was displaying a red aspect, this cleared to yellow and Driver P709 proceeded towards Signal CY26. Signal CY26 and Signal CY33 were displaying red aspects, see Figure 71. Driver P709 acknowledged the CAWS downgrades for Signals CY18 and CY26.

556 Signals CY26 and CY33 can be viewed in tandem by drivers approaching the platforms at Connolly Station, see Figure 71. When Train P709 was 509 m from Signal CY26, Driver P709 commenced braking and continued to do so until he came to a stop 3 m past Signal CY26. Three seconds prior to the SPAD Signal CY33 had cleared to yellow, with the route indicator displaying that the route was set for Platform 4.

559 IÉ assigned an SRR of 14 to this SPAD. IÉ's internal Operational Occurrence Report (OOR) (Report No. R0903-2014-34) published on the 22nd August 2014 identified the immediate cause of the incident as Driver P709 failing to stop at Signal CY26 due to a lapse of concentration. The OOR identifies causal factors as Driver P709's personal issues and preoccupation with Signal CY33; it also notes incorrect prioritisation of signalling sequence by the signalman. The OOR identifies that the ability to view Signals CY26 and CY33 in tandem as an underlying factor.

560 As a result of the incident Driver P709 was reclassified as a Category B Driver and placed on a DD&SS for a period of two years. In addition, SET carried out some maintenance works on the signals in the area and signalmen were requested not to clear CY33 when CY26 is at danger, where possible.

561 The OOR made three recommendations, two which were related to staff reporting personal issues to line managers and staff attending the Chief Medical Officer (CMO). And one recommendation was related to changing, if appropriate, Signal CY32 and CY33 to approach release to prevent read through of signals.

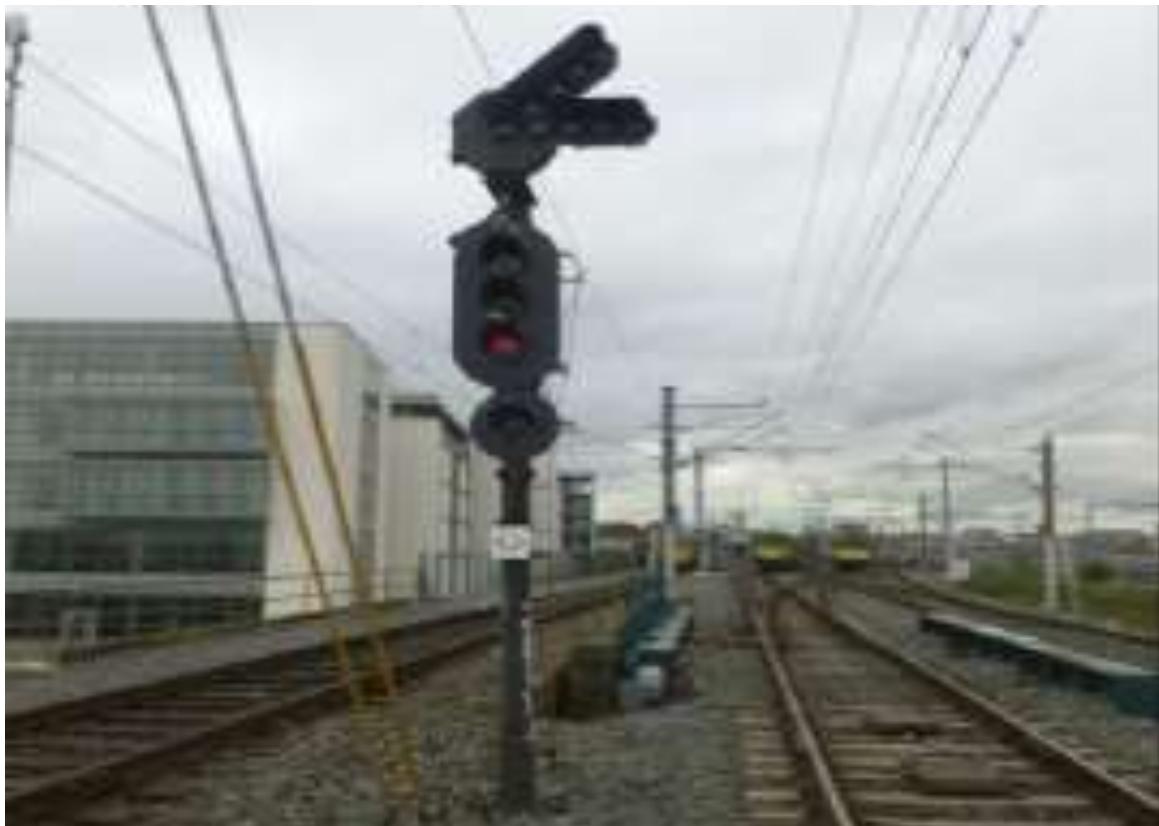
Figure 72 – Signal CY26, with Signal CY33 in background

562 The RAIU review of the incident found that the personal issues identified in the IÉ report did not contribute to the incident. Driver P709 had lost situational awareness and had an incorrect expectation as to the signal's aspect, as he was looking beyond the signal into Connolly Station.

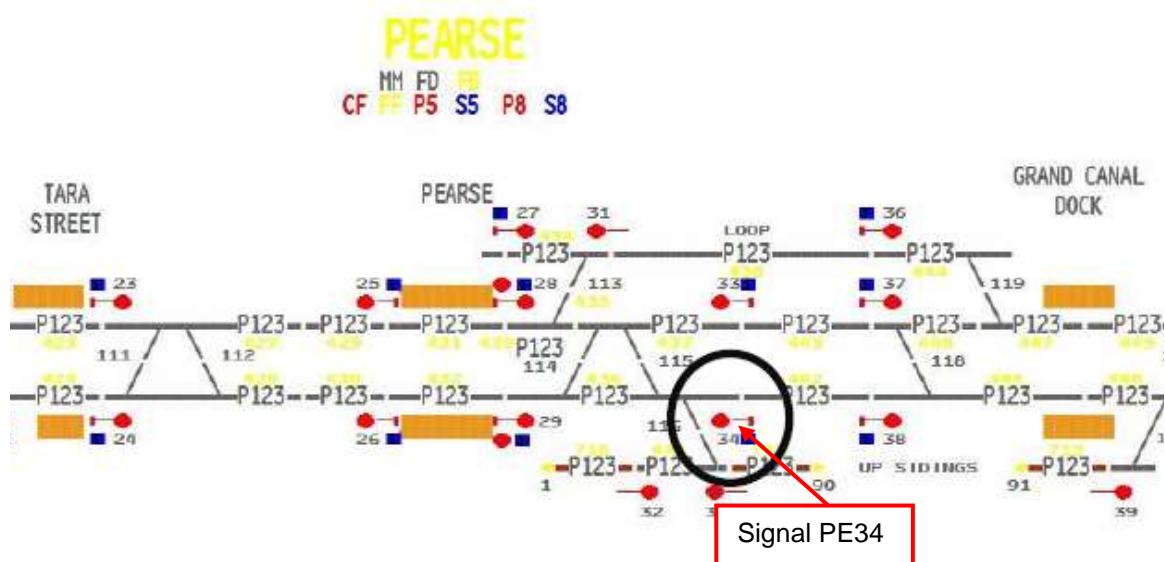
Figure 73 – Signalling at Pearse Station

570 On the approach to Pearse Station at 12:18:14 hrs, Driver A601 acknowledged the downgrade to red in the CAWS, while the train was travelling at 19 mph (30.4 km/h) and 193 metres in rear of Signal PE34, see Figure 73.

571 Driver A601 stated that at this time he began to pack his bag in anticipation of finishing his turn of duty at Connolly Station.

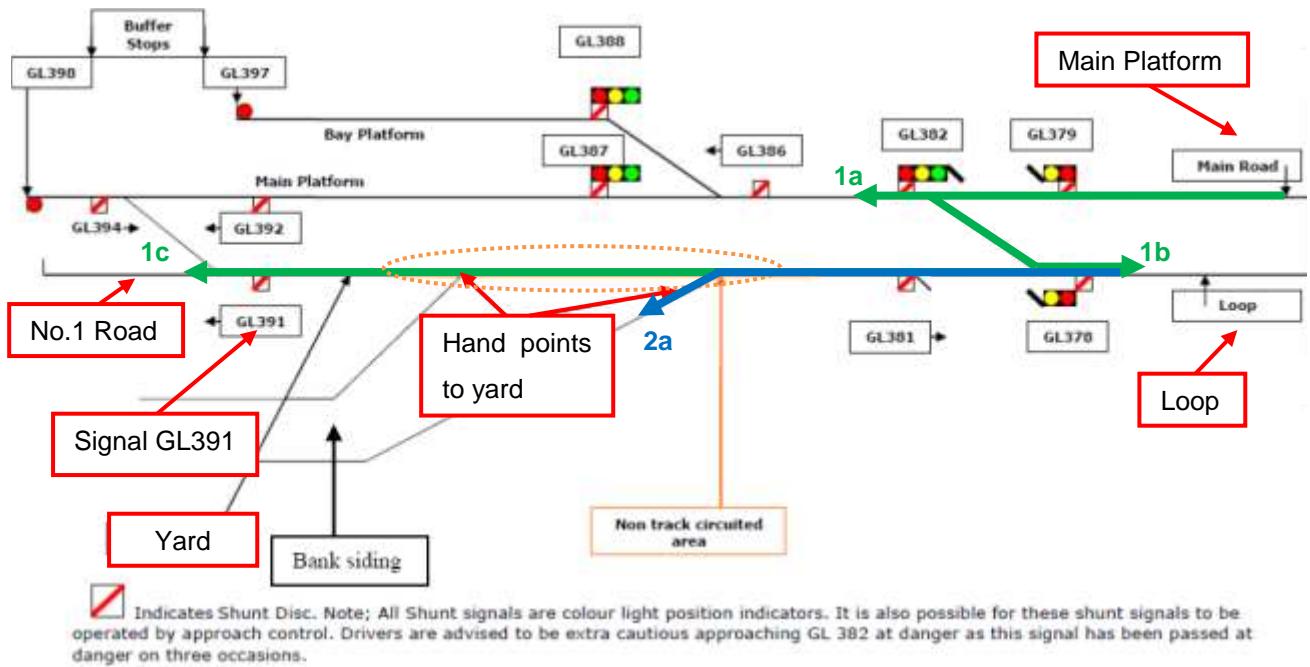
Figure 74 – Ceannt Station (Galway) Layout

578 The Galway Station Controller told the Galway Line Signalman (GLS) to set the route to allow Train A714 to from the main platform into the Loop and then down behind signal GL391 which is located on the No.1 Road (see green movements 1a, 1b & 1c, Figure 74). (Note: A train consist of less than seven pieces are stabled in the Yard, Train A714 consisted of seven carriages). As there was an area of non-circuited track (see Figure 74), the Galway Station Controller had set the hand points, located between signals GL378s and GL391, to the normal position, i.e. to the No.1 Road. The Galway Station Controller talked to Driver A714 on the Main Platform, mainly in relation to a change of driving shift; it cannot be established if a clear instruction was given for the movement of Train A714 onto No.1 Road.

579 The GLS was not familiar with the name 'No.1 Road', as he was more familiar with requests to place the train 'behind signal GL391'. As a result, the GLS thought the route was to be set into the Yard; and set the route from the Main Platform to signal GL378 on the Loop line at Galway (1a & 1b, Figure 74), and then cleared the route from signal GL378 to the Yard in Galway (blue route, 2a, Figure 74). As a result, the GLS did not clear the route into No.1 Road, and as a result, Signal GL391 remained at danger.

581 Driver A714 then proceeded to move the train, he had assumed that he was moving Train A714 into the Yard, he carried out the first movements as expected (1a & 1b, Figure 74). When Driver A714 approached the first set of handpoints, he was expecting the train to 'jolt' as it travelled over the handpoints into the Yard, he never felt the jolt and then remembered it was a seven piece train and realised he was travelling to the No.1 Road. He then travelled over the second set of handpoints and passed Signal GL391 which remained at danger, and another 113 m towards the stopblock to stable the train. Driver A714 was unaware he had passed Signal GL391 at danger and returned to the Main Platform.
