RAILWAY ACCIDENT INVESTIGATION UNIT IRELAND

INVESTIGATION REPORT

Investigation into SPADs on IÉ Network, from January 2012 to June 2015

RAIU Report No: R2016 – R001

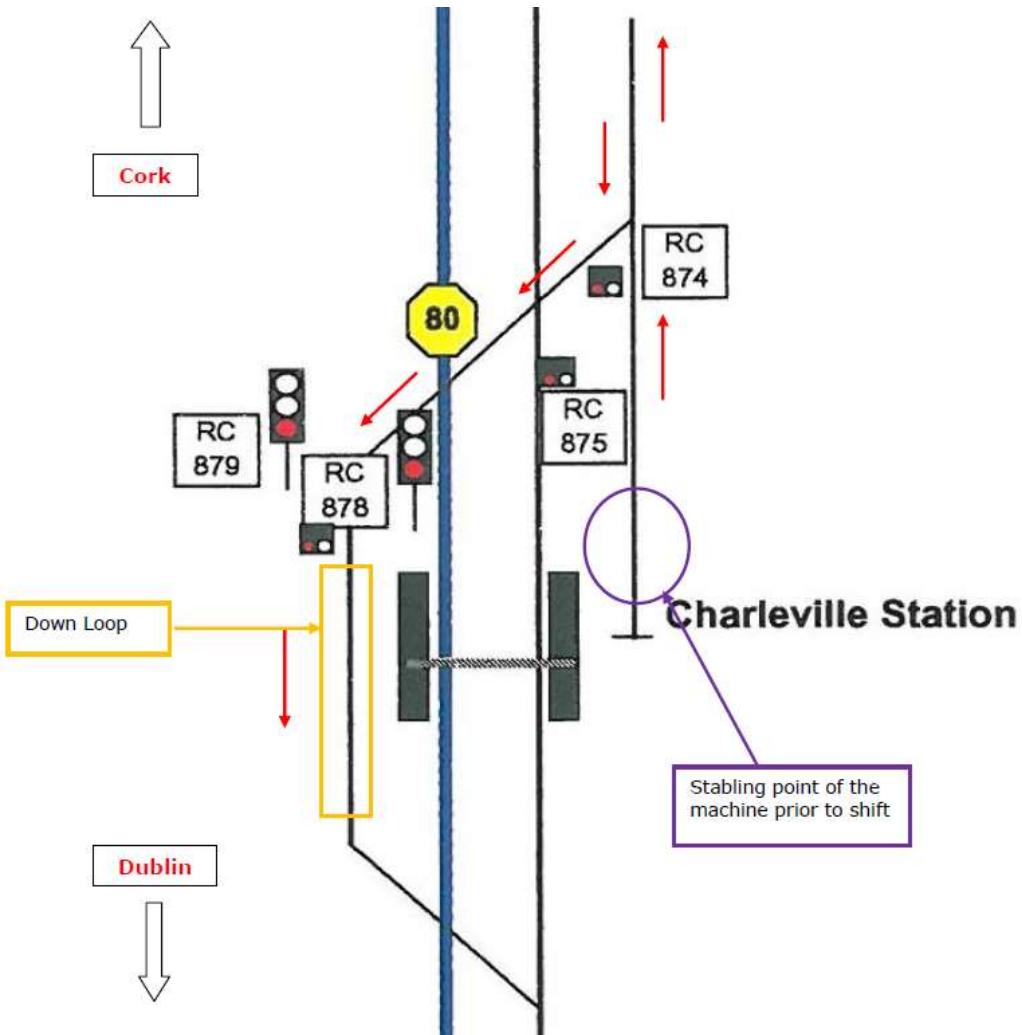
Figure 75 – Charleville Station layout and proposed movement outlined in red arrows (from IÉ investigation report)

605 The driver (Driver Y224), a Lloyd Rail staff member, received instructions from the Person in Charge of Possession (PICOP) in relation to moving the tamping machine from its stabling point onto the Down Loop prior to the possession being granted, see Figure 75.

606 Driver Y224 took up his position in the tamping machine and began moving it to the south of the yard. He then passed Signal RC874 at danger and on realising this stopped his train immediately.

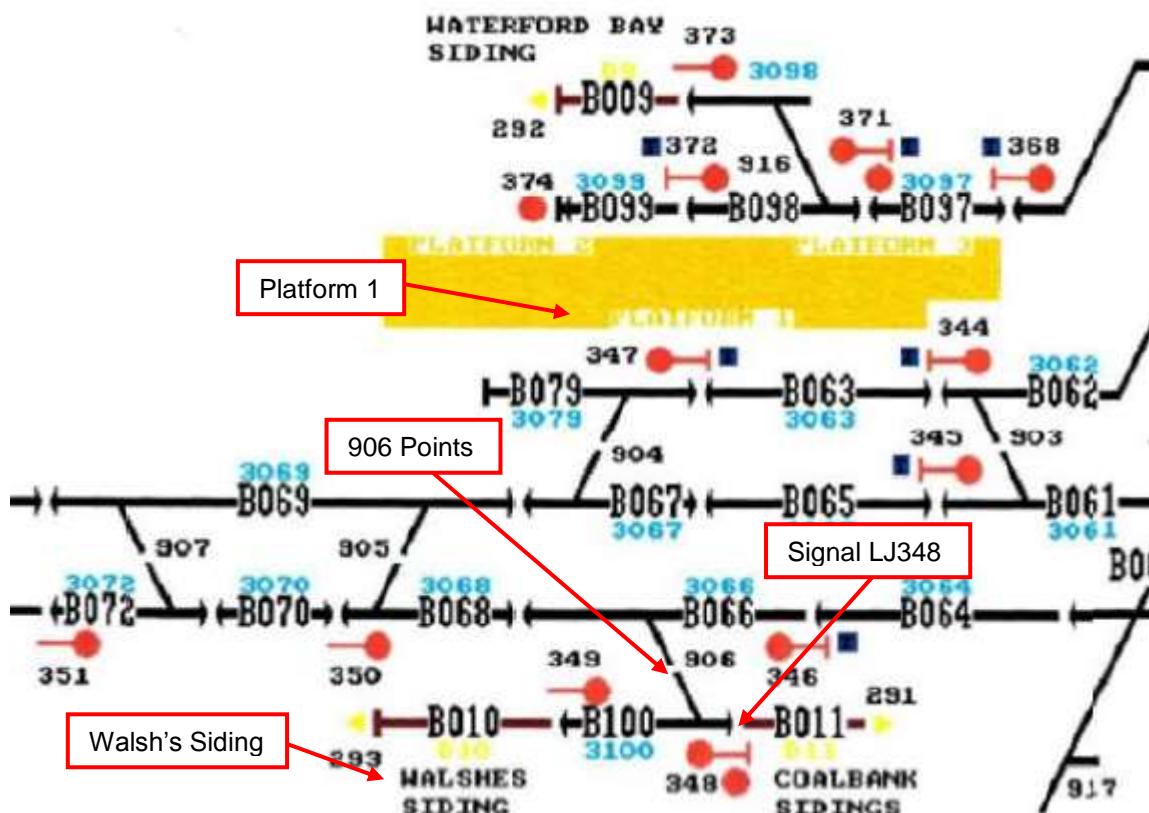
Figure 76 – Layout at Limerick Junction

612 At approximately 05:50 hrs the Spoil Train Driver arrived at Platform 1 at Limerick Junction and carried out a number of train movements to move the Spoil Train towards Walsh's Siding (see Figure 76).

613 When the Spoil Train was positioned in the Coalbank Siding, the Guard was standing at the back of the Spoil Train near 906 Points (see Figure 76) when he observed 906 Point being normalised (to travel into Walsh's Siding) and he assumed the shunt signal, Signal LJ348 was cleared for the Spoil Train Driver to propel the Spoil Train back into Walsh's siding.

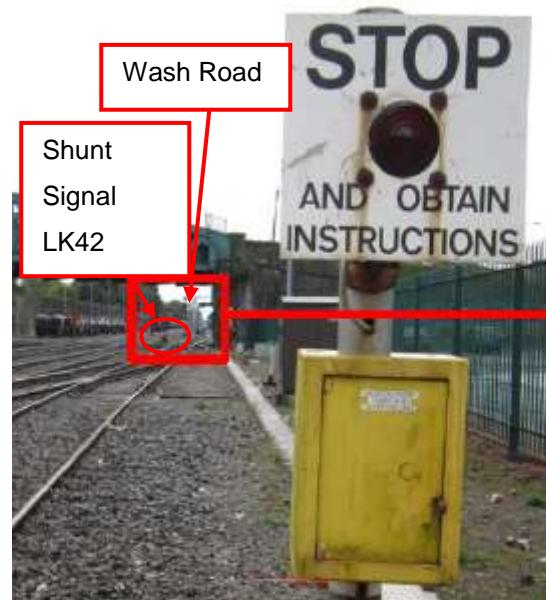
Figure 78 – SAOIB & LK42 & Wash Road

628 On seeing Shunt Signal LK42 set to proceed, the Pilot Driver re-contacted the Station Cabin Signalman. It is not clear what communications occurred between the Pilot Driver and the Station Cabin Signalman, but the Pilot Driver thought that he was authorised to travel into the Wash Road. However, 70 Points were not set and the Pilot Driver was not authorised to travel past the Stop & Obtain Instruction Board (SAOIB), which under the Rule Book has the same meaning as a stop signal and permission must be granted by an authorised person for drivers to pass these boards, see Figure 78. As a result, the Pilot Driver travelled past the SAOIB and 70 Points which were in the reverse position and proceeded into the Wash Road.

629 When SET completed repairs to the panel in the Station Signal Cabin, the Station Cabin Signal commenced completing the route for the train when he noticed that the train was not on Tobin's Road, and saw that there was no detection on 70 Points; he then requested SET to examine. SET found that the points had been run through. When Pilot Driver changed driving cab ends, he noticed the gapping points and contacted the Station Cabin Signal.

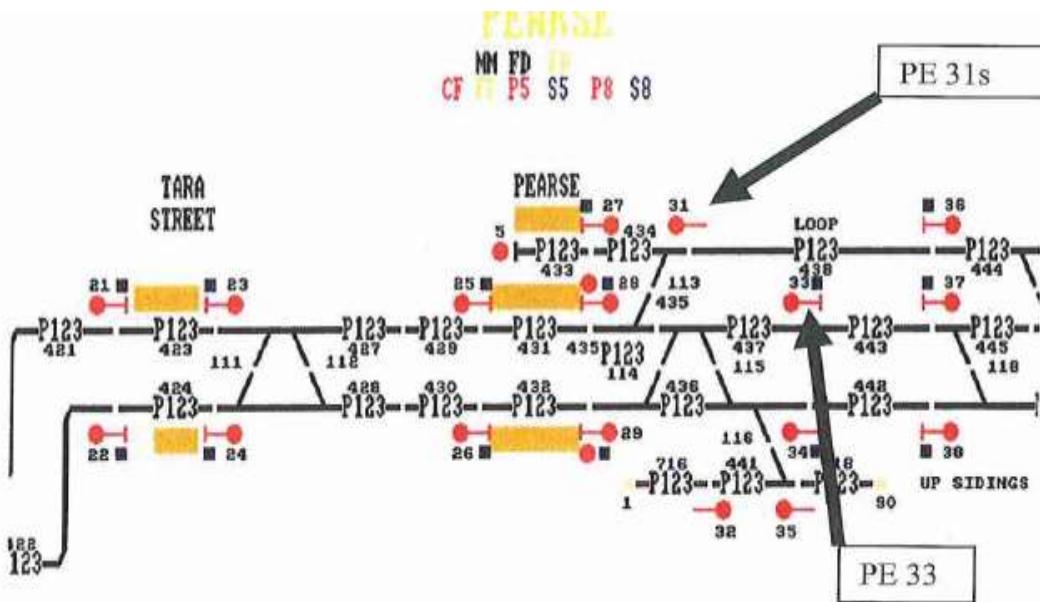
Figure 79 – Pearse Station layout (taken from IÉ report)

652 The driver (Driver P671) operated the 21:05 hrs passenger service from Maynooth to Pearse (Train P671) without incident. At Pearse, Driver P671 stabled the train in the down loop due to *reversible working* between Pearse and Tara (and vice versa). Driver P671 sees signal PE33 upgrade to yellow and assumes he is clear to return the platform; he does not see signal PE31s and passes it at danger, see Figure 79.

653 At the time of the incident, Signal PE31 had been previously past at danger on one occasion in the previous ten years.

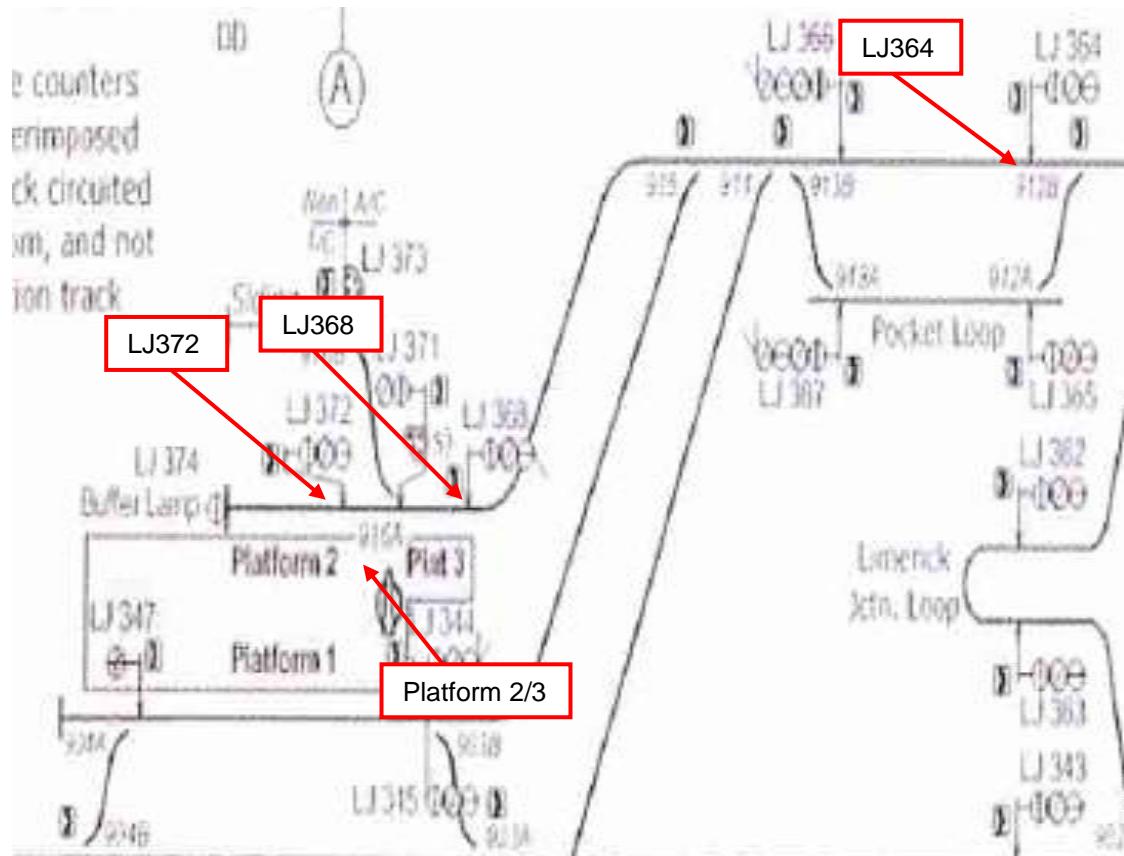
Figure 80 – Limerick Junction layout leaving Platform 2/3 (taken from IÉ report)

658 As the train was occupying Platforms 2/3 the CTC Signalman issued Driver A406 an authority number to pass Signal LJ372 at danger and proceed up to and obey LJ368 where the CTC Signalman would contact him again, see Figure 80 for location of signals. Although the CTC Signalman was aware that Signal LJ372 was behind Driver A406, as he was occupying both platforms, the CTC Signalman did not state that the authority number was being issued for Signal LJ372, behind him.

659 Driver A406 thought that Signal LJ372 was in fact the signal ahead of him, Signal LJ368 and passed the signal at danger. The CTC Signalman contacted Driver A406 and asked him if he had passed Signal LJ368 at danger, Driver A406 stated that he was approaching Signal LJ368. The CTC Signalman ended the call but called back requesting that Driver A406 stop the train. Driver A406 was now standing in rear of Signal LJ364, where he then realised he had passed Signal LJ368 at danger.

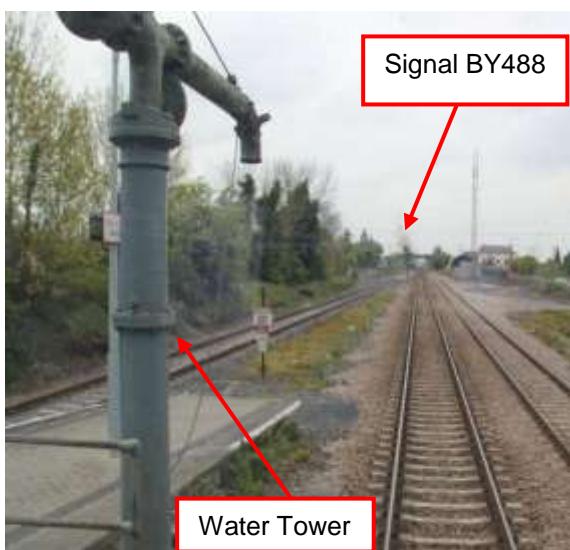
Figure 81 – Drivers' view of Signal BY488

663 On Tuesday 8th May Driver A312 was operating the 17:05 hrs passenger service from Heuston to Tralee (Train A312). After the passengers alighted and boarded Train A312, the PIC gave the 'Station Work Complete' signal and Driver A312 then closed the doors. Despite Signal BY488 displaying a red aspect (see Figure 81 for drivers' view of Signal BY488) the PIC gave the 'Ready to Start' signal without checking the signal as it was obscured by a water tower (see Figure 82 for PIC's obscured view of Signal BY488); however he was aware, due to experience, that it would be displaying a red aspect as a result of the previous train, travelling in the same direction, being delayed (as a result it had not cleared the section, resulting in Signal BY488 remaining at red). Signal BY488 is located 119 m from the platform end and the PIC assumed that Driver A312 would depart from the station and stop at Signal BY488.

664 Driver A312 did not look at Signal BY488 prior to departing, and while departing was looking at the PIC on the in-cab MMI screen in case the PIC wanted to stop the train. Driver A312 travelled past Signal BY488 at danger. On passing the signal, Driver A312 saw that the next signal, Signal CLXDD, was showing a yellow aspect while the CAWS indication in the cab was displaying red. Driver A312 then realised that he may have passed Signal BY488 at danger and started to bring his train to a stop, he stopped 815 m past Signal BY488. The signalman then contacted Driver A312 to inform him of the SPAD. As there were no other drivers available, Driver A312 was allowed to proceed with a second person, the Travelling Ticket Checker (TTC) to Thurles and then a DTE from Thurles to Limerick Junction, where he was relieved from his duties.

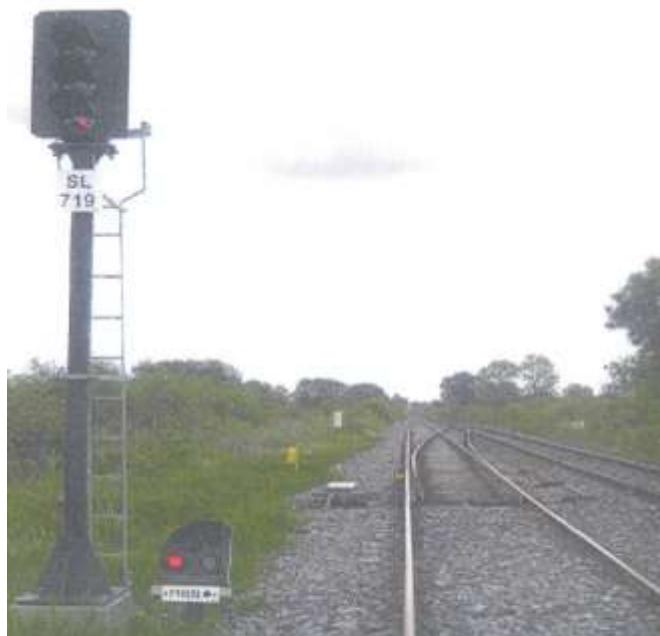
Figure 83 – Signal SL719

684 Driver A913 then entered his new train but did not look at Signal SL719 (which was located 77 m from the front of the train) before departing Killucan, see Figure 83 for the signal displaying a red aspect. Train A913 accelerated to a speed of 16 mph (25.6 km/h) before Driver A913 saw Signal SL719 at danger and applying the full service and emergency brakes. However, Train A913 passed Signal SL719 at danger, with the train stopping 10 m beyond the signal.

686 The SPAD was assigned an SRR of 12. IÉ's internal investigation report (Safety Office Ref 130621-1) published on the 8th October 2013 identified the immediate cause of the incident as Driver A913 failing to look at Signal SL719 before moving his train. Causal factors were identified as Driver A913 being distracted by the earlier incident of a passenger being taken ill. An underlying cause to the incident was Driver A913 having a lapse in concentration as a result of the earlier incident. As a result of this incident, Driver A913 was removed from driving duties.

687 The RAIU review of the incident found that Driver A913 had become distracted by the passenger taken ill on the train, in addition, he forgot to reset the passenger phone resulting in him becoming preoccupied in thinking about the phone. He also had an incorrect expectation of the signal, as he had looked at the green aspect for Train A913 and forgot (loss of situational awareness) that he was no longer on Train A913.

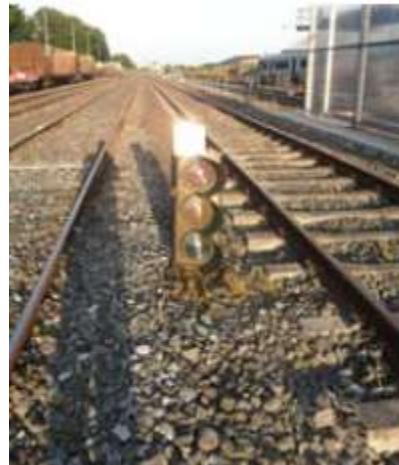
Figure 84 – Signal LK5

690 This SPAD was assigned an SRR of 14. Signal LK5 is now a multi-SPADED signal. IÉ's 5DIR (Report No. R0402-2014-19), published the 31st March 2013 determined that the immediate cause of the incident was Driver A478 misread Signal LK5 due to the visibility of the signal being affected by the sunlight, see Figure 84 for a photograph taken the day following the incident at approximately the same time. Underlying causes were identified as Driver A478's perception of Signal LK5 was affected by the sunlight and that as Signal LK5 is ground mounted on the right, these signals are harder to interpret during bright conditions.

692 The RAIU found that Driver A478 had become distracted by the bright sunlight, leading him to an incorrect expectation that Signal LK5 was displaying a yellow aspect.

691 Driver A478 was assigned a DD&SS. IÉ also undertook a number of other actions as a result of this incident, including a plan for the repositioning of LK5, as well as re-briefing to Signallers and drivers on issues involved in this incident. In relation to the sunlight, the District Manager Limerick issued a drivers notice in January 2014 highlighting the effect that sunlight can have on visibility of signals and the risks associated with starting on yellow when departing Limerick Station. As a result of these actions, and previous actions already taken in relation to signalling in the area, the

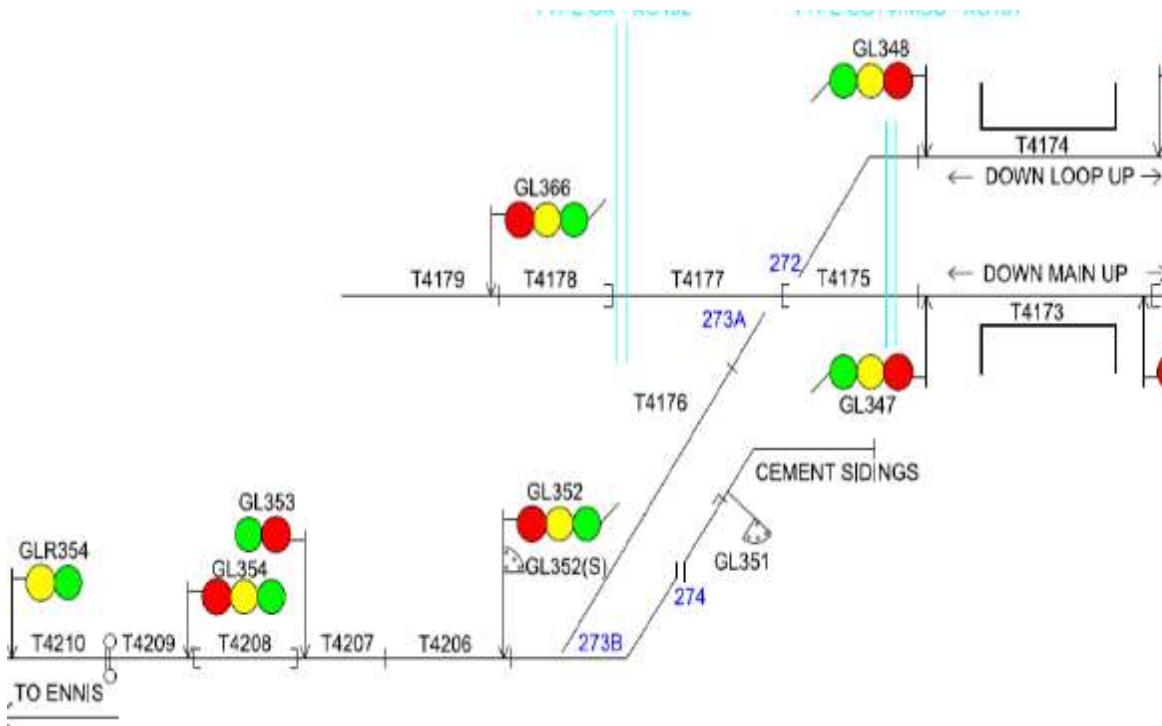
Figure 85 – Athenry Station layout

695 While Train A489 was at Athenry Station, the signalman requested Signal GL348, which upgraded to yellow, and the train departed, see Figure 85. The signalman requested GL353 (see Figure 85) three times within thirty seconds but the signal did not upgrade. This was as a result of the incorrect WSLP switch being operated (the switch was operated for the Athenry to Gort line instead of the Athenry to Galway line), however, this was not noticed by the signalman.

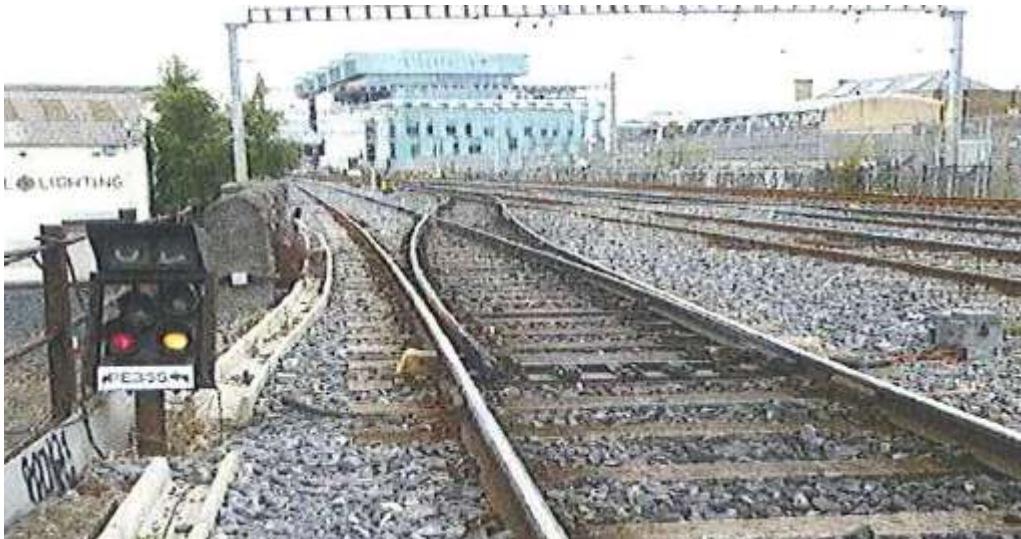
Figure 86 – Position light signal, Signal PE35s

714 Driver A905 checks that the points are set for his return onto the platform at Pearse Station and sees that they are. He then starts driving the train towards the platform without checking what aspect position light signal, Signal PE35s was displaying (which was displaying a danger aspect). Driver A905 then travels past Signal PE35s at danger (see PE35s in Figure 86).

717 This SPAD was assigned an SRR of 17. Signal PE35s is now a multi-SPADed signal. The IÉ internal investigation report (Safety Office Ref: 130810-IM01) published on the 8th October 2013 identified the immediate cause as Driver A905 failing to look at Signal PE35s before moving his train; the causal factor was that Driver A905 was distracted by another task (setting up the train radio); and the underlying cause was a lapse in concentration by Driver A905.

719 The RAIU review of the incident found that Driver A905 had become distracted and preoccupied with the radio which he could not get to work. He also had an incorrect expectation that the signal was displaying a proceed aspect, as when he saw the points set for his route, he assumed the signal was displaying a proceed aspect, as a result of losing situational awareness.

718 As a result of this incident Driver A905 has been reclassified as a Category B Driver for a period of two years and assigned a DD&SS. The report also makes two recommendations: for the signal to be identified as a multi-SPADed signal and for drivers to be re-briefed on the auto routing system (especially the movement of points).

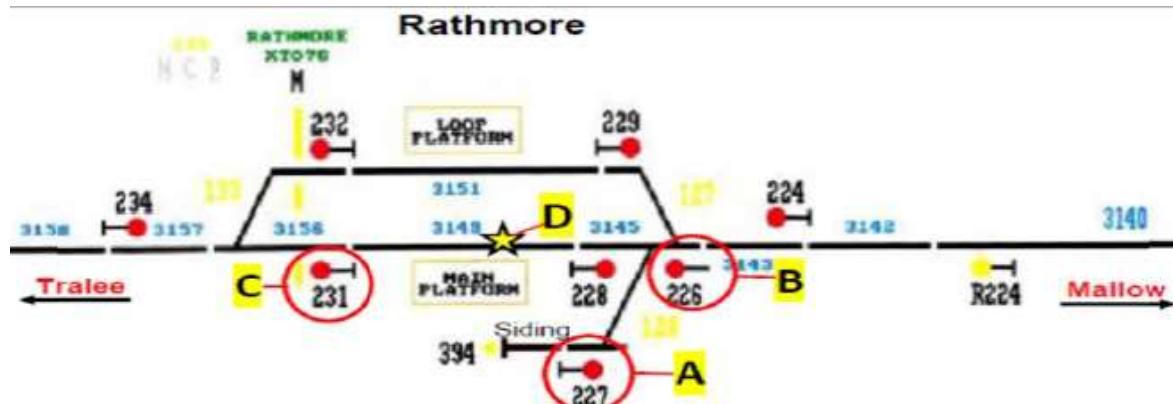
Figure 87 – Layout at Rathmore

721 When CTC cleared Signal TL227 (See signal marked A in Figure 87) Driver Y370 drove Train Y370 onto the running line and stopped in rear of Signal TL226 (see signal marked B in Figure 87). He then switched the control of Train Y370 in order to travel towards Tralee. Driver Y370

then saw that the point were set towards Tralee and saw that Signal TL231 (see signal marked C in Figure 87) was displaying a green aspect. Train Y370 then proceeded towards Tralee, with Signal TL226 displaying a danger aspect, and passed Signal TL226 at danger without authority.

723 The SPAD was assigned an SRR of 0. The BBRI/IÉ-IM's 5DIR (Ref: 24076) published the 2nd May 2014 identified the immediate cause of the inspection as Driver Y370 reading the wrong signal (TL231) as his starting signal. Causal factors associated with Driver Y370 were identified as the driver not having: a full understanding or appreciating requirements associated with Signal TL223; or adequate route knowledge.

725 The RAIU found that Driver Y370 had lost situational awareness as he did not have a full appreciation of the movement to be carried out, this may have been the result of inadequate route knowledge.

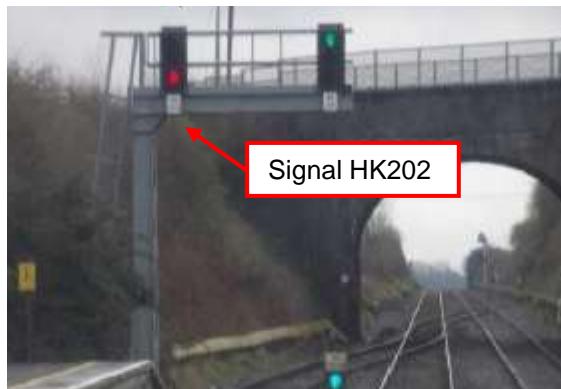
Figure 88 – Signal HK202

726 On Friday 14th March 2014 Driver A801 took up driving duties out the 05:15 hrs passenger service from Westport to Heuston at Athlone. As the train approached Kildare Station, Signal HK210R and Signal HK210 displayed double yellow and single yellow aspects, respectively. The starting signal, Signal HK202 (see Figure 88), was initially displaying a red aspect, which

727 There was no PIC present at the Kildare Station resulting in Driver A801 performing the train despatch procedures. Driver A801 departed Kildare Station at approximately 07:53 hrs, with the starting signal, Signal HK202 still displaying a yellow aspect. The weather was foggy at the time. Driver A801 increased speed to 60 mph (100 km/h) over a distance of 1.2 miles (1.96 km).

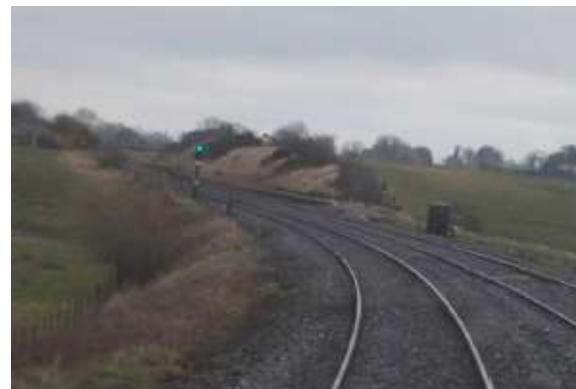
Figure 89 – Signal HK196

728 When Signal HK196 (see Figure 89) came into view, Driver A801 remembered that Signal HK202 was displaying a yellow aspect. He immediately applied the brakes to the full service position (07:55 hrs), but the train passed signal HK196 at danger by twenty metres.

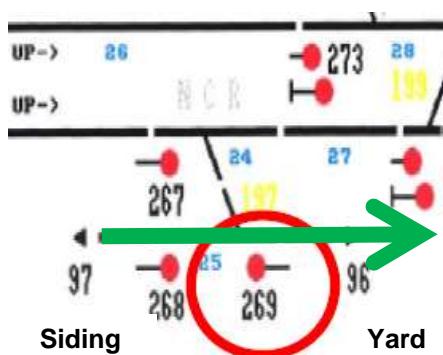
Figure 90 – Shunt Driver movement into Yard

734 The Shunt Driver contacted the signalman for permission to carry out the shunting moves, which was granted. The Shunt Driver then carried out the first shunt move from the front cab of the train, by taking the train from the siding up into the yard, see Figure 90. The Shunt Driver then keyed out of driving duties from the front cab.

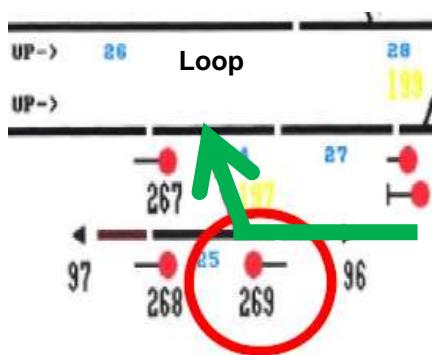
Figure 91 – Train Driver movement onto Loop

735 The Dundalk Driver, who was positioned in the rear cab, keyed into driving duties from the rear cab. The Dundalk Driver thought that Shunt Signal 269 was displaying as proceed aspect (two white lights), and began the shunting move from the yard onto the loop, see Figure 91. On approaching Shunt Signal 269 he saw that it was in fact displaying a restrictive aspects (one red

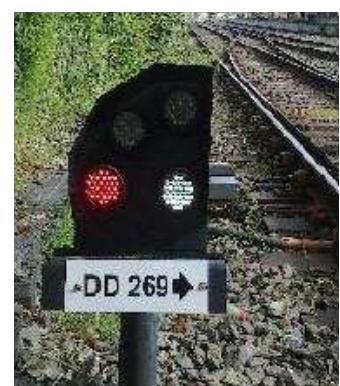
Figure 92 – Shunt Signal DD269

and one white light), as illustrated in Figure 92. He immediately applied the emergency brake, however he passed Shunt Signal DD269 at danger by three metres.

737 The internal IÉ OOR, R1001-2014-40, published on the 8th September 2014, assigned an SRR of 10 to the SPAD. It found that the immediate cause of the incident was as a result of the Dundalk Driver viewing but misreading Shunt Signal DD269. Causal factors were identified as the fact that two drivers were performing the duties of one driver and that the Dundalk Driver was speeding at the time of the incident. IÉ did not identify any underlying causes.

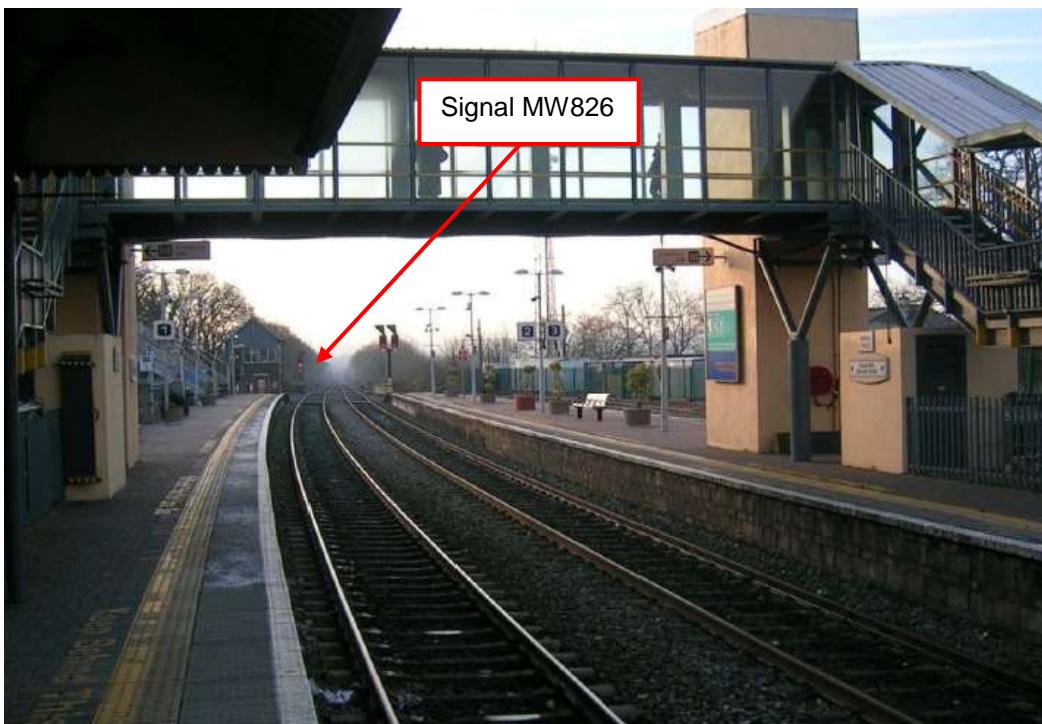
Figure 93 – Mallow Station with Signal MW826

744 Driver A302 then looked along the train and departed without checking the Signal MW826 (see Figure 93), assuming this was done by the PIC prior to giving the "ready to start" signal. Signal MW826 was displaying a red aspect as the CTC Signalman had not yet set the route. Driver A302 passed Signal MW826 at danger, and continued a distance of 966 m before the train was stopped on the request of the Waterford/Tralee Line Signalman.

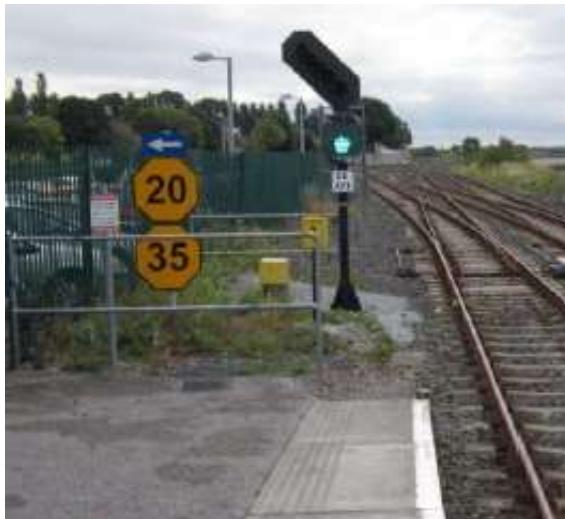
Figure 94 – Signal CE473

750 On arrival at the platform, the driver (Driver D273) carried out a number of station platform and despatch duties. Driver D273 departed Glounthaune Station, ahead of schedule, with the starting signal, Signal CE473 (Figure 94), displaying a yellow aspect and proceeded towards Signal CE842 (Figure 95) which was displaying a red aspect (this was as a result of the Cork East Signalman waiting for the train approaching Glounthaune Station in the opposite direction to clear the section).

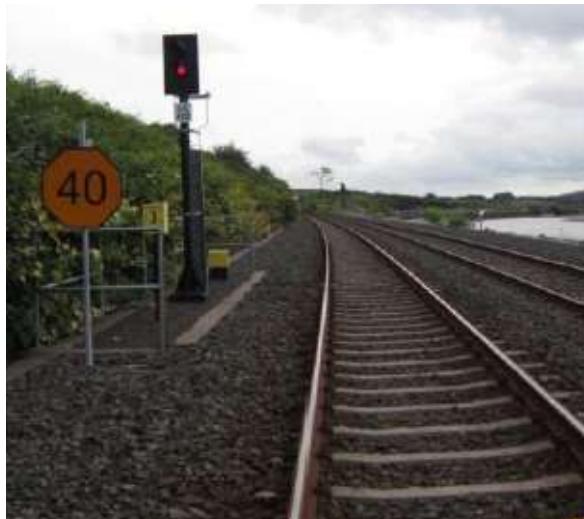
Figure 95 – Signal CE482

751 On approach to Signal CE482, Driver D273 saw that it was displaying a red aspect and applied the brakes. However, Train D273 passed Signal CE842 at danger, passing the signal by 82 m before coming to a stop.

that he had become distracted by the speed board¹⁸ located in rear of Signal CE482 which was displaying an increased speed (see Figure 95). The RAIU found that Driver D273 was not adversely affected by any personal issues at the time of the incident as stated in the internal IÉ report.

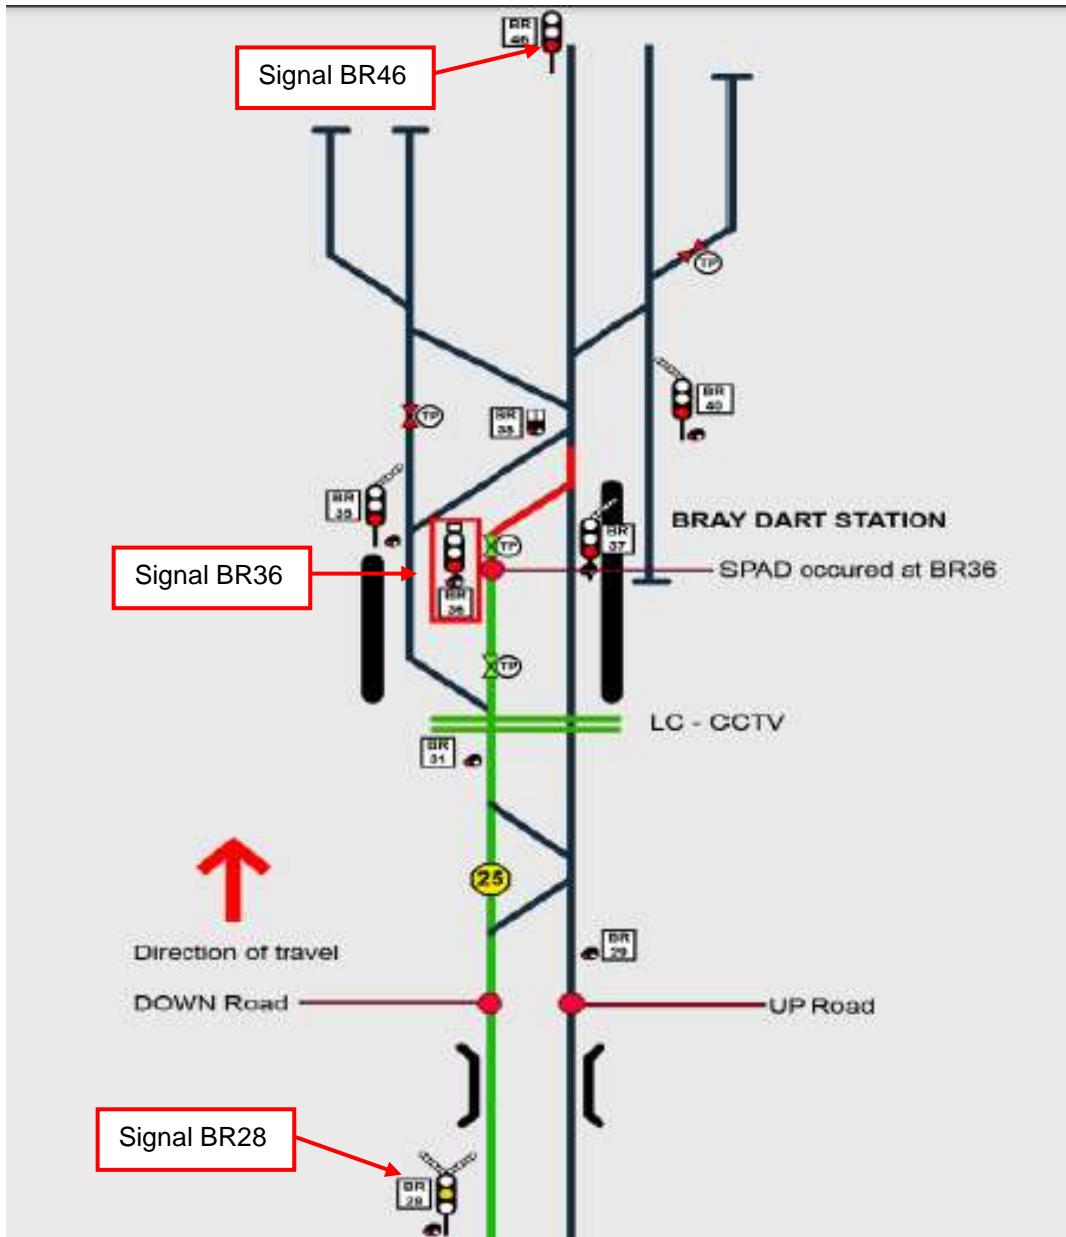
Figure 96 – Bray Station Layout & intended route (taken from IÉ internal report)

756 On the 20th August 2014, Train Y674 (an inspection car) was due to travel from Connolly to Greystones at 10:00 hrs, it was being operated by a BBRI staff member (Driver Y674). On the approach to Bray DART Station, Train Y674 stopped at the next red aspect, Signal BR28, see Figure 96. The signalman upgraded BR28 to a yellow aspect (meaning the next signal, Signal BR36 (see Figure 96) was displaying a red aspect) and Train Y674 travelled past Signal BR28 and continued towards the red Signal BR36. Driver Y674 saw that the route was made for his movement and looked at BR46 which was displaying a proceed aspect. Driver Y674 did not see Signal BR36 and continued past it at danger without authority. The signalman phoned Driver Y674 requesting that he immediately stop the train.

757 IÉ assigned an SRR of 16 to the SPAD. The BBRI/IÉ-IM investigation report found that the immediate cause of the SPAD was Driver Y674 "not locating and observing Signal BR36 at danger". Causation factors were identified as Driver Y674 "focussing on Signal BR46" and not having "adequate route knowledge for the route concerned". The underlying cause of the SPAD was "the lack of route packs for operators".

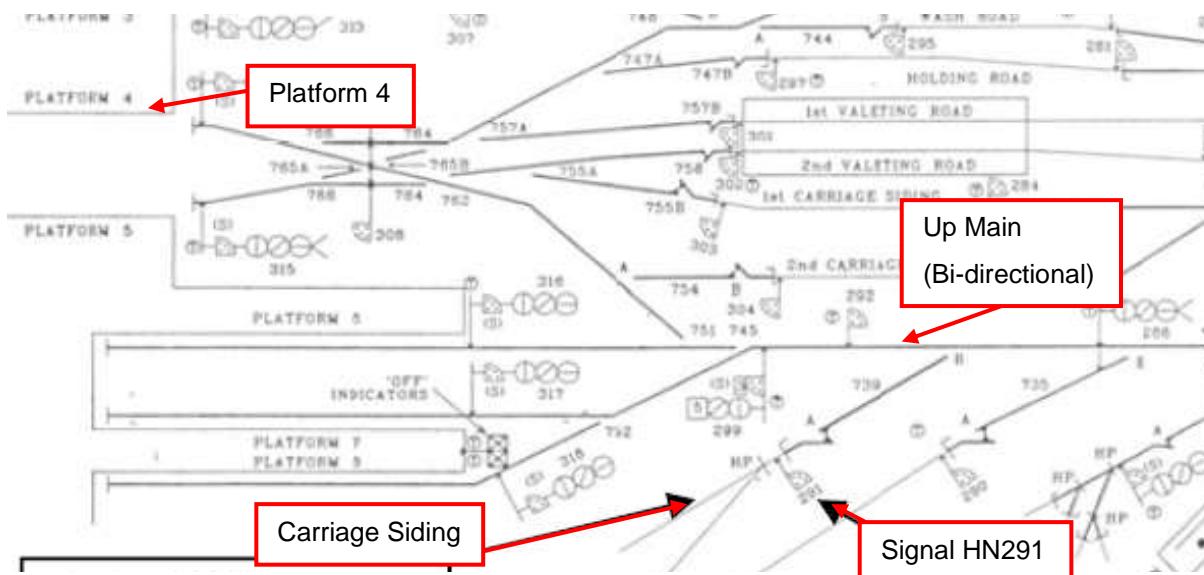
Figure 97 – Layout at Heuston

761 After requesting the movements from Signal Equipment Room (SER) Driver I215 commenced the movement, believing that Signal HN291 (see Figure 97) was displaying a proceed aspect. As Driver I215 proceeded with the movement and on the approach to Signal HN291 Driver I215 noticed that the points were lying in the trapping position and immediately applied the emergency brakes. However, Train I215 continued past Signal HN291 at danger, and became derailed as it travelled over the points; he immediately called the signalman in SER to inform him of the SPAD.

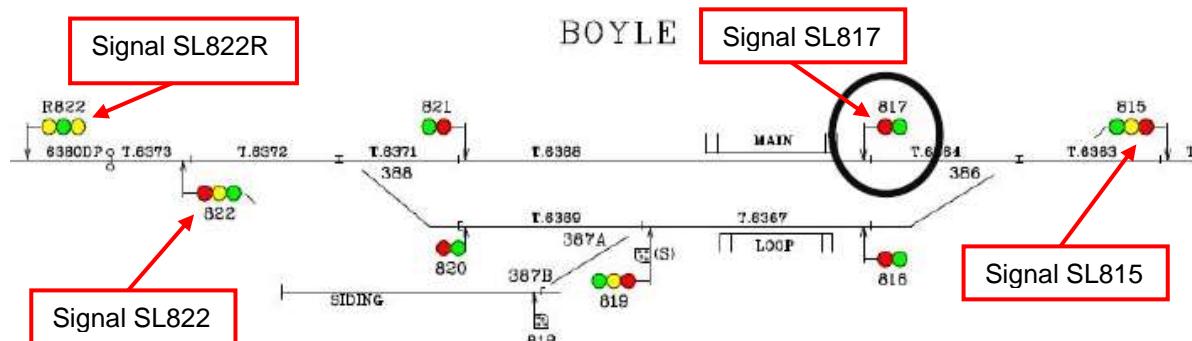
Figure 98 – Signalling at Boyle Station

768 Driver A911 travelled to the approach of Boyle Station, without incident. On the approach to the distant signal, Signal SL822R at Boyle, it was displaying a double yellow aspect; the home signal, Signal SL822, was displaying a single yellow aspect and the section signal, Signal SL817 was displaying a red aspect, see Figure 98.

770 At Boyle Station, train despatch was performed by Driver A911 and after completing these duties he closed the doors and applied power to the train, departing Boyle Station with Signal SL817 displaying a red aspect (Signal SL817 is located 24 m from the top of the ramp on the main platform at Boyle Station). Train A911 was travelling at 7 mph (11.2 km/h) when Driver A911 saw that Signal SL817 was displaying a red aspect; he immediately applied the brakes, but the train travelled past the signal by approximately 5 m.

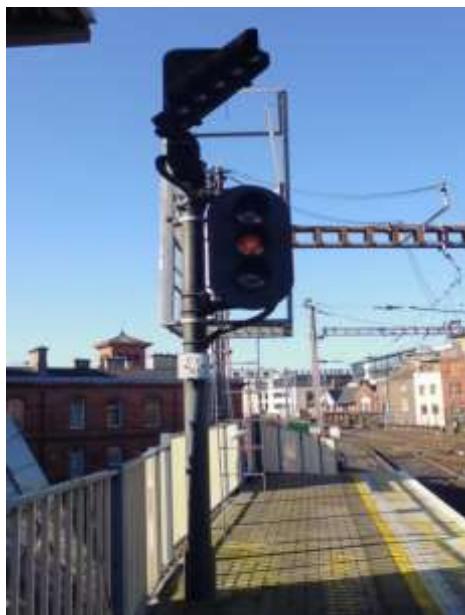
Figure 99 – Signal CY91 (Platform 5)

778 Train P618 continued, without further incident, until it arrived on Platform 5, Connolly Station. The signal departing Platform 5, Signal CY91, was displaying a red aspect on arrival of Train P618 (see Figure 99). The signal upgraded to a single yellow while passengers were boarding and alighting from the train on Platform 5. When station working was complete Driver P618 closed the doors on the train, rechecked the monitor on Platform 5 and departed Connolly Station at approximately 18:01:39 hrs.

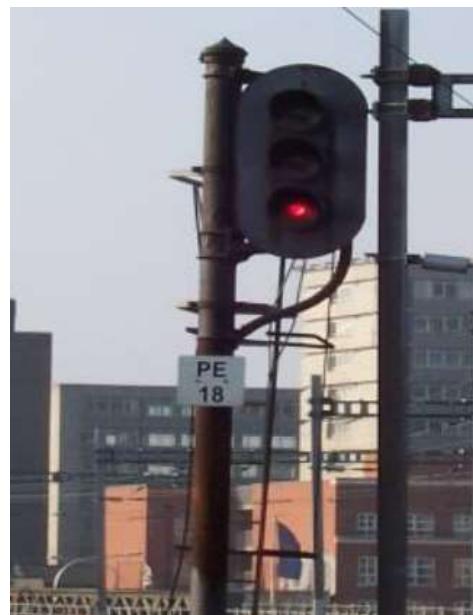
Figure 100 – Signal PE18

779 Driver P618 started to accelerate the train, and 147 m in rear of Signal PE18 (see Figure 100), Driver P618 acknowledged the downgrade to red in the CAWS whilst travelling at 18.16 km/h. At 18:02:27 hrs, 14 m in rear of Signal PE18, Driver P618 applied the brake to the braking position; he applied the emergency brake 5 m in rear of Signal PE18; however, Train P618 passed Signal PE18 at danger by approximately 3 m.

782 IÉ assigned an SRR of 16 to the SPAD. The OOR, published in May 2015, identified the immediate cause of the SPAD as Driver P618 not focusing on the primary task of controlling the train sufficiently on approach to Signal PE18 resulting in the signal being passed at danger. Contributory factors were identified as:

783 IÉ identified the underlying cause to the SPAD as the train not being fitted with the ATP function.

787 The RAIU found that Driver P618 had become distracted and preoccupied by thinking of future movements on the approach to Pearse, leading to him losing situational awareness.

785 The OOR notes that the train protection upgrade programme, IÉHS, is underway. In addition, Signal PE18 is to be removed from its current position and replaced with two new signals, installed between Connolly and Tara Street Stations.

786 As a result, this OOR resulted in one new recommendation, whereby, the RU Safety Manager is to prepare and issue a specific briefing/notice to remind train drivers of the risks of running on restricted signals, the management of the resultant CAWS interventions and the necessity to remain focused on the driving activity in such circumstances.

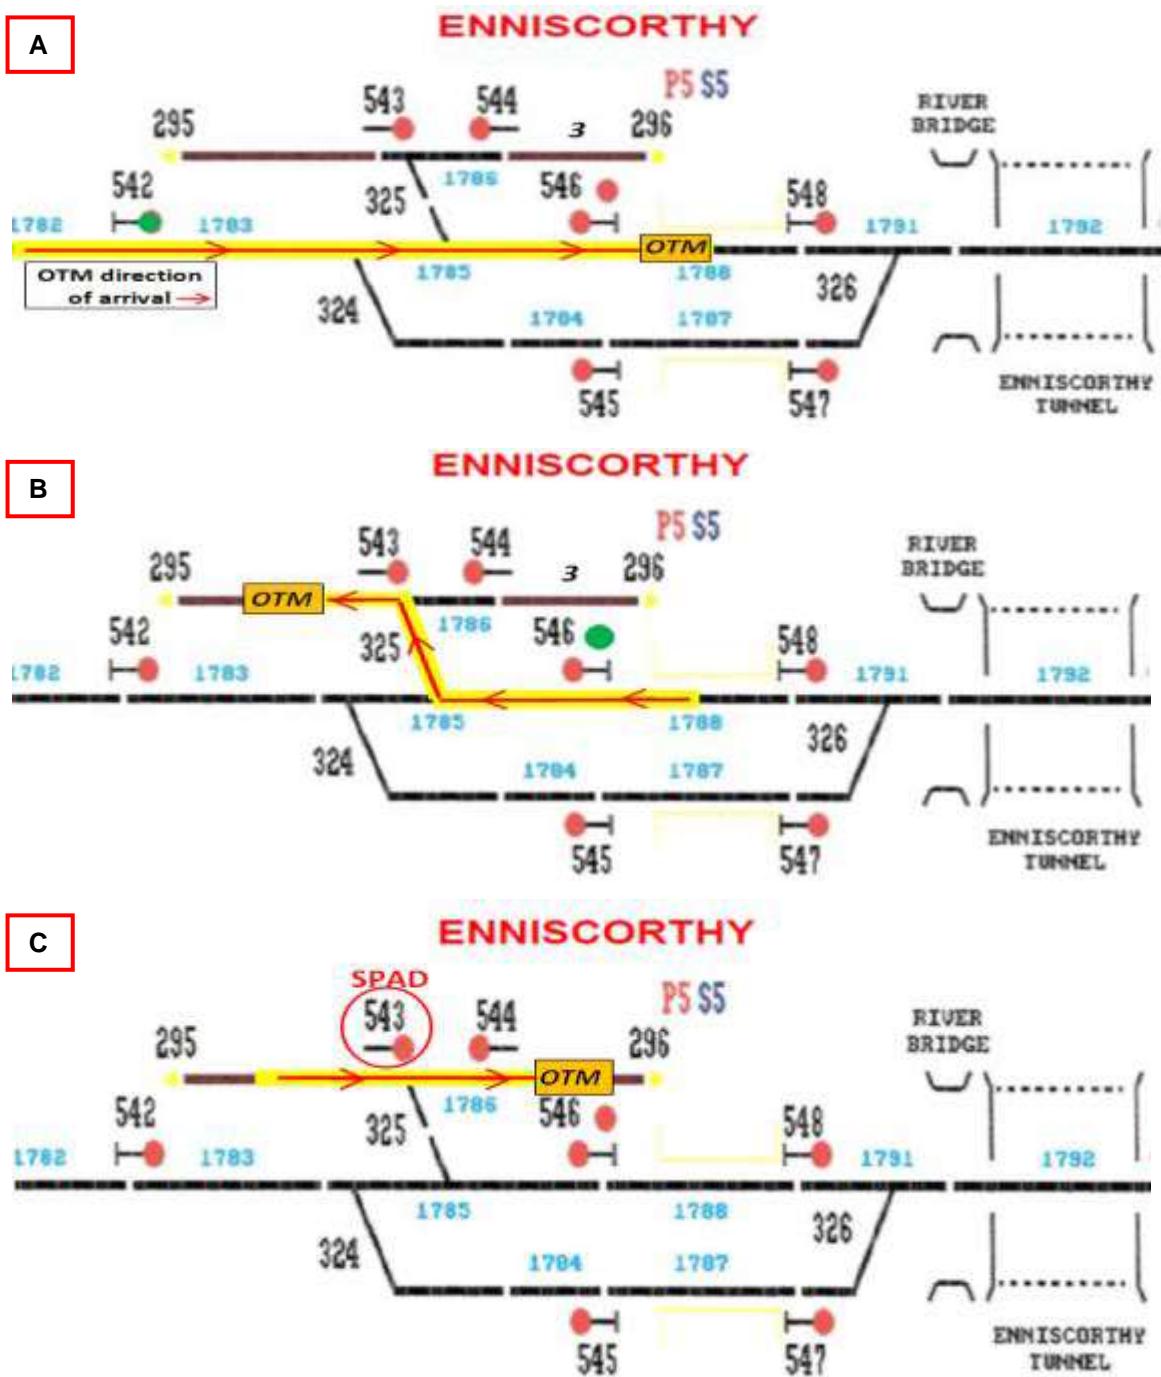
Figure 101 – Sequence of movements for the OTM (taken from IÉ/BBRI Report)

804 The Signalman then signalled the OTM into the siding and Driver Y632 stopped the OTM approximately 18 m in rear of Signal RL543 and advised the Signalman he was in clear and safe (Figure 101 B). He changed from Cab B to Cab A (facing Signal RL 543) with the intention of stabling the OTM in rear of Signal RL544 which was at the opposite end of the siding and also the last movement of the day; however, he did not relay this intended movement to the Signalman.

805 From Cab A Driver Y632 observed the points ahead moving to the normal position and assumed this was for his intended route. Driver Y632 checked Signal RL543, thought he saw a proceed aspect, and moved the OTM to the opposite end of the siding and passed Signal RL543 at danger in the process (Figure 101 C). The Signaller then contacted Driver Y632 to query his movement and it was confirmed that the OTM had passed Signal RL543 at danger without authority.

807 The SPAD was assigned an SRR of 0. The IÉ-IM / BBRI report of investigation 'SPAD involving On-track Machine (703 Ballast Regulator) at Signal RL543 in the siding at Enniscorthy 9th of June 2015', published on the 14th September 2015, found that the immediate cause of the SPAD was "Train Y632 passed Signal RL543 at Danger after the Driver failed to check the signal". Causal factors were identified as "The Driver observed the points returning to normal and then drove the OTM to the opposite end of the siding passing Signal RL543 at Danger without authority"; and "The Driver did not request Signal RL543 from the Signalman during the communication. Although the Signalman repeated back the message to confirm the OTMs position in the siding, the Driver continued the call in a form of words which did not clearly indicate his intentions and the Signalman did not realise or query what he meant by this. As a result a clear understanding was not reached". No underlying causes were identified.

809 The RAIU found that Driver Y632 had an incorrect expectation Signal RL543 was displaying a proceed aspect. This incorrect expectation was as a result of strong sunlight shining onto the signal at the time (and into the face of the Driver Y632); this meant that Driver Y632 did not request the signal from the Signalman. Driver Y632 was also distracted at the time of the incident as a result of changing pay conditions being enforced at the time¹⁹. Poor communications also contributed to not gaining a clear understanding of the movement to be undertaken.
