REPORT

JB 2011/03

REPORT ON RAILWAY ACCIDENT WITH FREIGHT CAR SET THAT ROLLED UNCONTROLLEDLY FROM ALNABRU TO SYDHAVNA ON 24 MARCH 2010

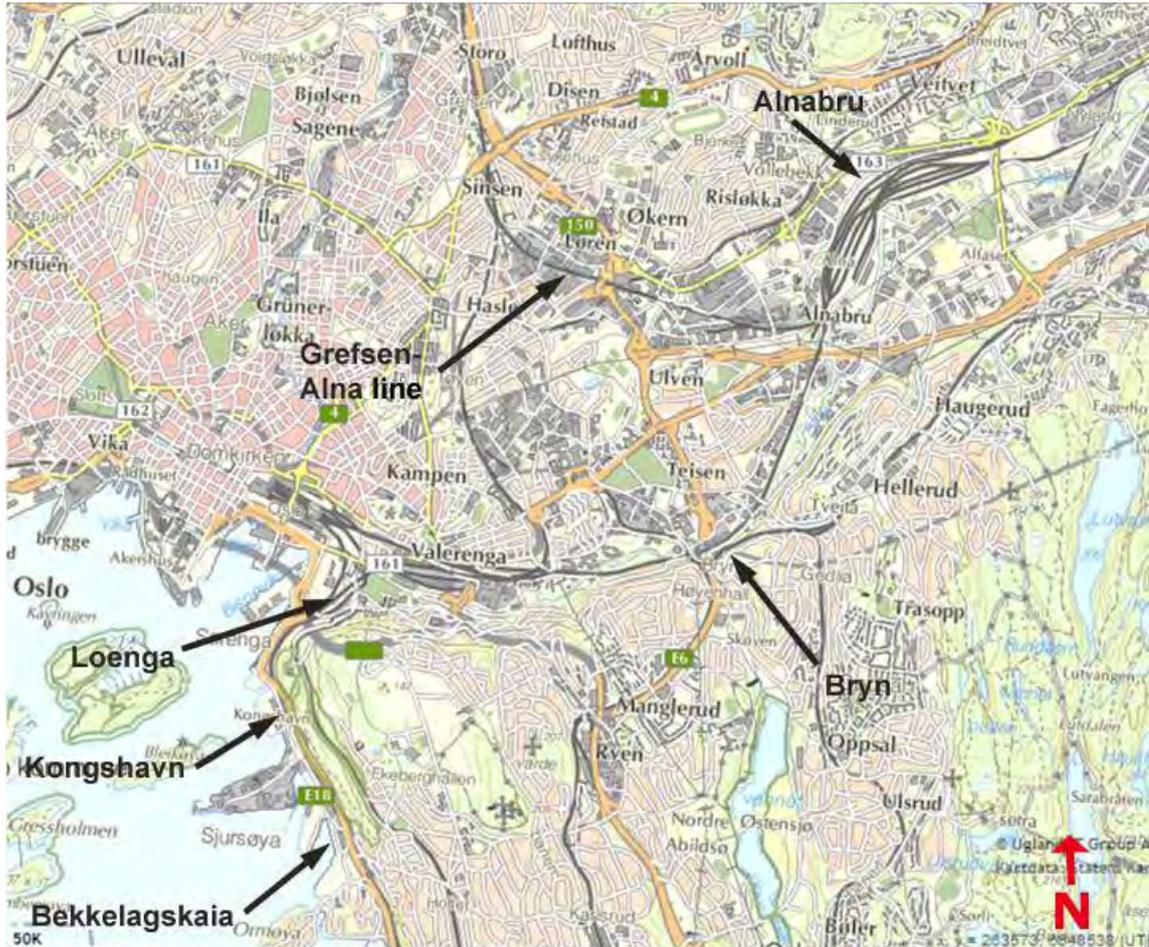
Figure 1: Map of the section travelled by the freight car set.

The freight cars broke loose at the northern part of Alnabru shunting yard, rolled through Alnabru freight terminal and out onto the Loenga-Alnabru freight line. The freight car set continued via Bryn station all the way down to Loenga station and then out into the Sydhavna area of the Port of Oslo. The rear section of the freight car set derailed at Kongshavn beside sheds 7476. The front part of the freight car set passed through the Sjørsøya junction and continued onto Bekkelagskaia and towards the container terminal, where the freight cars hit the gate building. The freight cars rolled a total distance of more than 9 km.

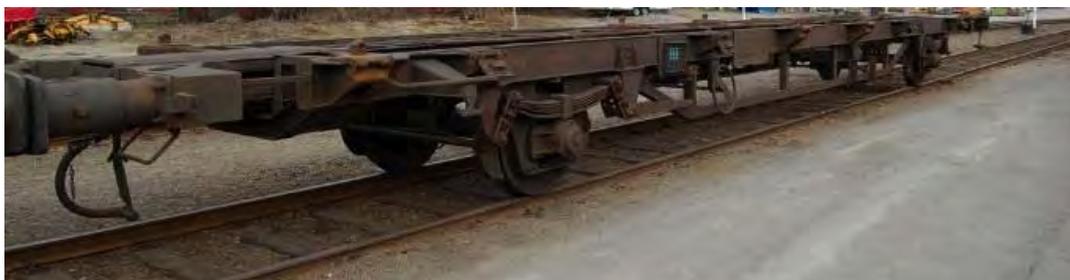
Figure 4: Two-axled container freight car.

No technical faults or defects of any relevance to the incident were found in the rolling stock involved.

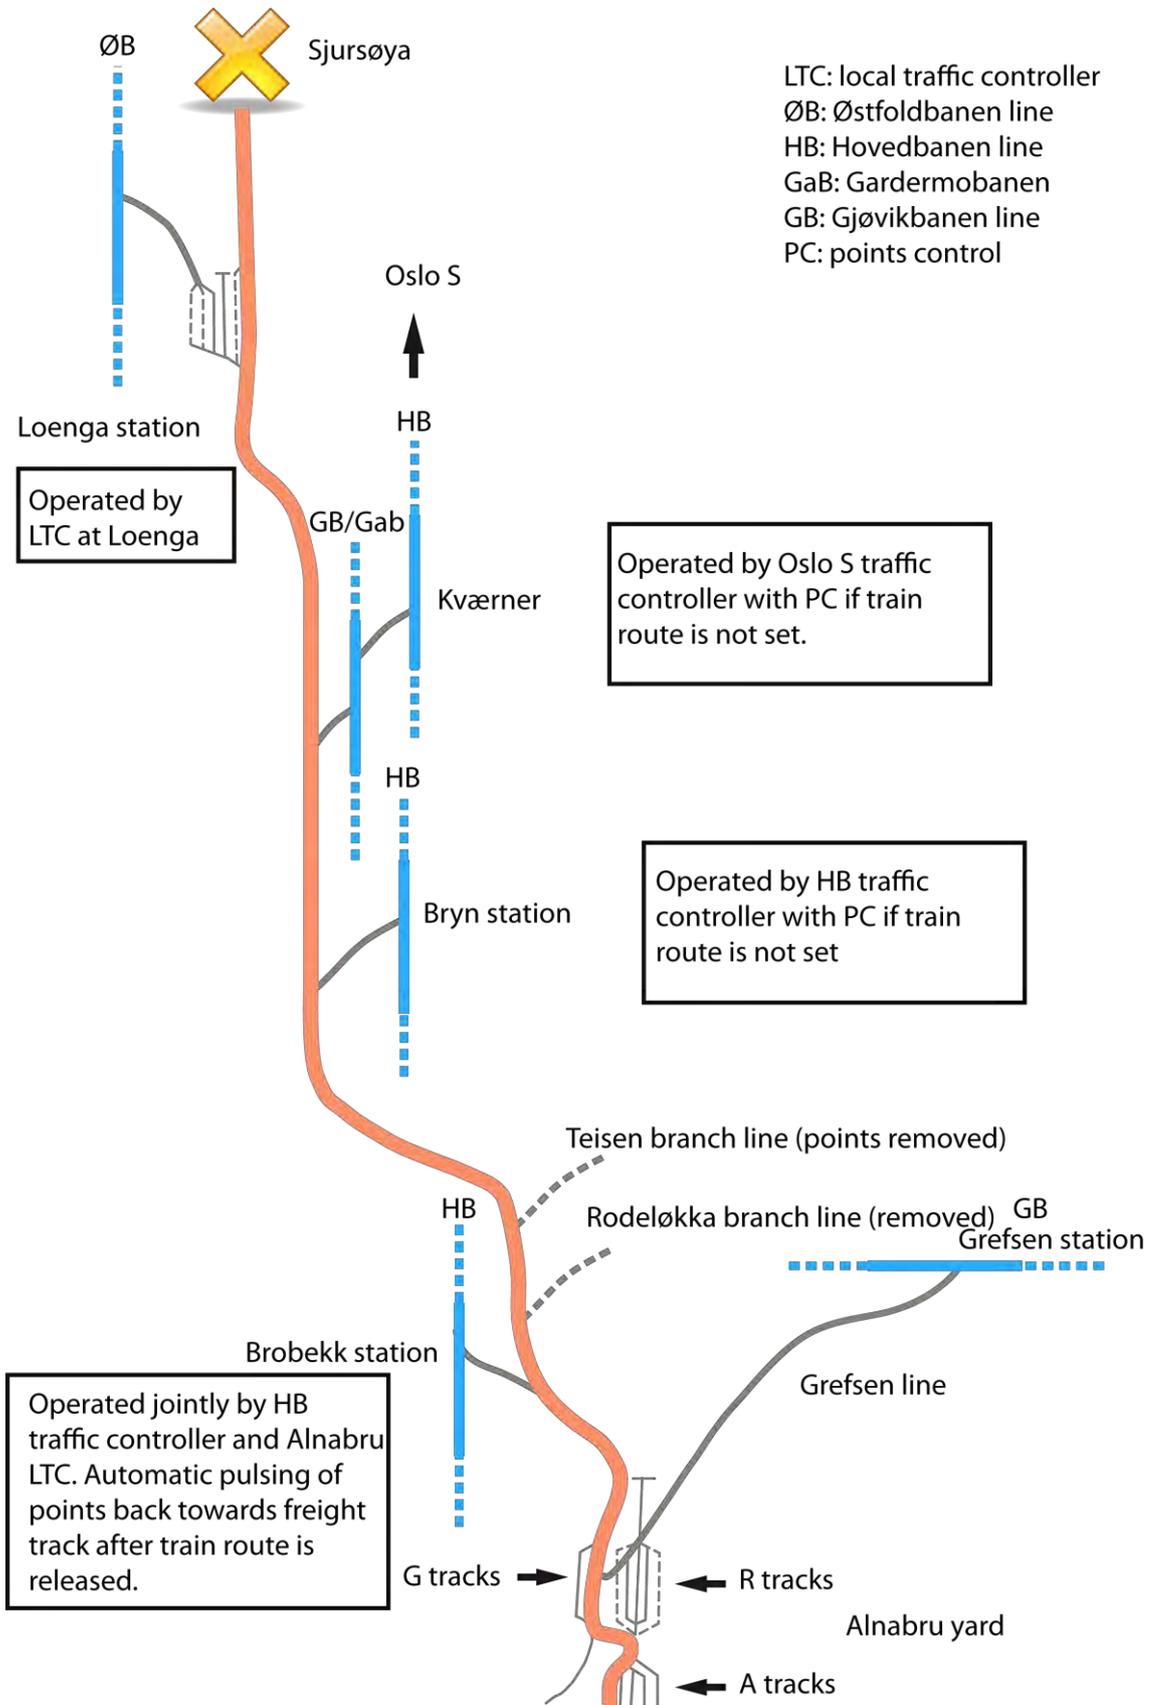
Figure 13: Plan of track connections between Loenga and Alnabru.

Figure 13 illustrates the section travelled by the runaway freight car set, in addition to the alternative train routes which could have been available in the Asker, Bryn, Kværner and Loenga areas.

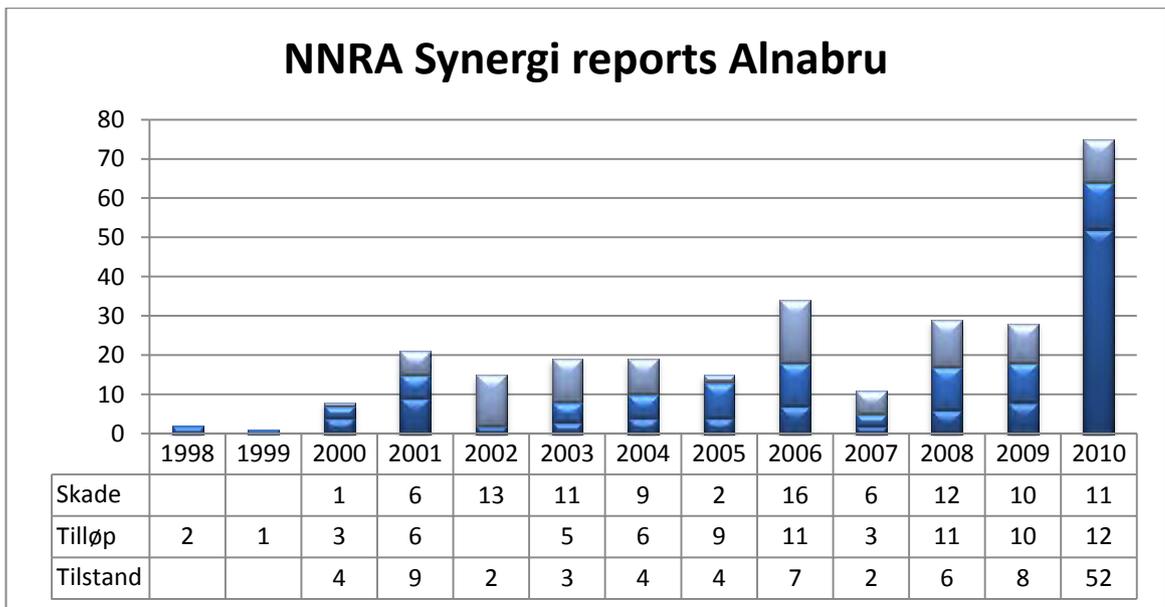
Figure 21: Synergi reports for Alnabru, NNRA 1998-2010. (Skade = injury/loss, Tilløp = Near misses, Tilstand = conditions).

Figure 21 shows that there were considerably more incidents reported in Synergi for Alnabru in 2010. This increase occurred after the accident. There was no increase in the number of reported near misses or injuries in 2010, but there were more reports regarding conditions. For example, after the accident in March 2010, there were more reports in Synergi regarding the working environment for local traffic controllers. The local traffic controllers' line manager has stated that they were not accustomed to reporting any working environment problems in Synergi, and that if they had any of those kinds of problems, they were handled through the performance appraisal and development discussions.

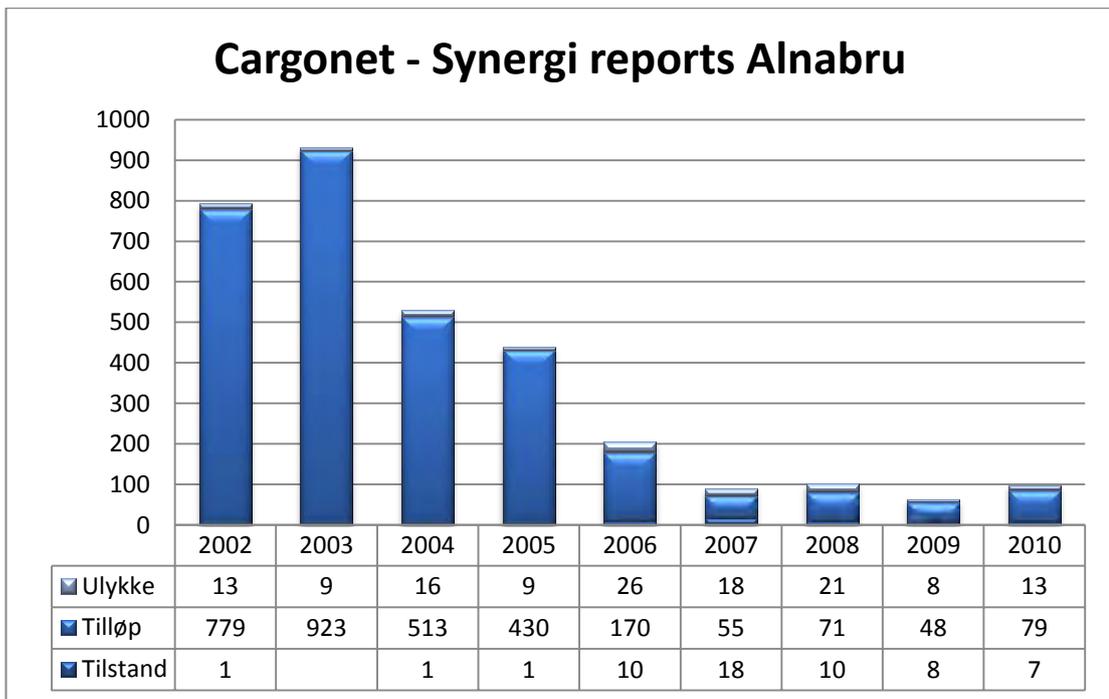
Figure 22: Synergi reports of all undesirable incidents for CargoNet AS Alnabru 2002-2010. (Ulykke = Accident, Tilløp = Near misses, Tilstand = Conditions).

Figure 22 shows a considerable reduction in the reporting of near-misses in Synergi. CargoNet AS has stated that the reduction is mainly due to the fact that near-misses that are detected during pre-departure inspections and rectified before departure are no longer reported in Synergi.
