**Report 06-106, express freight Train 826, signalling irregularity, Cora Lynn,  
31 July 2006**

**Report 06-106**  
**express freight Train 826**  
**signalling irregularity**  
**Cora Lynn**  
**31 July 2006**

On Monday 31 July 2006 at about 2054, eastbound express freight Train 826 stopped at Cora Lynn Arrival Signal 10244 on the Midland Line. The arrival signal was displaying a green aspect, while at the same time the facing points were set in the reverse position and the “L” light was not illuminated.

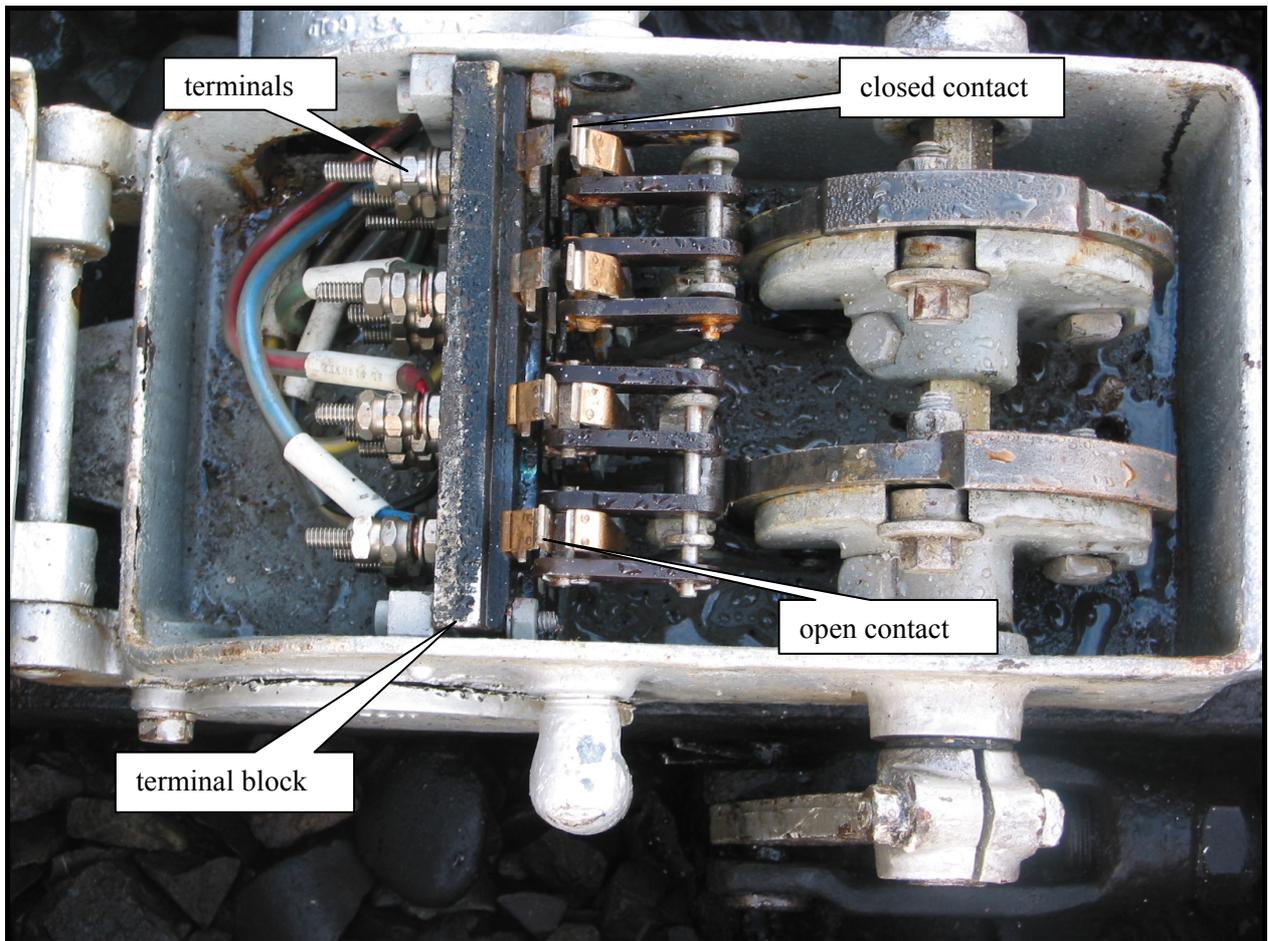
**Figure 6**  
**Universal switch controller**

- 1.4.2 The universal switch controller was housed in a cast-iron protective casing designed so that it could be mounted on an extended sleeper and suitable for continuous use under extreme weather conditions.

- 1.4.3 The universal switch controller consisted of a camshaft mechanically connected to the set of rail points. When the points were moved, the camshaft rotated. The double-cam followers were attached to the camshaft and arranged so that they positively activated both the opening and the closing of the electrical contacts (see Figure 6). The camshaft rotated approximately 90 degrees by the movement of the point's mechanism as it changed from either the normal (mainline) to the reverse (diverging line) or reverse to normal positions. The 3 contacts on each switch, Common, Normally Open and Normally Closed, were wired out through a terminal block to dedicated terminals (12 terminals in total) to connect with the local signal indication circuit.

- 1.4.4 The cams were adjusted to operate one pair of changeover switch contacts when the track points were in the normal position and the other pair when the track points were in the reverse position. Ontrack's setting instructions required the Common and Normally Open contacts on the cam-operated switch to close when the track points were within 6 mm of the respective state. The switch had to be closed within 2 mm of the respective state and open when more than 6 mm from the respective state.
