**Report 06-110, passenger Train 4045, uncontrolled movement, between Britomart station and Quay Park junction, 9 October 2006**

**Report 06-110**  
**passenger Train 4045**  
**uncontrolled movement**  
**between Britomart station and Quay Park junction**  
**9 October 2006**

On Monday 9 October 2006 at 0806, passenger Train 4045 travelled 526 metres between Britomart station and Quay Park junction with the locomotive engineer not at the controls of the train. The locomotive engineer had left the train to operate a valve to restore air-brake pressure following an uninitiated emergency brake application. Once air-brake pressure had been restored, the train began to move before the locomotive engineer re-boarded the train.

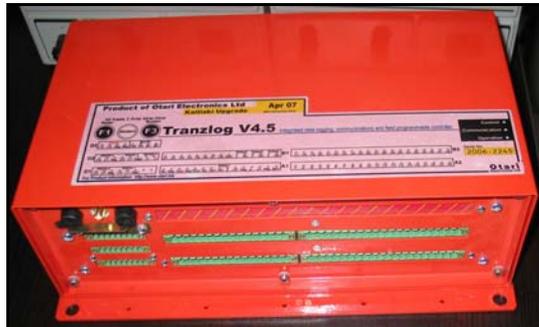
**Figure 7**  
**A Tranzlog-type of event recorder**

1.3.15 The event recorders fitted to the ADL/ADC sets were a modern "Tranzlog" type (see Figure 7).

1.3.14 Event recorders were subsequently installed in all the cabs of the ADC cars by June 2007 and in the ADL cars by November 2007. Priority was given to installing the recorders in the ADC cabs to ensure there was at least one recorder on each ADL/ADC set. Event recorders were installed in ADC860 on 24 May 2007 and in ADL810 on 31 October 2007.
