RAILWAY OCCURRENCE REPORT

06-112

Report 06-112, loss of airbrakes and collision, Tram 244,
Christchurch

November 2006

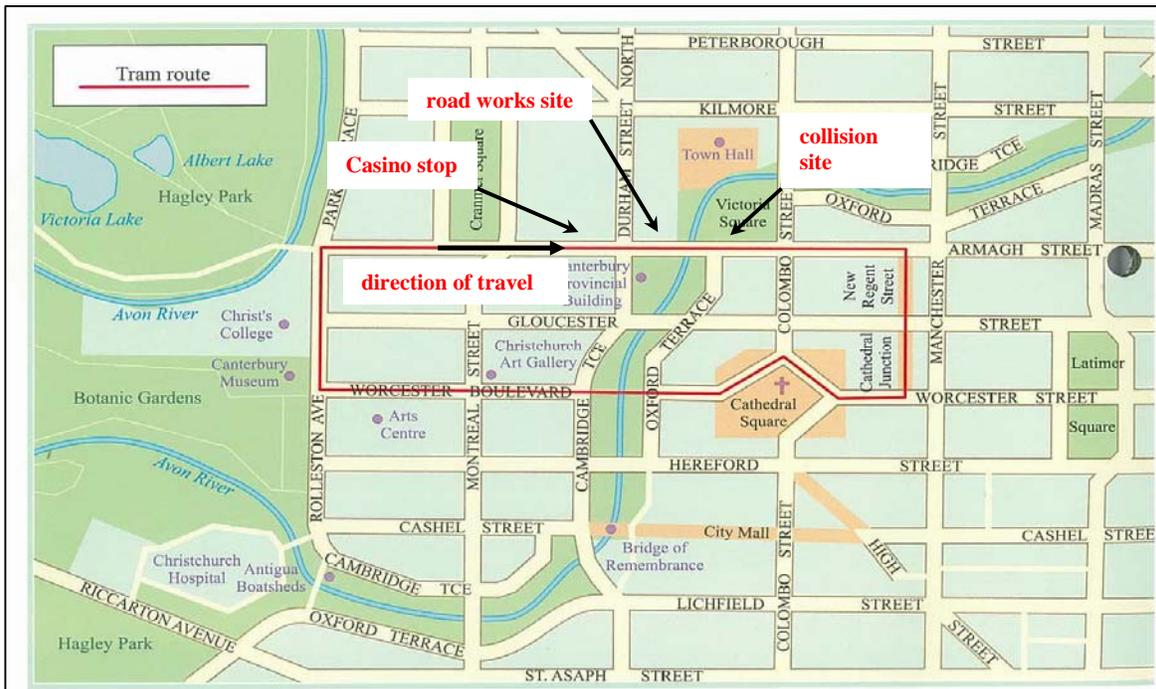
Figure 2
Tram route map (courtesy Christchurch Tramway)

- 1.2.3 Most of the route was on roads where the trams ran with other vehicles. The trams were required to obey traffic signal indications or special, tram-only, indications at intersections.

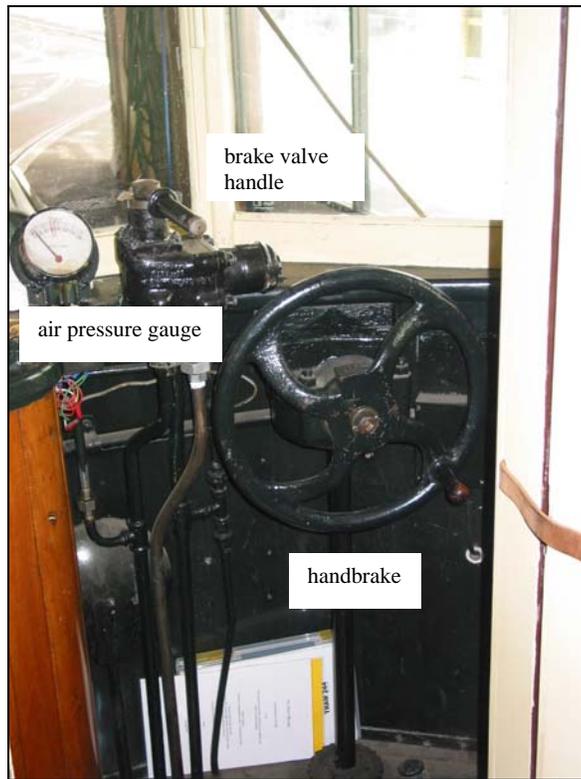
Figure 4
Driver's cab of Tram 244

- 1.3.2 The driver's brake valve handle (see Figure 4) was used to control the flow of compressed air to and from the brake cylinder. A piston actuated the brakes through a system of levers, rods and chains, collectively known as the brake rigging. The brake rigging forced brake blocks onto the rim of the wheel to provide braking action.
