**Report 07-103, passenger express Train 200, collision with stationary passenger  
express Train 201, National Park, 21 March 2007**

### **Abstract**

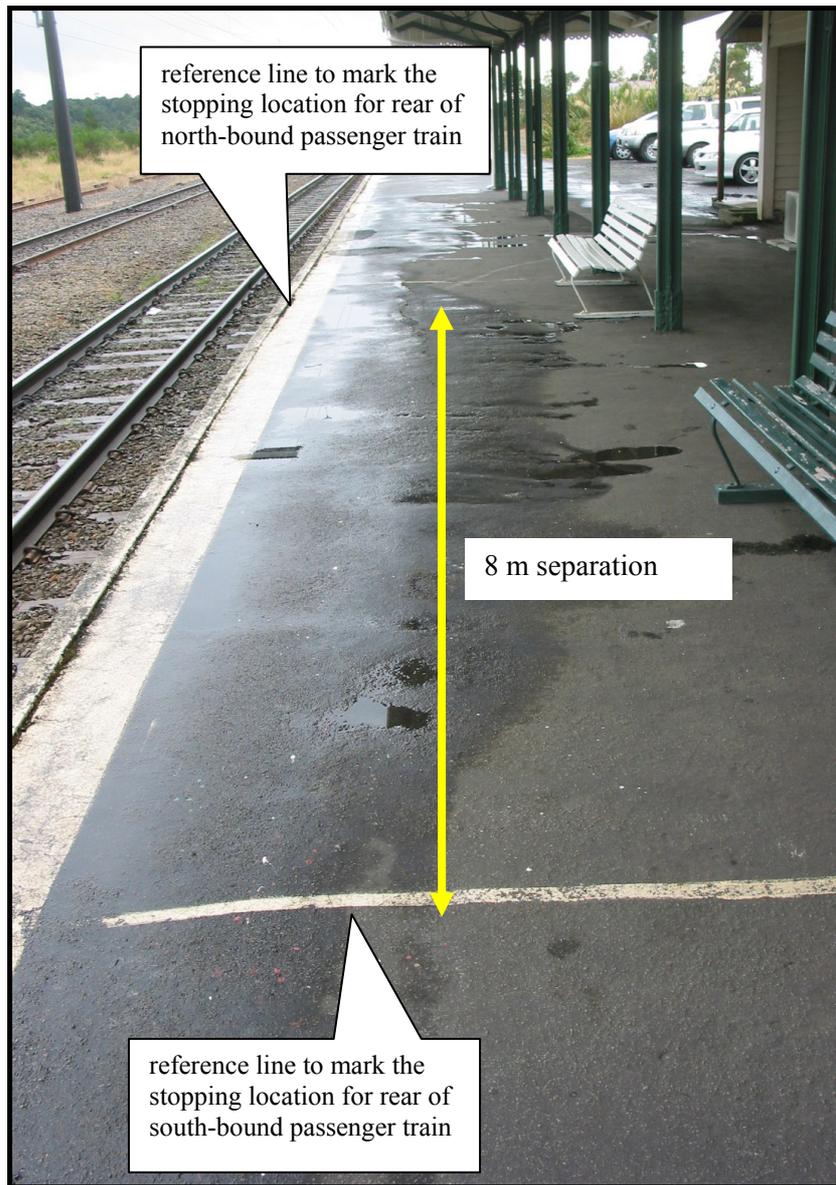
**Figure 2**  
**Designated stopping locations for passenger trains at National Park Station**

- 1.1.8 At 1250:23<sup>3</sup>, Train 201 passed Down Home Signal 8L at National Park on its approach to the station platform. The train manager, who was positioned close to the observation window of the rear passenger car, maintained radio contact with the locomotive engineer and called him to stop clear of the designated stopping point marked on the 129 m long station platform (see Figure 2).

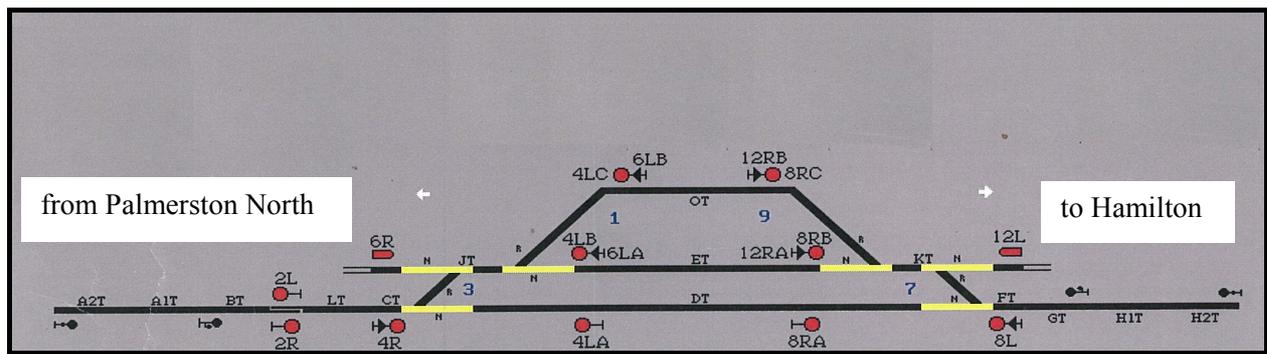
**Figure 3**  
**Signals layout at National Park (provided by Ontrack)**

- 1.1.9 At 1252:54, north-bound Train 200 entered the crossing loop at the south end of National Park, passed Train 201 and then crossed back to the main line at the north end. The locomotive engineer stopped the train when the train manager told him that the last carriage had cleared Signal 8L (see Figure 3). The north-end main line points were then restored to normal for the setback movement to the platform.
