**Report 07-108, express freight Train 720, track warrant overrun at Seddon,
Main North Line, 12 May 2007**

Report 07-108
express freight Train 720
track warrant overrun at Seddon
Main North Line
12 May 2007

On Saturday 12 May 2007, at 0400, northbound express freight Train 720 travelled past Seddon towards Vernon on the Main North Line without the authority of a track warrant issued from train control.

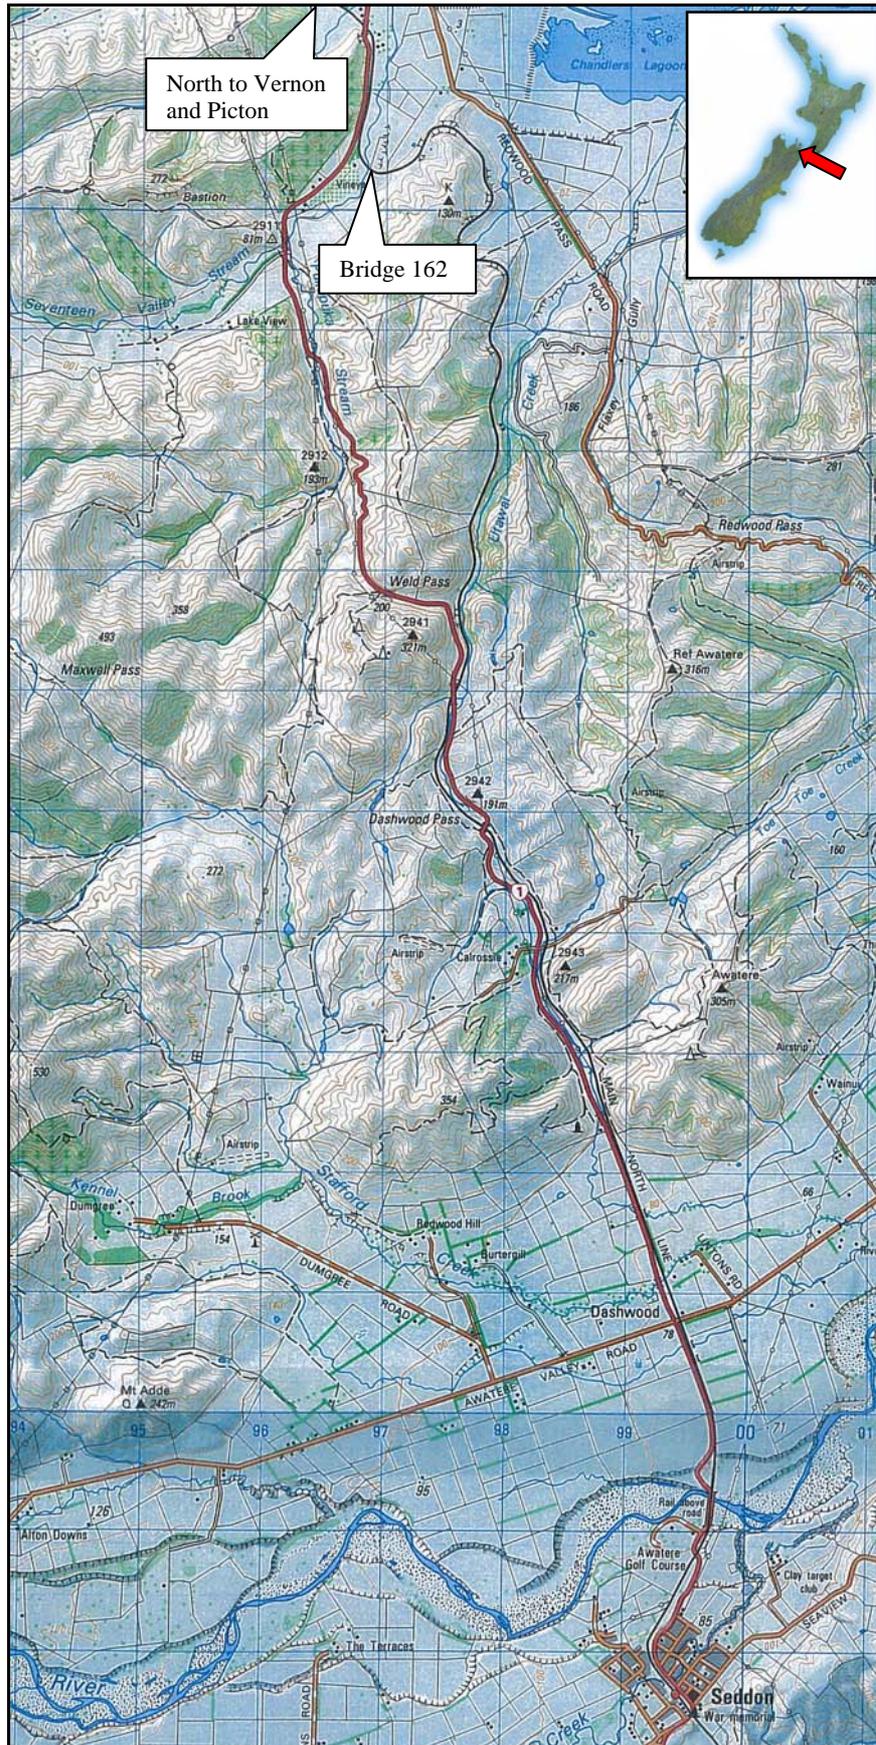
MNL from Seddon towards Vernon

The locomotive engineer did not stop on the main line at Seddon as required and obtain a new track warrant to travel beyond Seddon. Southbound Train 723 was sitting on the loop when Train 720 passed through Seddon. There were no other conflicting movements and as a result there was no damage or injury.

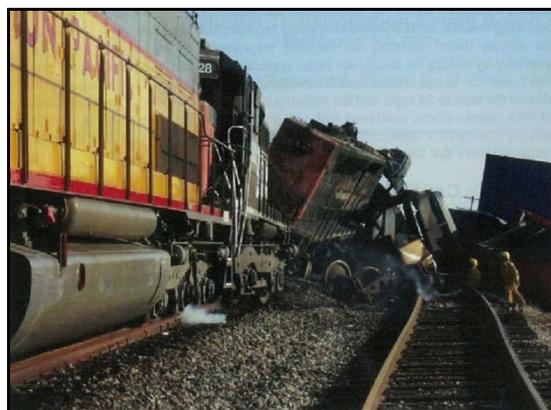
Figure 9
Freight train collision in California

1.8.1 On 8 September 2008, the NTSB published a railroad accident brief following a rear-end collision between 2 freight trains in California that occurred on 10 November 2007. The NTSB found that the 2 crew members did not comply with stop indications on any of 3 signals as their train approached a stationary train because they were likely asleep. The 2 crew members did not survive the collision (see Figure 9). The NTSB also found that a lack of a positive train control system contributed to the collision. It was estimated that the cost of damage was US\$ 2 million.
