**Report 08-108, express freight Train 845, track warrant overrun,  
Reefton–Cronadun, 13 August 2008**

**Report 08-108**  
**express freight Train 845**  
**track warrant overrun**  
**Reefton-Cronadun**  
**13 August 2008**

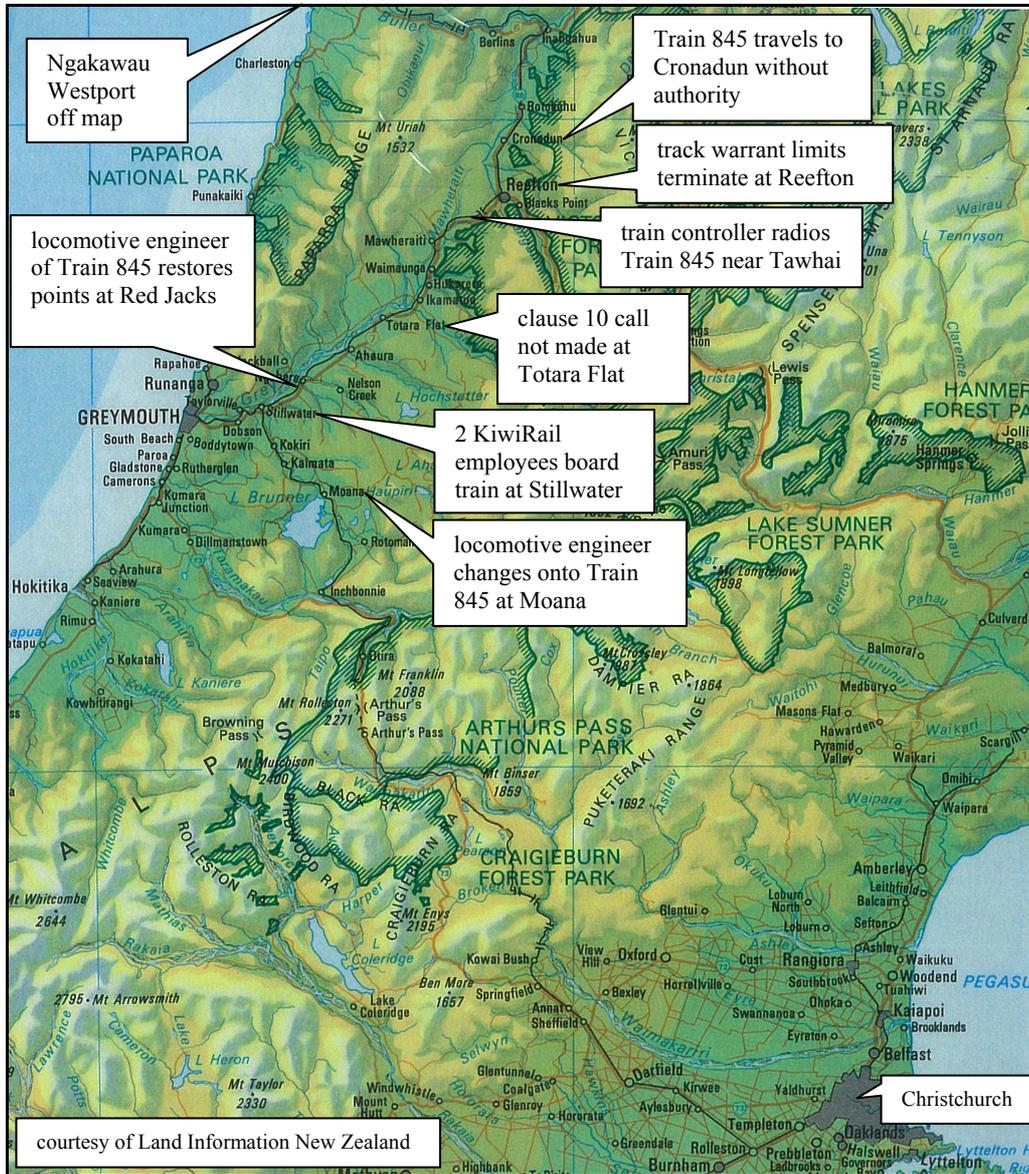
**Figure 2**  
Coal route map showing pertinent locations

- 1.1.2 The locomotive engineer changed onto Train 845 at Moana, (see Figure 2) and obtained an operating instruction to travel through to Stillwater, about 33 kilometres (km) ahead. While Train 845 was still at Moana the train controller also issued a track warrant for it to proceed from Stillwater to the main line at Reefton only, because another train was running ahead of Train 845 and held authority, at that time, to occupy the section of track beyond Reefton. Instructions, contained in clause 10 of the track warrant, required the locomotive engineer to make radio calls<sup>2</sup> to the train controller, one at Stillwater and the other at Totara Flat.
