Report 99-109

Southerner passenger express Train 902

track warrant overrun

21 May 1999

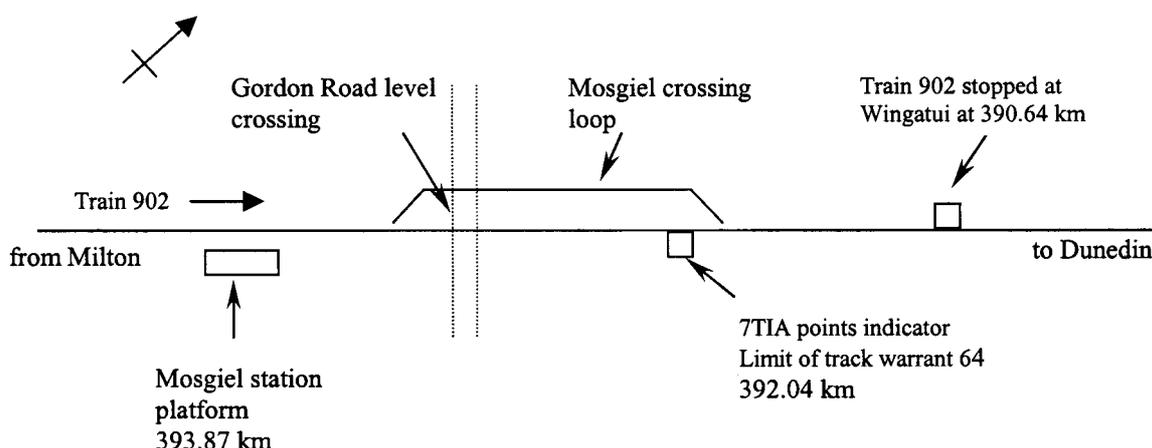
Figure 1
Site plan of Mosgiel (not to scale)

- 1.1.2 Track Warrant 64 was issued to the LE at Milton and authorised him to travel to 7TIA points indicator at the north end of Mosgiel station limits, approximately 1.8 m north of the Mosgiel station platform (see Figure 1).

- 1.1.4 Upgrading work was being undertaken at Gordon Road level crossing approximately 500 m north of the Mosgiel station platform. Because the LE was unsure of the progress of work going on at the level crossing, and whether the protection was operating automatically or manually, prior to arrival at Mosgiel he had instructed the train manager not to cancel the protection on arrival at the platform. The normal practice for stopping passenger trains was to cancel the protection.

¹ When approaching Mosgiel platform from the south a train automatically activated the level crossing protection at Gordon Road before reaching the platform. Protection would continue during a passenger stop unless manually cancelled by the train crew at Mosgiel.
