RAILWAY ACCIDENT

Report on the Derailment
that occurred on 20th May 1970
at Audenshaw Junction
near Guide Bridge

IN THE
LONDON MIDLAND REGION
BRITISH RAILWAYS

1971

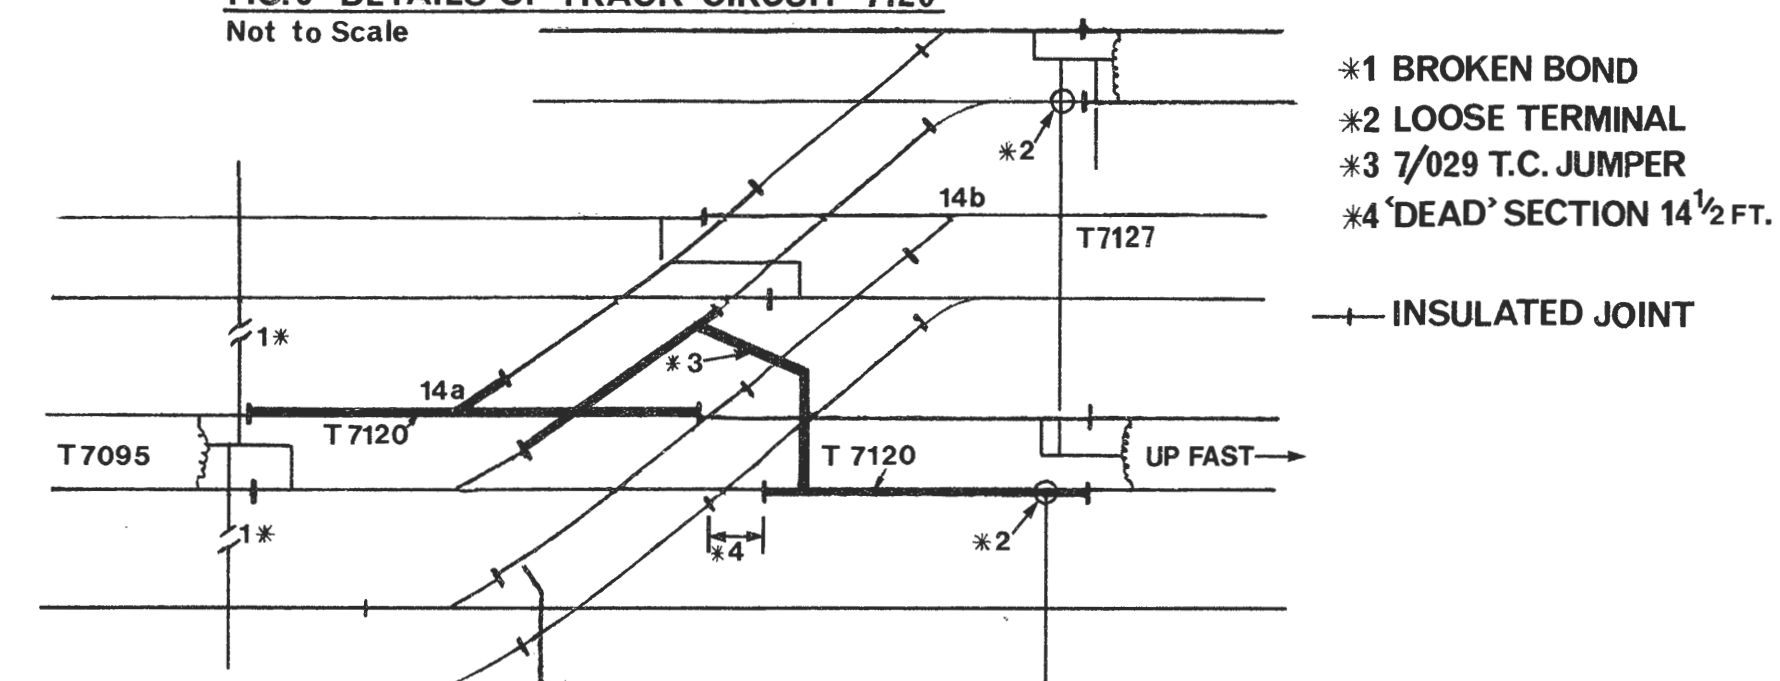
FIG.5 DETAILS OF TRACK CIRCUIT 7120

4. The points are air operated, controlled electrically by solenoid valves mounted on racks at the lineside. All track circuits are AC type. Track circuit 7120 which is of the single rail type (see fig. 5) begins 35 yards ahead of signal No. 5 and ends some 105 yards past No. 14a facing points. No. 14 slide cannot be pulled unless No. 7120 track circuit is unoccupied and both the track circuit relay and 14 slide electric lock thereby energised. Similarly the slide cannot be pulled unless track circuit 7127 on the Down Slow line which starts some 32 yards past signal No. 34 and some 83 yards before points No. 14B, is unoccupied. Points No. 14 are also approach locked when track circuit 7095 on the Up Fast line is occupied. This approach locking is meant to be released when the track circuit has been occupied with signal No. 5 at Danger after a period of 90 seconds from the time a treadle positioned 232 yards on the approach to them is operated. However tests after the accident showed that the timer had in fact been set at 137 seconds. The points are similarly approach locked when the track circuit 7156 on the Down Slow line which starts some 555 yards before them, is occupied and the release period in this case was correctly set at 120 seconds.
