DEPARTMENT OF TRANSPORT

RAILWAY ACCIDENT

**Report on the Collision that
occurred on 19th December 1978
between Hassocks and Preston Park**

IN THE
SOUTHERN REGION
BRITISH RAILWAYS

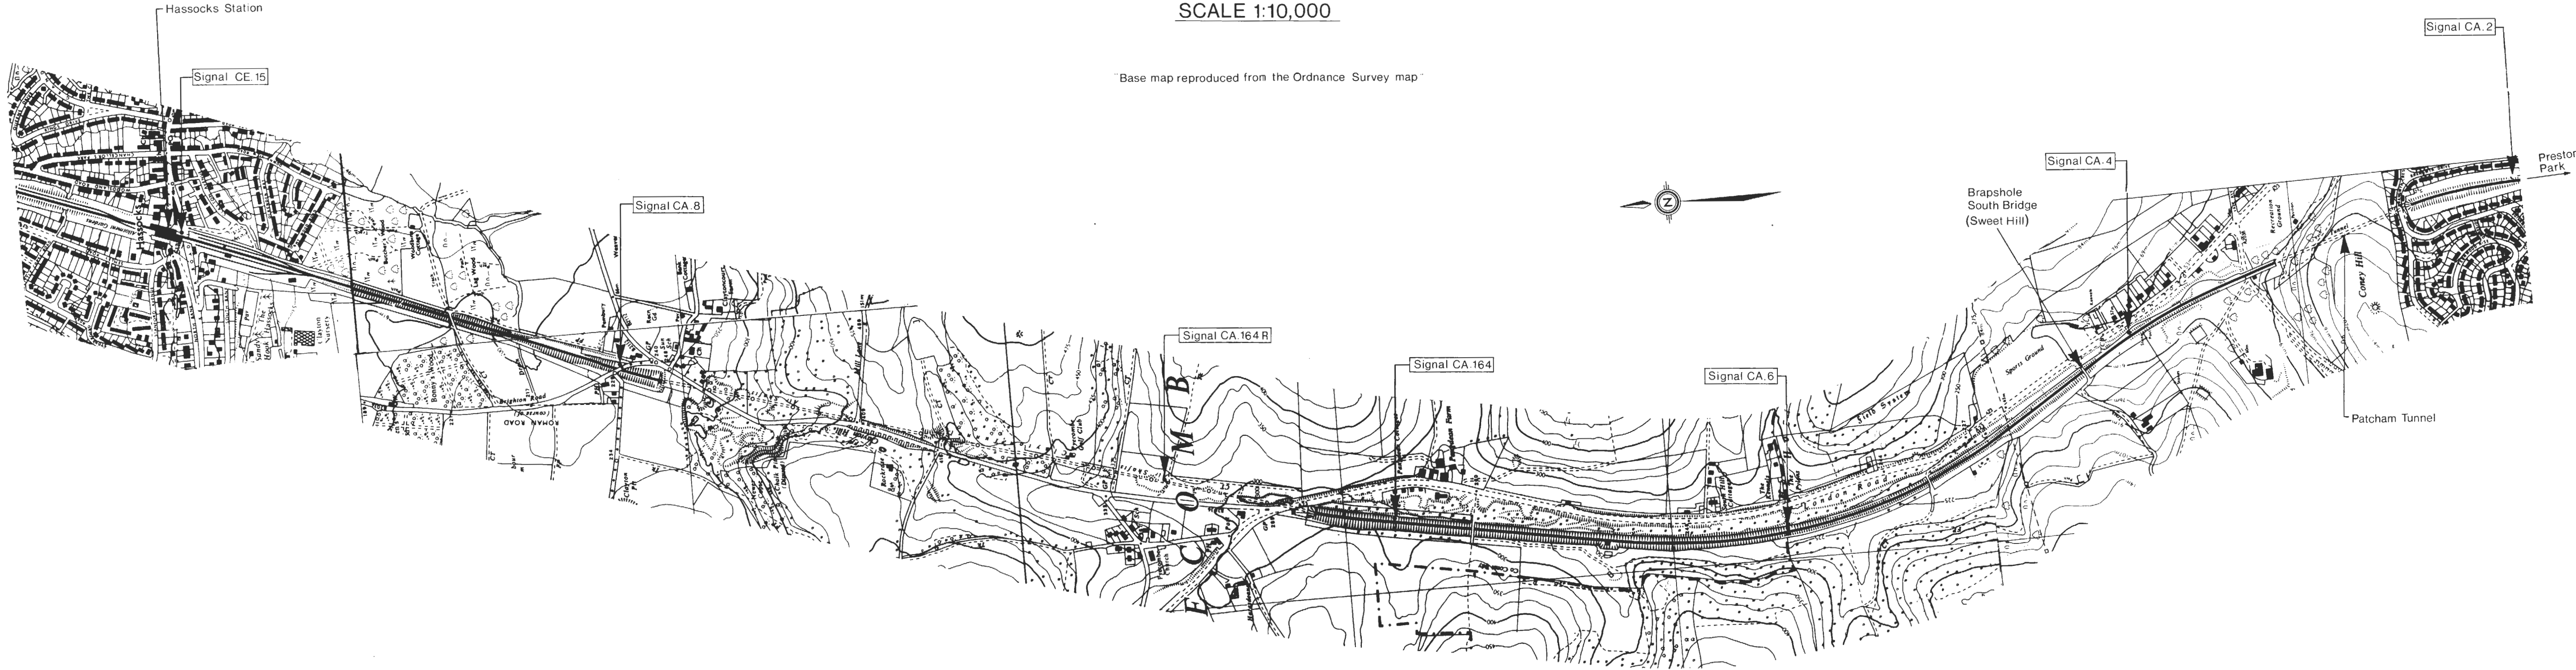
FIG:2

8. Figure 2 at the back of the report shows the position of the individual coaches within each train at the time of the accident.

PLAN SHOWING POSITION OF THE TRAINS AFTER THE COLLISION
