**A report of the collision  
that occurred on 8 January 1991  
at Cannon Street Station**

The Permanent Under Secretary of State  
Department of Transport

2 March 1992

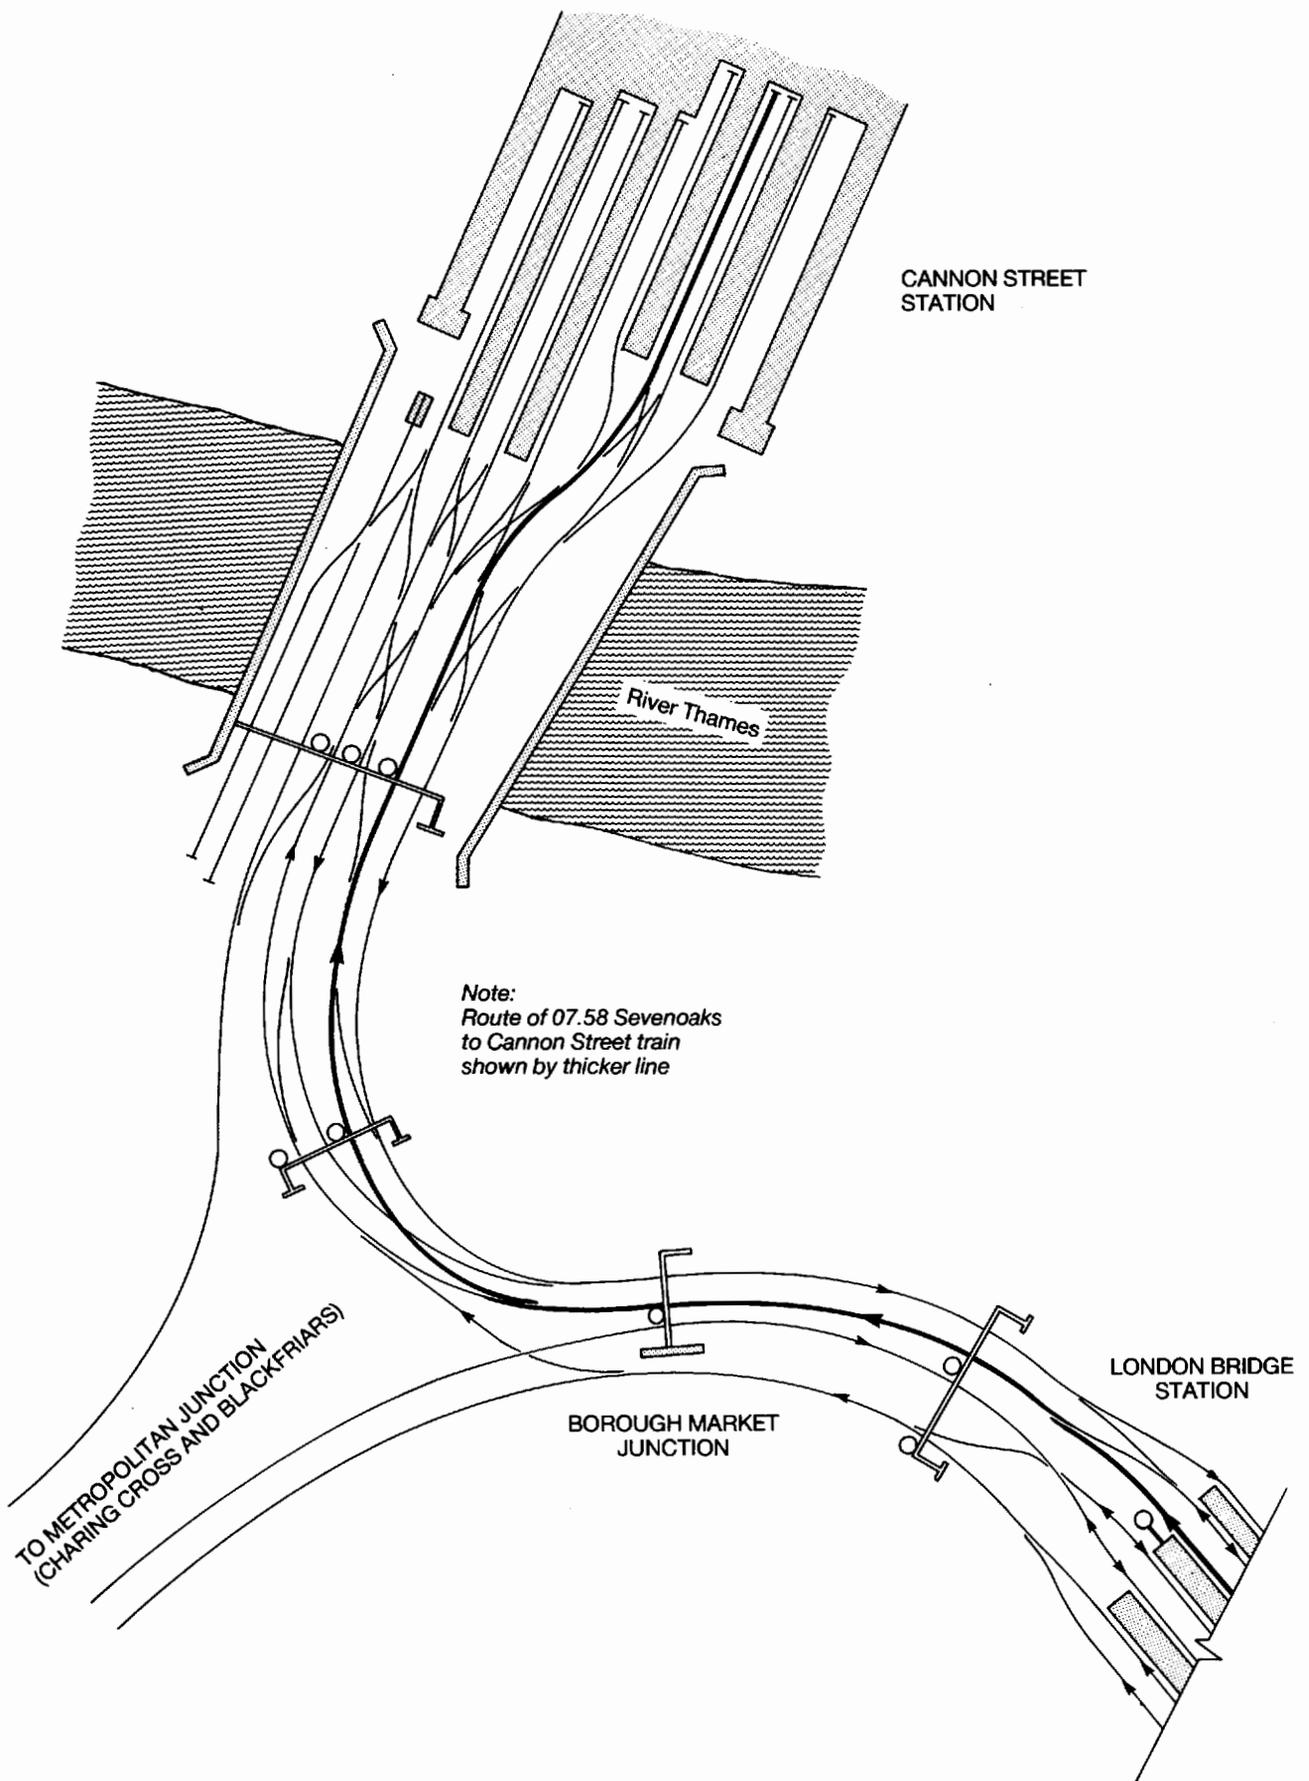
Figure 2 Track layout on approaches to Cannon Street Station

5 The track layout at the time of the accident on the approaches to Cannon Street Station is shown in Figure 2. From Borough Market Junction to Cannon Street Station there are four running lines: up fast; down fast; up slow; and down slow; from left to right in the direction of approach to Cannon Street. A permanent speed restriction of 20 mile/h applies on all lines between Borough Market Junction and the platform approaches at Cannon Street with a 15 mile/h permanent speed restriction applying thereafter.

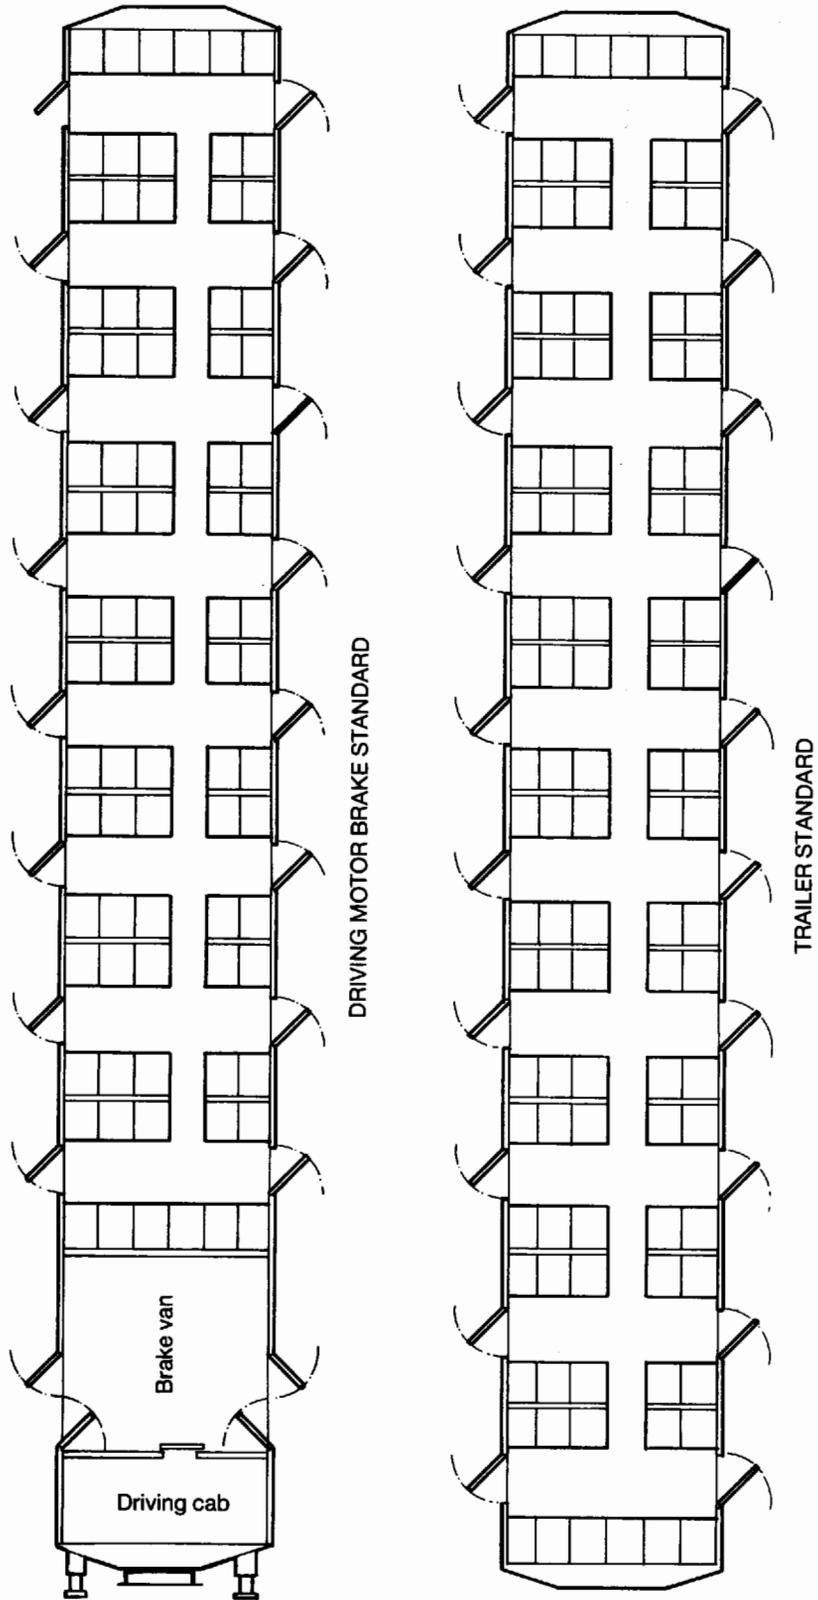
Figure 3 Seating arrangement of electrical multiple unit

12 The intermediate trailer coaches of unit Nos 5618 and 5484, that is, vehicle Nos 70444, 70443, 15308 and 15031, each had 102 standard class seats in an open saloon. The driving trailer coach No 77526 of unit No 6227 had a driving cab with an access vestibule at the end and 102 standard class seats in a mixture of open saloon and individual compartments. The typical seating arrangement is shown in Figure 3.

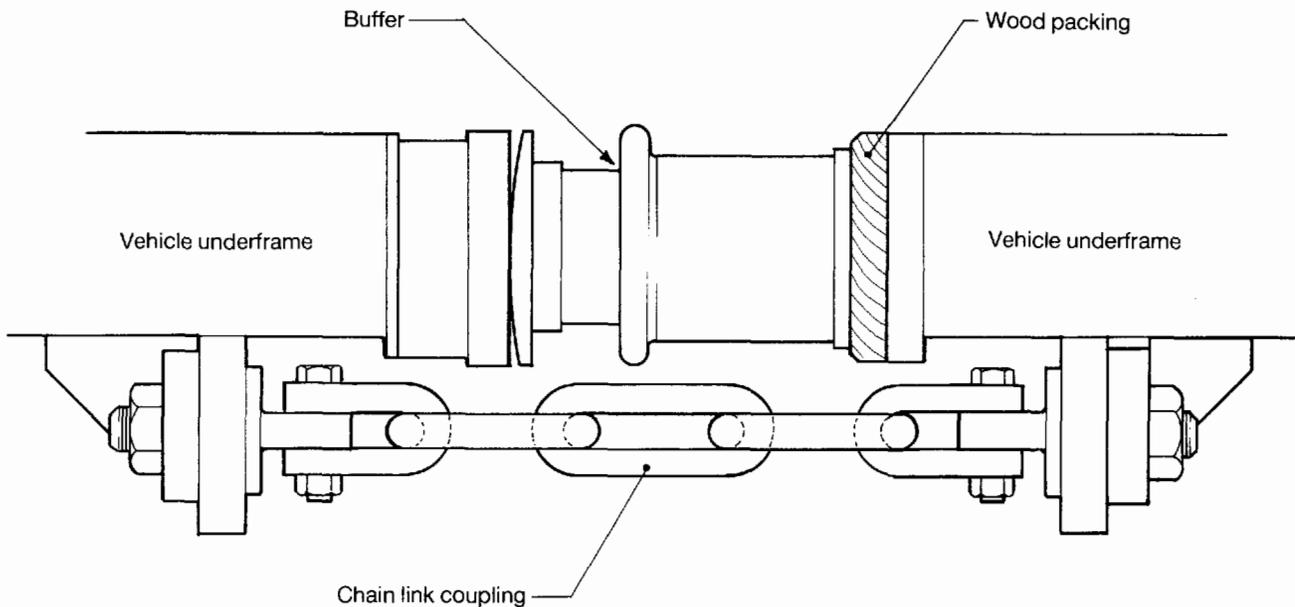
**Figure 4** Centre buffer and coupling

13 There were no gangway connections between the units or individual vehicles in the units. Each compartment or seating bay had individual hinged, passenger-operated (slam) doors. The outer ends of the units were equipped with side buffers and an automatic coupler. The internal couplings within the unit were provided by a centre buffer and chains. This arrangement is shown in Figure 4.
