# **The Southall Rail Accident Inquiry Report**

**Professor John Uff QC FREng**

### **Inquiry into Southall Railway Accident**

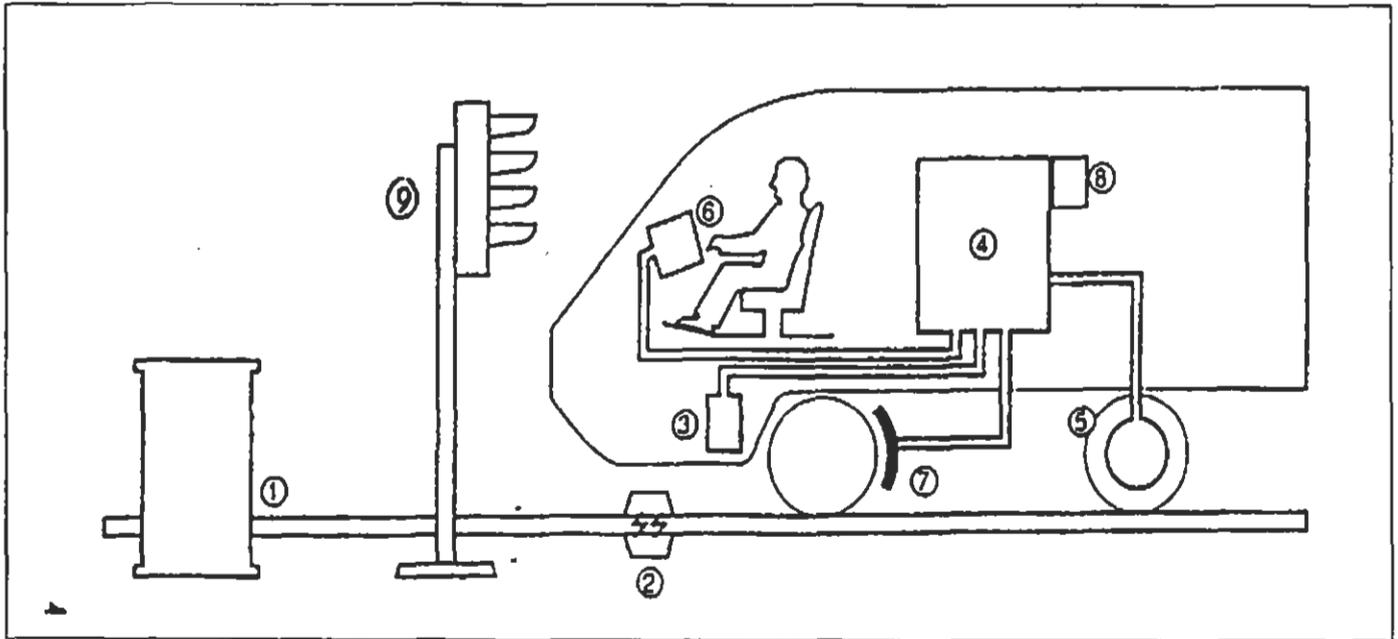
DIAGRAM OF ATP

1. Lineside equipment supplies information on speed limits, gradients and the signal(9) aspect to:-
2. A track transmitter which transmits data telegrams to:-
3. An antenna on the train from which they are passed to:-
4. An onboard computer. This has details of train length, weight, formation and braking characteristics entered by the drivers at the start of the journey along with his identification (6).
5. The tachometer, which provides train speed and distance travelled to the computer, which has triplicated channels. The computer calculates a speed distance curve for the train.
6. The terminal and display showing safe speed and signal aspect. If the driver fails to respond correctly to the information displayed in the cab, the computer causes:-
7. A brake application.
8. A data recorder, which records all the relevant information.
9. Signal.
