MINISTRY OF TRANSPORT & CIVIL AVIATION

REPORT ON THE DERAILMENT

4th September 1953

BETHNAL GREEN STATION

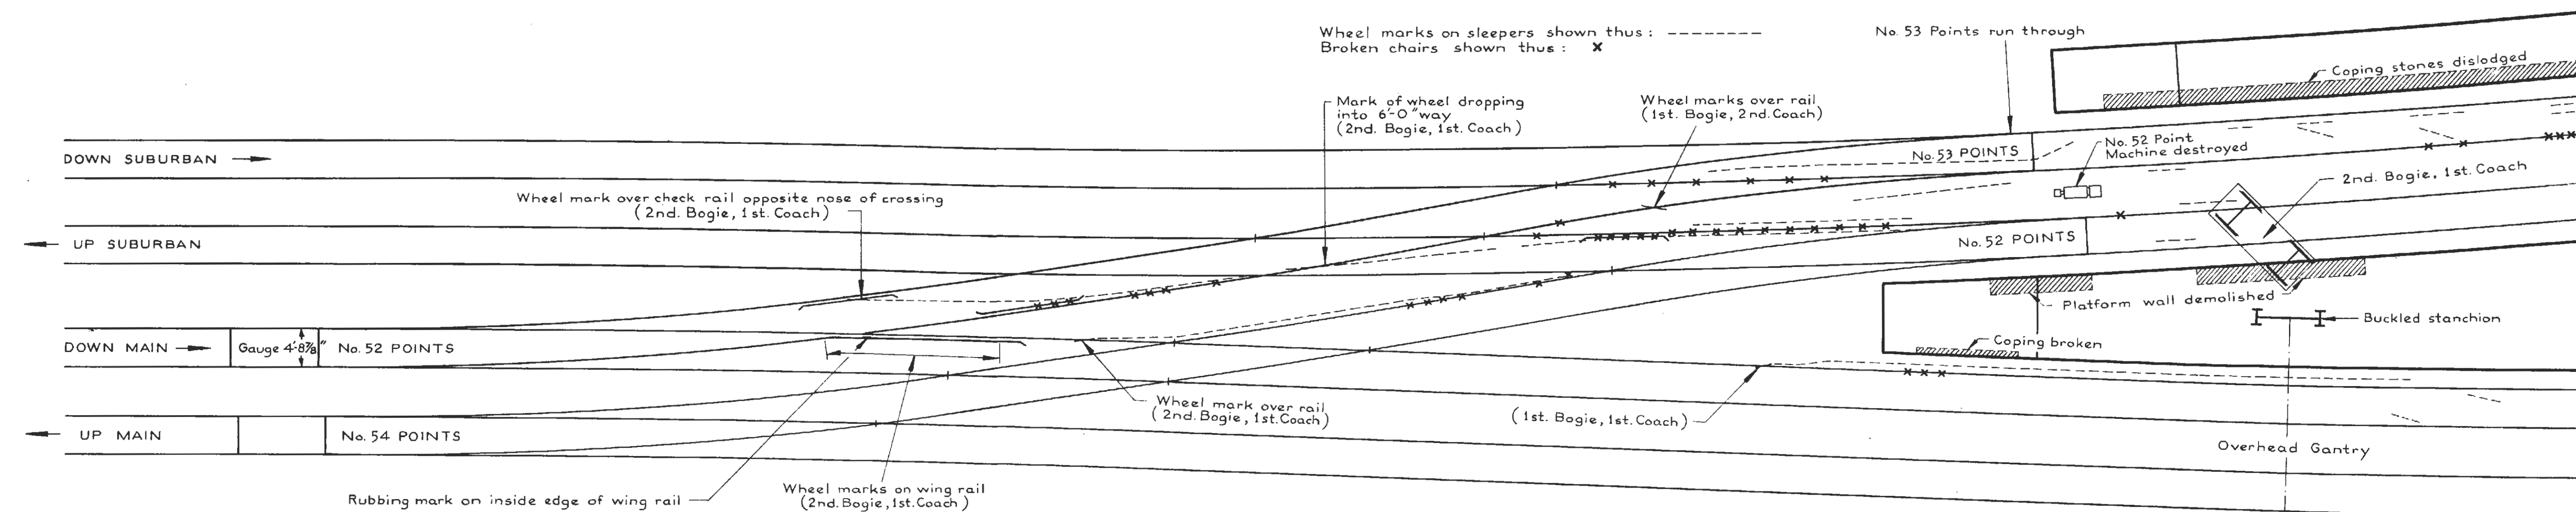
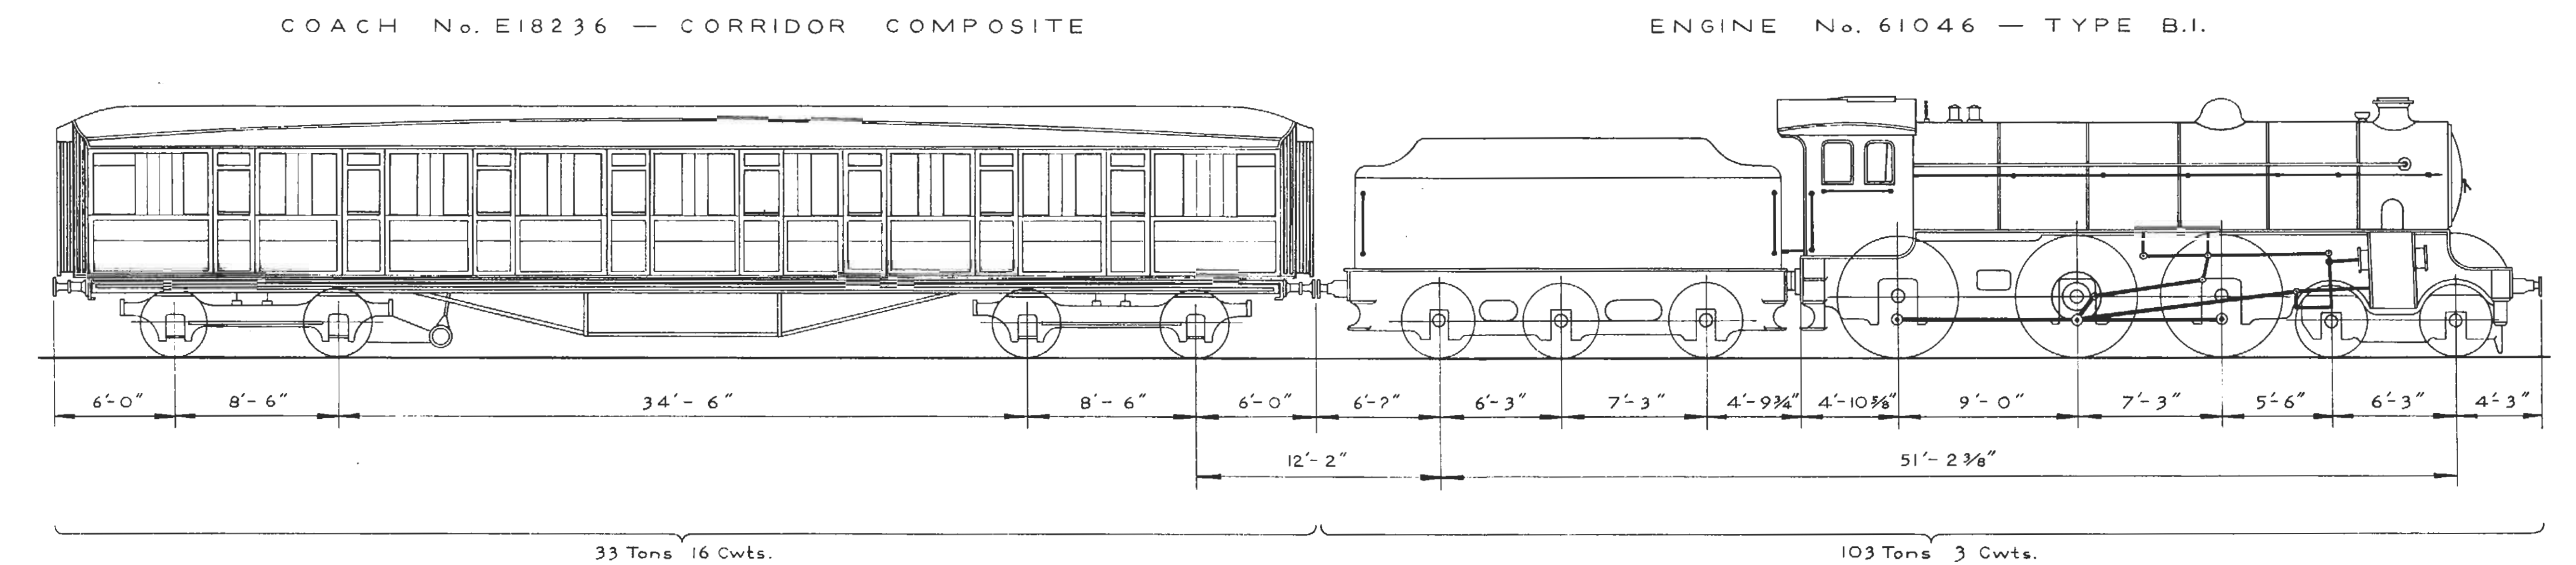
FIG. 4
GENERAL SIGNALLING PLAN
SCALE: 2 CHAINS TO 1 INCH

12. The signalling at Bethnal Green, which is illustrated by Fig. 4, was brought into use in January 1949 in connection with the Liverpool Street—Shenfield electrification. There is continuous track circuiting on all lines and movements are advised on automatic train describers, working on a coded impulse system with standard telephone type equipment. The signal box is in the angle between the Up Fast Cambridge line and the Down Main, just to the east of the junction, and it is equipped with route relay interlocking with an illuminated panel on which the route selecting switches are mounted.

22. As will be seen from the signalling diagram Fig. 4, No. 52 point machine not only operates the facing points of the Down Main to Down Suburban crossover but also the facing points of the Up Suburban to Up Main crossover. The actual machine, which is of the combined type incorporating the facing point lock and detector, is located opposite the Up Suburban facing points in the six foot way between the Up and Down Suburban lines. The Down Main points are worked by rodding which also operates the facing point lock and detector at this end of the layout.

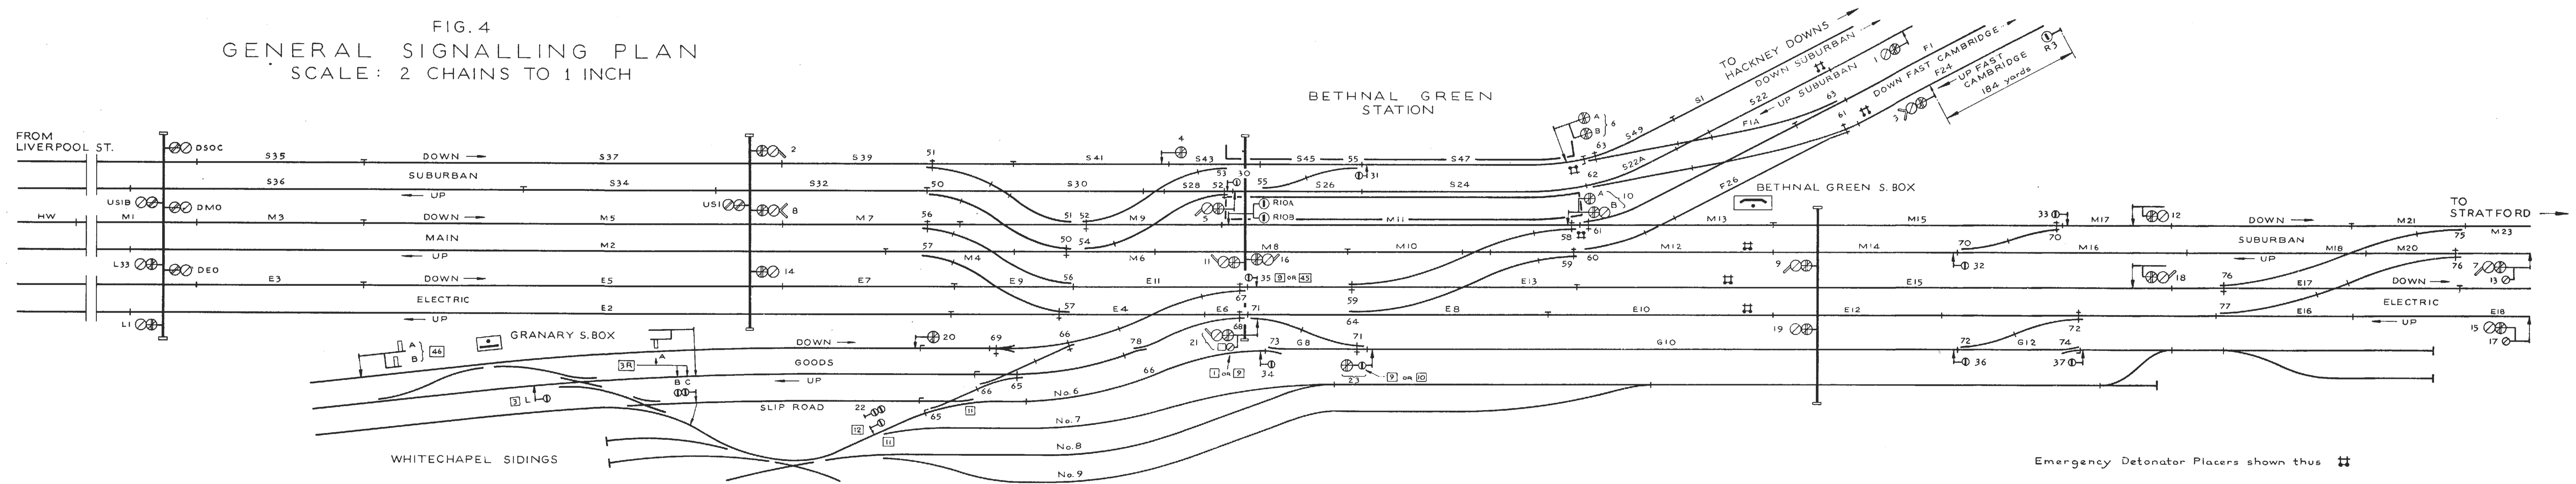
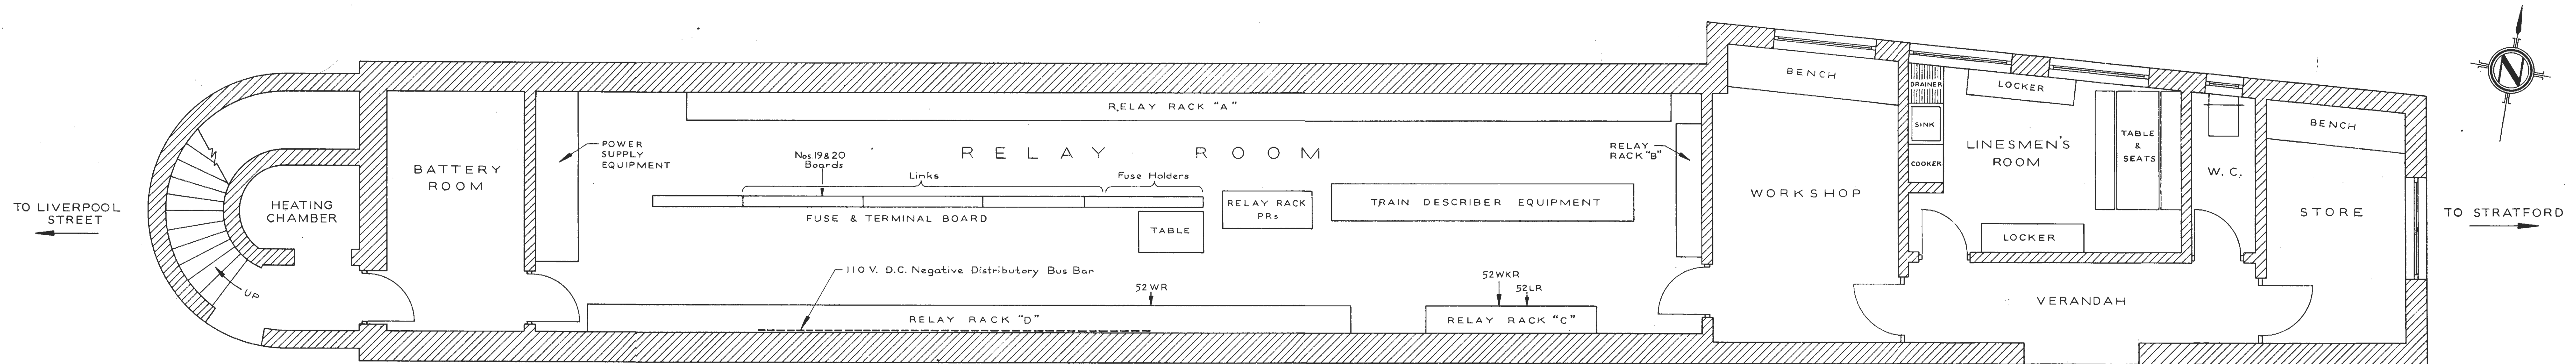
FIG. 5
RELAY ROOM AND LINESMEN'S ACCOMMODATION — BETHNAL GREEN SIGNAL BOX
SCALE: 1/4" TO 1'-0"

17. The relay room is on the ground floor of the signal box with the battery room adjoining it at the west (London) end, and the workshop, linemen's room and store at the other end; the general layout is shown by Fig. 5. It houses the following types of relay:—

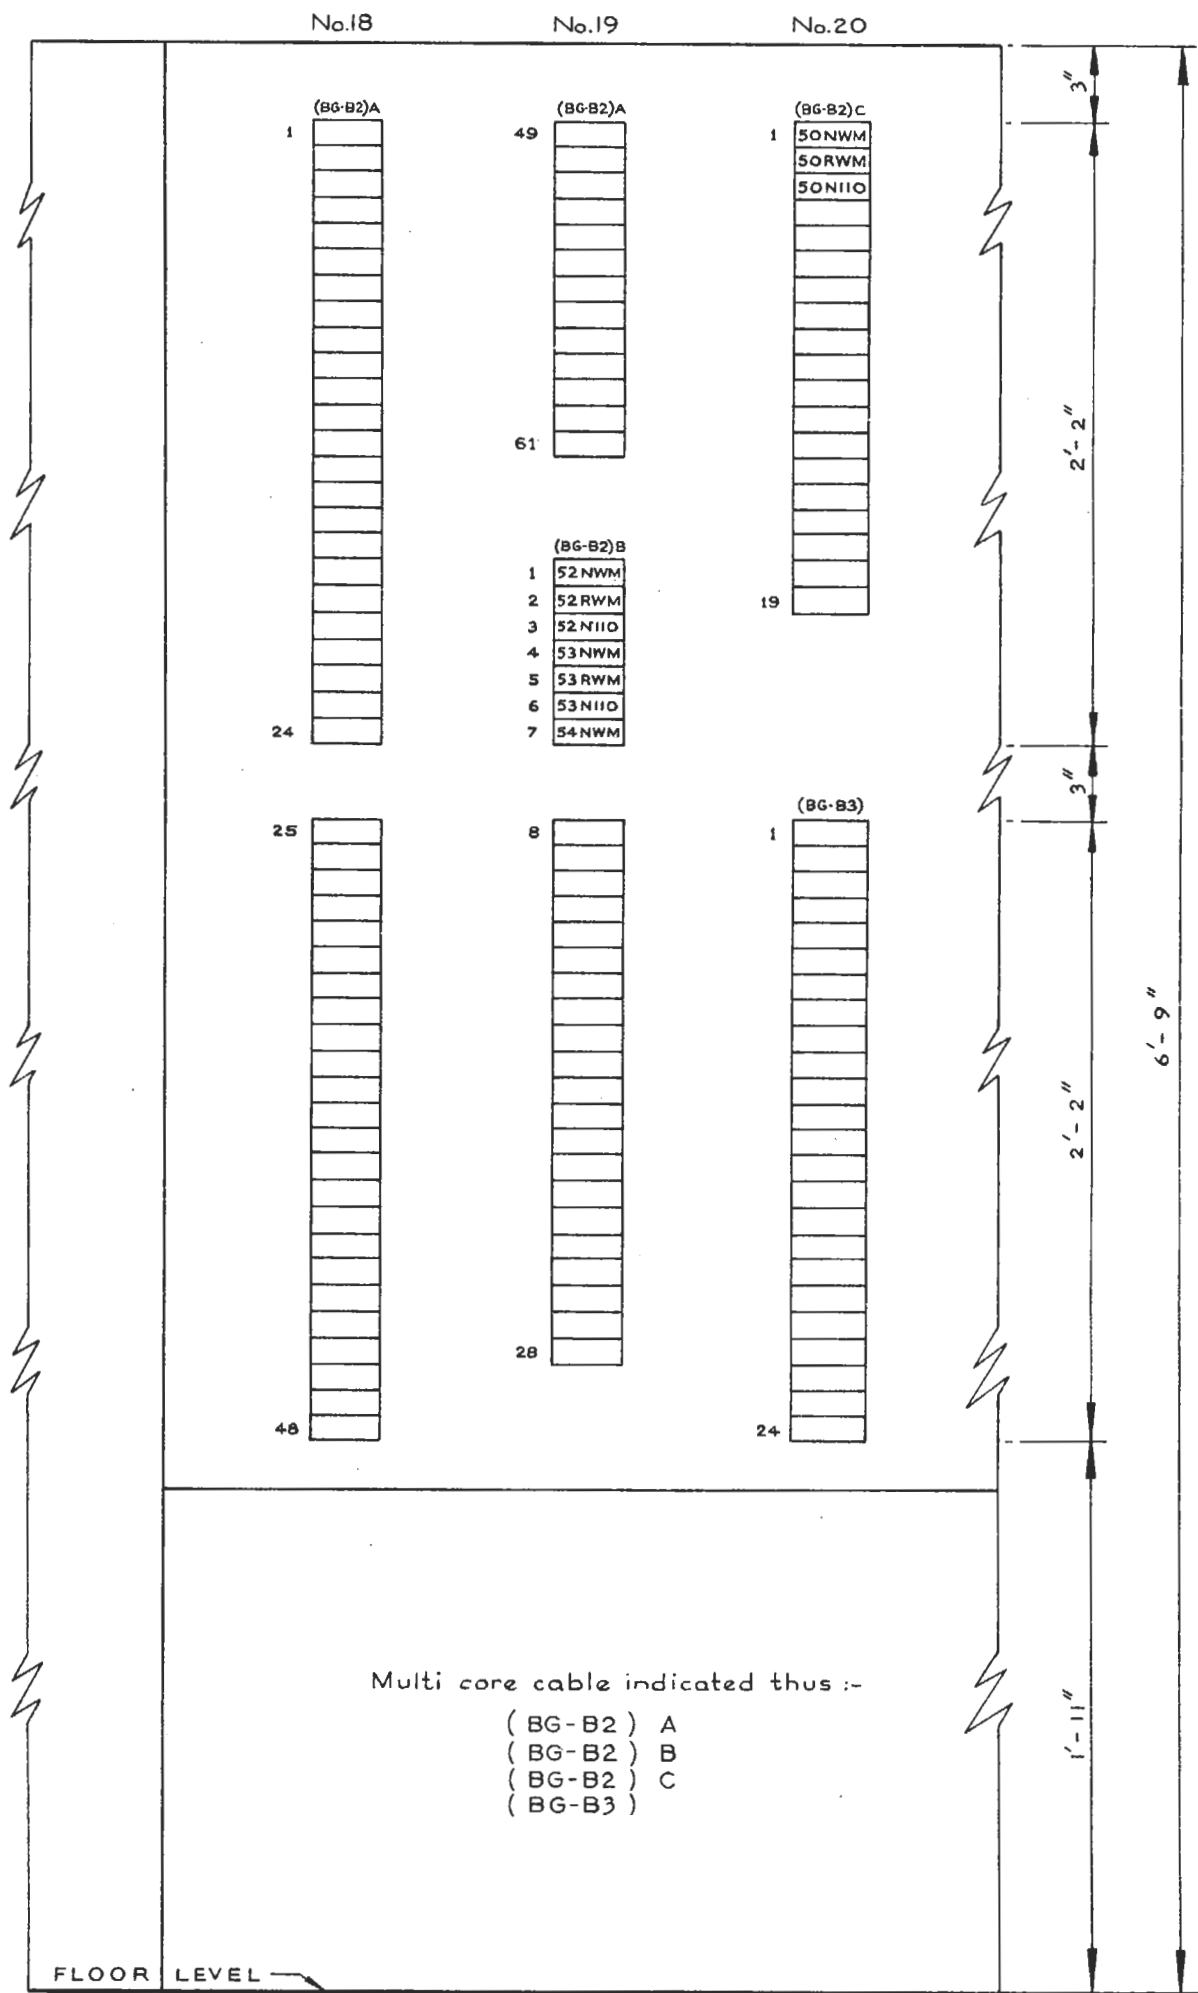
FIG. 6

20. The incoming 110 volt D.C. and other circuits are mounted on porcelain blocks arranged in groups on the terminal panel, a section of which is shown by Fig. 6. Each group, or board, accommodates all the circuit connections of one or more multicore cables, e.g. No. 19 board has 41 and No. 20 board 43 sets of terminals. Each pair of terminals is connected together by a pressed steel link which has a slot at one end and a U opening at the other so that it can be drawn back to break the circuit for testing and other purposes. An illustration of the top seven terminals of multicore cable (BG-B2)B on No. 19 board, to which reference is made later in the report, is given in Fig. 8.
