MINISTRY OF TRANSPORT

# RAILWAY ACCIDENT

## **Report on the Failure of an Overbridge that occurred on 10th May 1965 at Clapham Junction**

IN THE  
SOUTHERN REGION  
BRITISH RAILWAYS

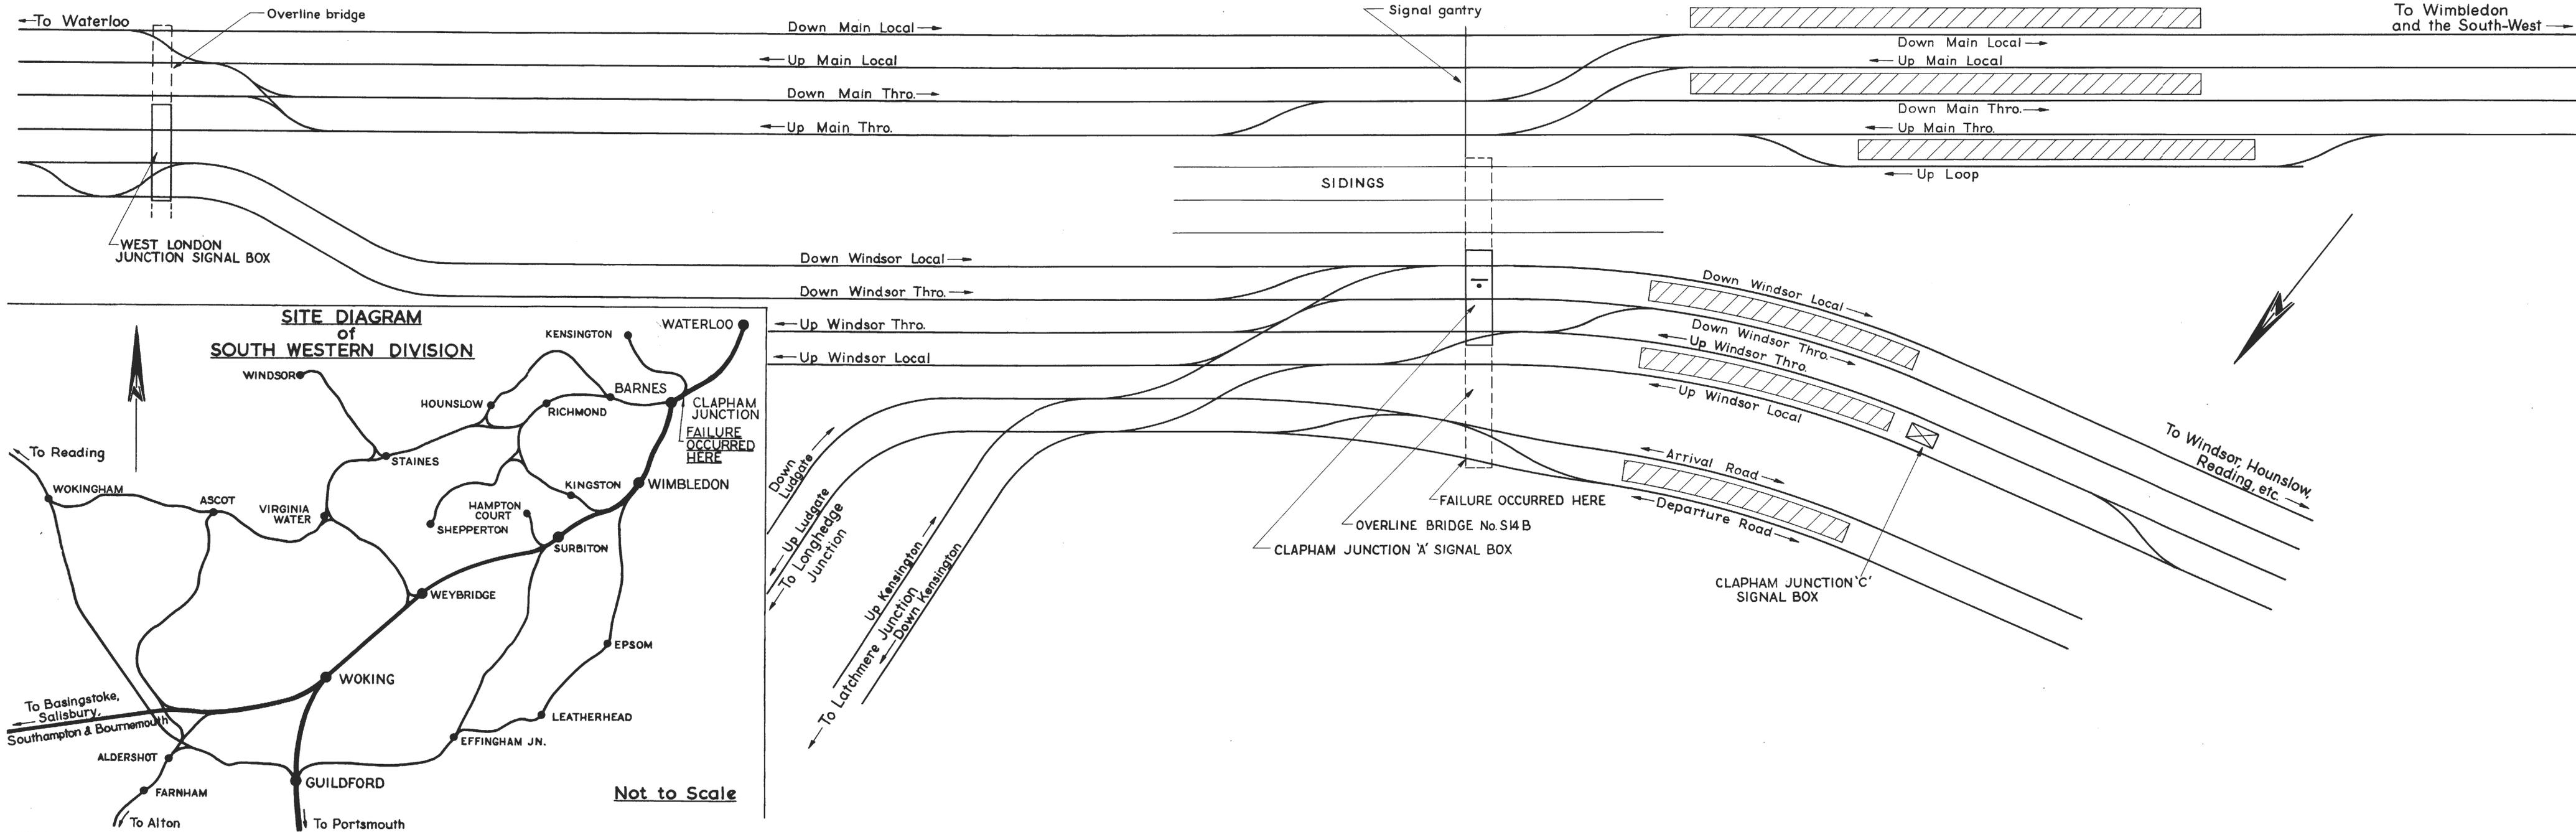
SITE DIAGRAM of SOUTH WESTERN DIVISION

2. Sheet 1 of the attached drawings shows the layout of Clapham Junction and the location of the overline bridge, and it includes a site diagram showing the lines of the South-Western Division that were affected by the failure. This drawing and diagram show that the Main lines and the Local lines from the South-West and the suburban lines from Windsor, Richmond, Ascot, Reading, Hounslow, etc. converge just beyond Clapham Junction station which has separate platforms for each set of lines, and that all the trains on these lines are signalled by Clapham Junction 'A' signalbox, 2½m short of Waterloo, which is situated on the overline bridge that failed. The next box towards Waterloo is West London Junction, 1,079 yards distant, while the boxes on the country side are Earlsfield, 1¼m towards Wimbledon, and Clapham Junction 'C' box, some 325 yards towards Barnes.
