RAILWAY ACCIDENT

Report on the Derailment
that occurred on
27th September, 1967
at Foxhall Junction, Didcot

IN THE
WESTERN REGION
BRITISH RAILWAYS

DERAILMENT AT FOXHALL JUNCTION, DIDCOT. WESTERN REGION. 27th SEPTEMBER 1967.

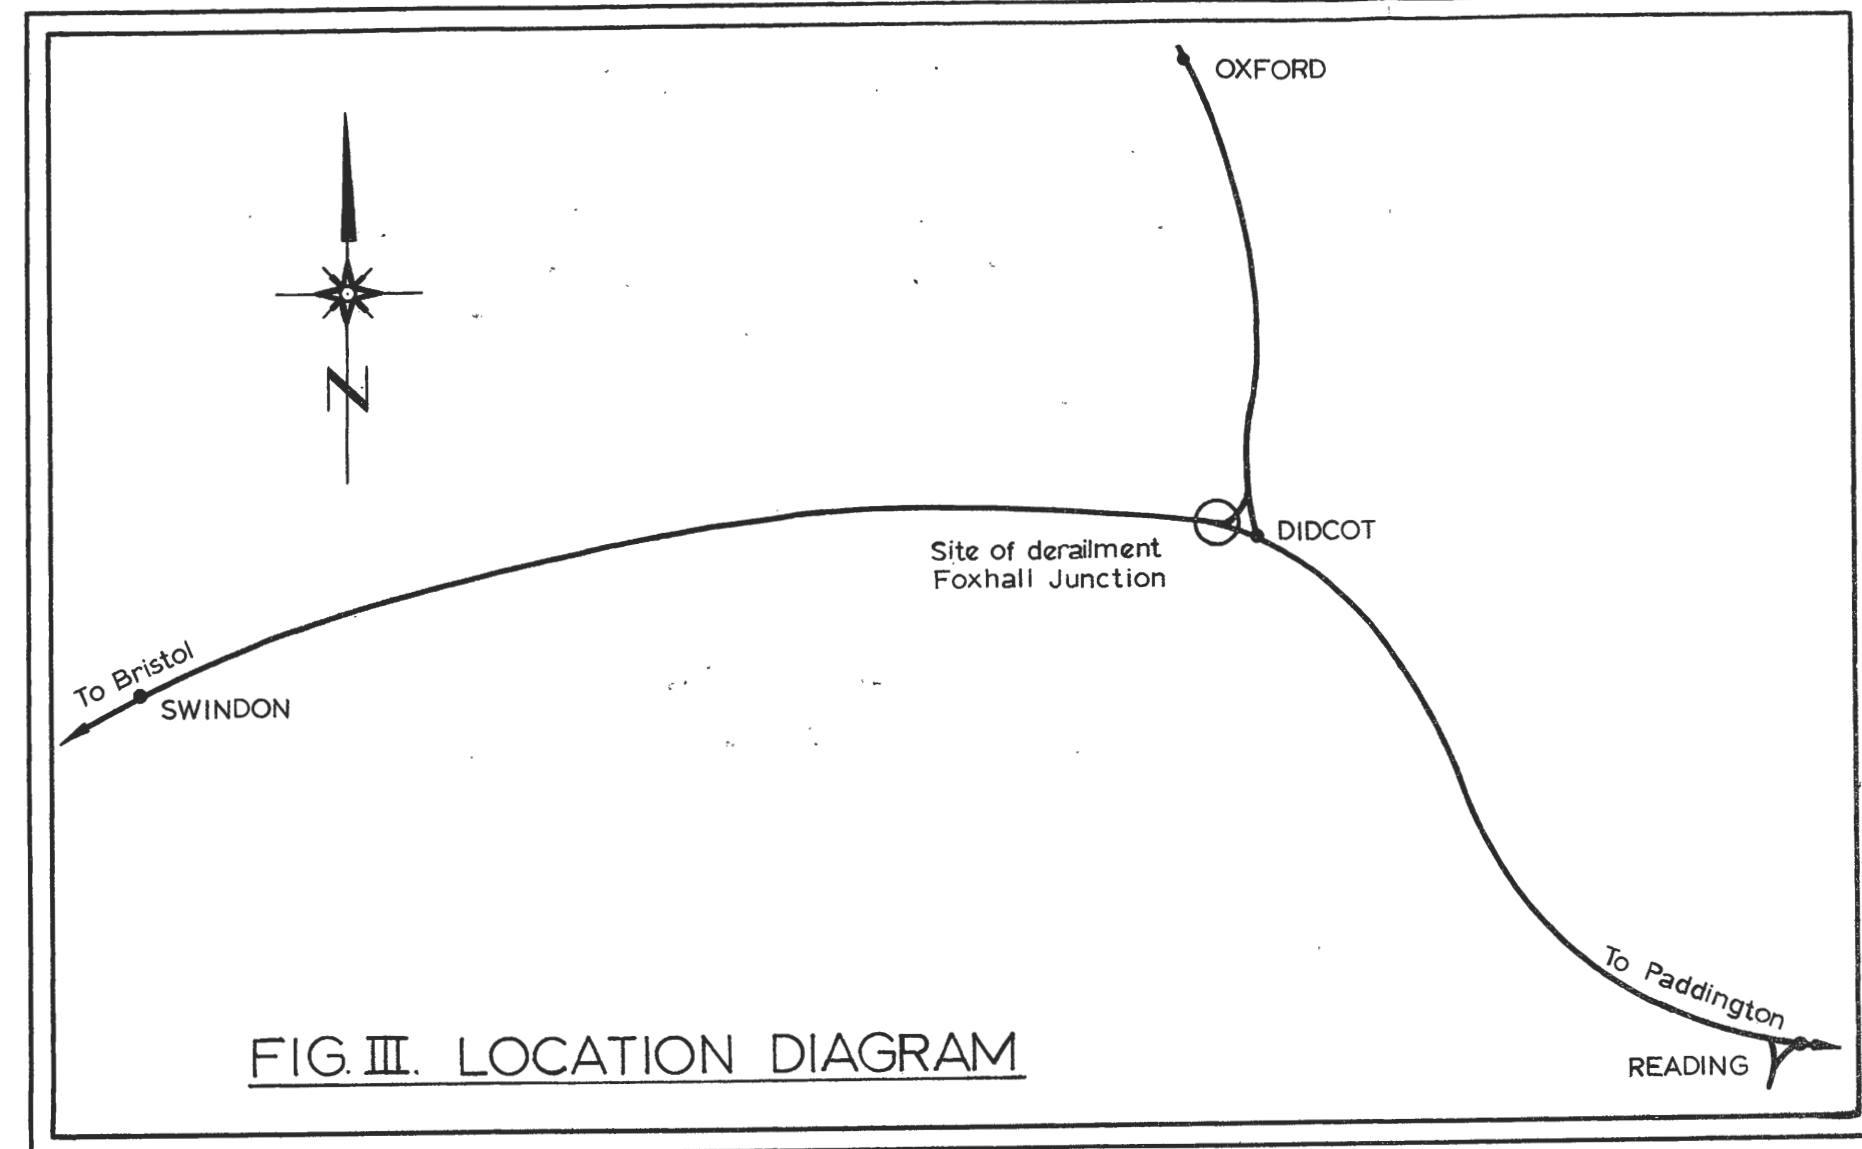
FIG. I. FOXHALL JUNCTION TRACK AND SIGNALLING LAYOUT

8. The two crossovers Down Relief to Up Main and Up Main to Down Main were extensively damaged and the track of the Up and Down Main lines destroyed for some 360 yards. The signalling equipment associated with the crossovers was also severely damaged.

13. *Permanent Way Inspector G. E. Naish*, in whose area Foxhall Junction lies, arrived on the site of the accident at about 11.00 and found that the heel of the facing switch Down Relief to Up Main had been pushed out of line by about 2 in. The first indications of the derailment were marks along the head of the left hand stock rail of the trailing end of the crossover Down Relief to Up Main. Naish said he had examined the crossovers on September 19th and confirmed that they were in first class condition, all cross levels being correct to within 1/16 in. The track in the Down Relief line leading up to the junction was also in good condition and there were no excessive variations in cant.
