RAILWAY ACCIDENT

REPORT ON THE COLLISION

21st April 1963

KING'S LANGLEY

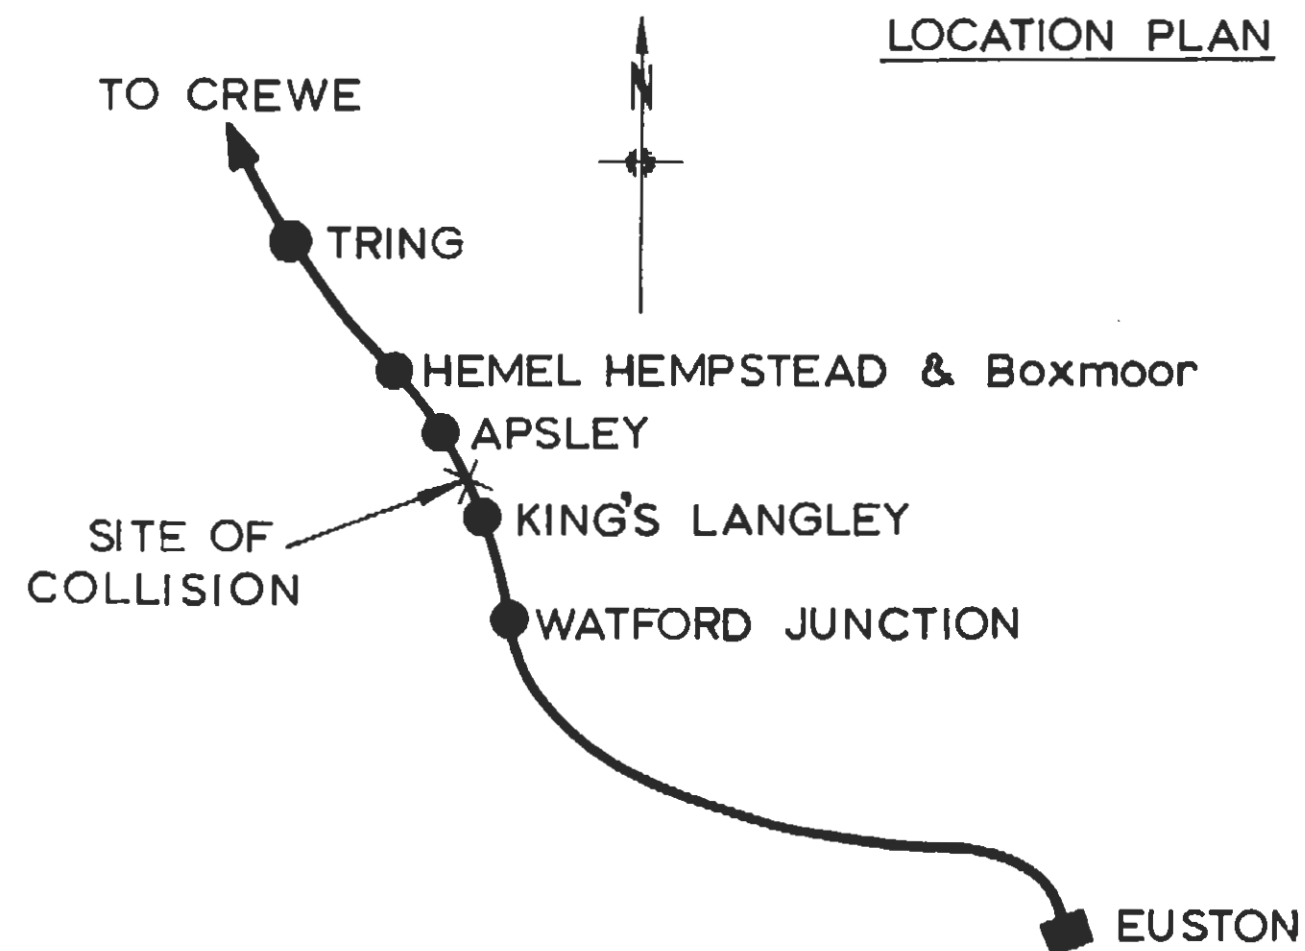
FIGURE 3. DETAIL AT POINT OF COLLISION (21 mls. 1347 yds.)

The left side of the nose of the diesel engine hit the tail counterpoise of the crane a glancing blow at a speed of about 20 m.p.h. and the resulting side thrust was sufficient to burst the offside rail causing the derailment of the engine and four leading coaches of the train which ran on for approximately 75 yards before coming to a stand foul of the Down Fast line. The derailed vehicles remained upright with couplings intact. Fortunately, apart from a member of the restaurant car staff who fell and injured his leg, nobody on the passenger train was hurt.

19. Approximately 80 yards of the long welded track in the Up Fast line was completely destroyed and 30 yards in the Down Slow was badly damaged.

20. All the damage was consistent with the collision taking the form of a glancing impact at a speed of about 20 m.p.h.
