RAILWAY ACCIDENTS

REPORT ON THE COLLISION

4th December 1957

ST. JOHNS STATION

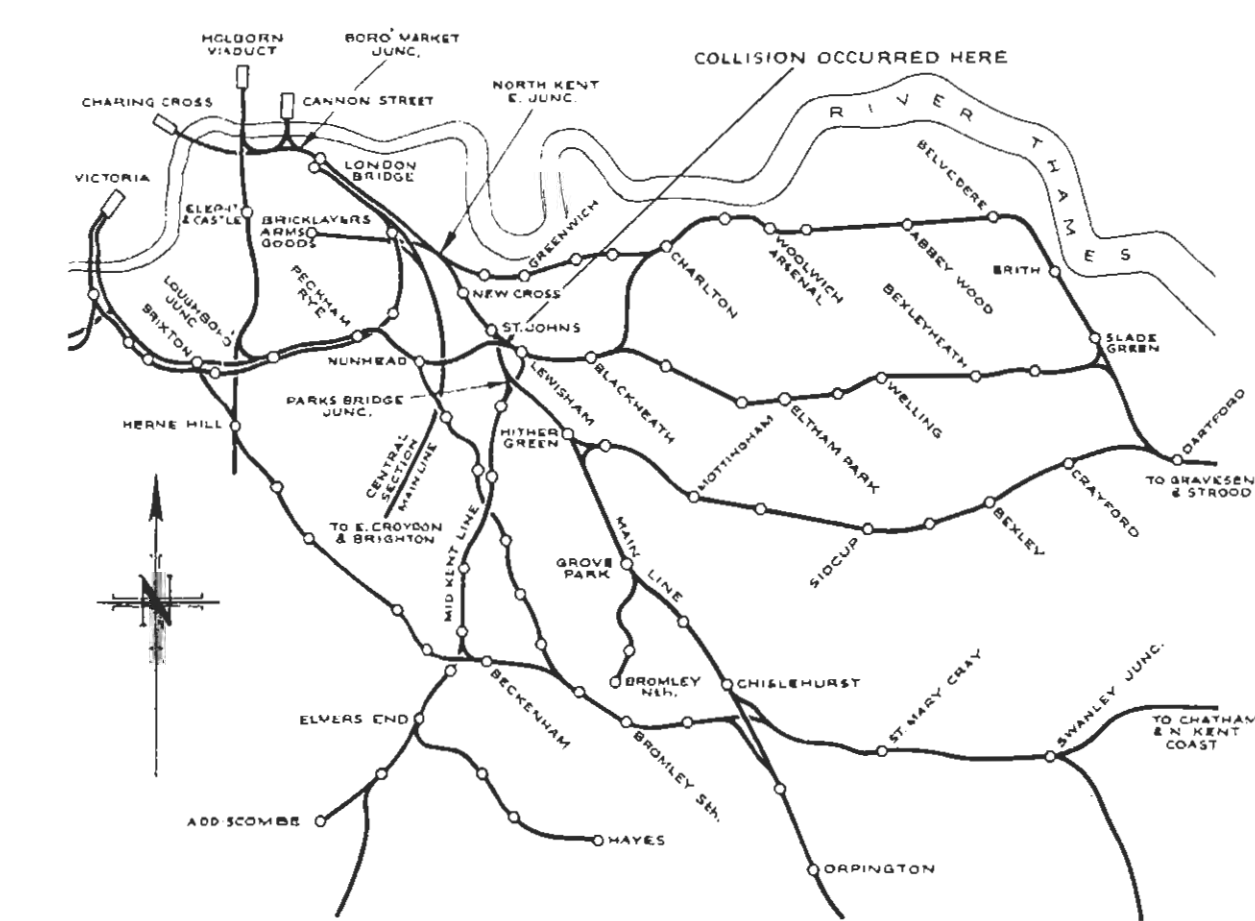
FIG. 1
SKETCH MAP SHOWING THE
PRINCIPAL EASTERN SECTION
LINES IN THE LONDON AREA

12. The routes of the Eastern Section of the Southern Region are in the main those of the former South Eastern and Chatham Railway, and the network in the London area is shown by Fig. 1. It will be seen that the two routes from Charing Cross and Cannon Street converge at Borough Market Junction just before they reach the Eastern Section through station at London Bridge, which lies close alongside the Central Section terminal. The general direction thenceforward is towards the south east. For most of the $2\frac{1}{2}$ miles from London Bridge to North Kent East Junction there are six Eastern Section tracks, three Up and three Down, and for the whole of this distance they are carried on a brick arched viaduct alongside the independent Central Section tracks, which curve away to the southward on their own viaducts about two miles from London Bridge.

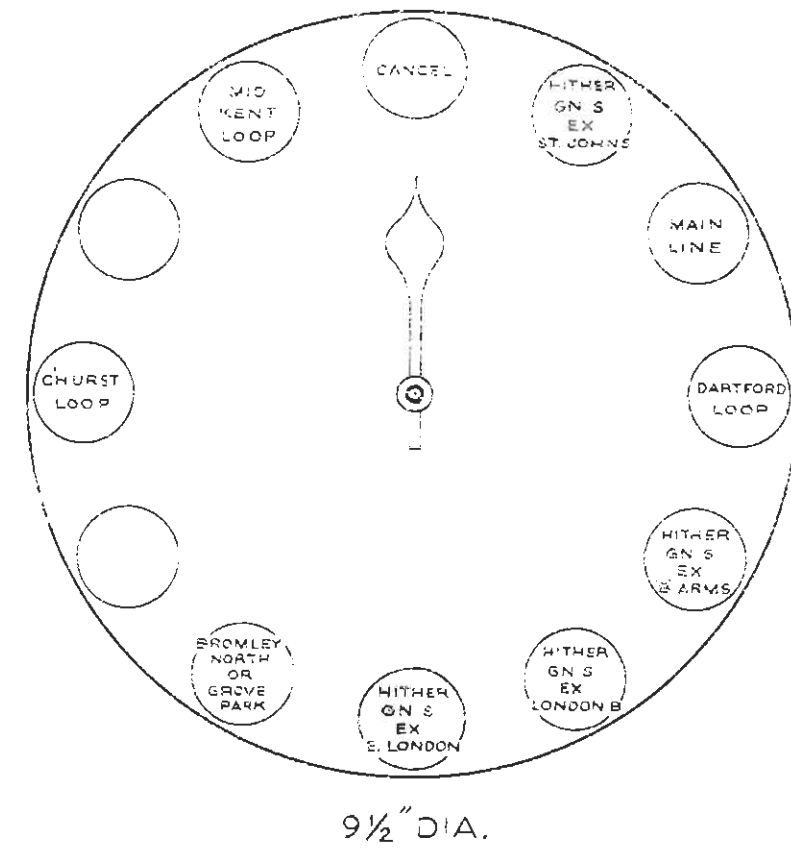
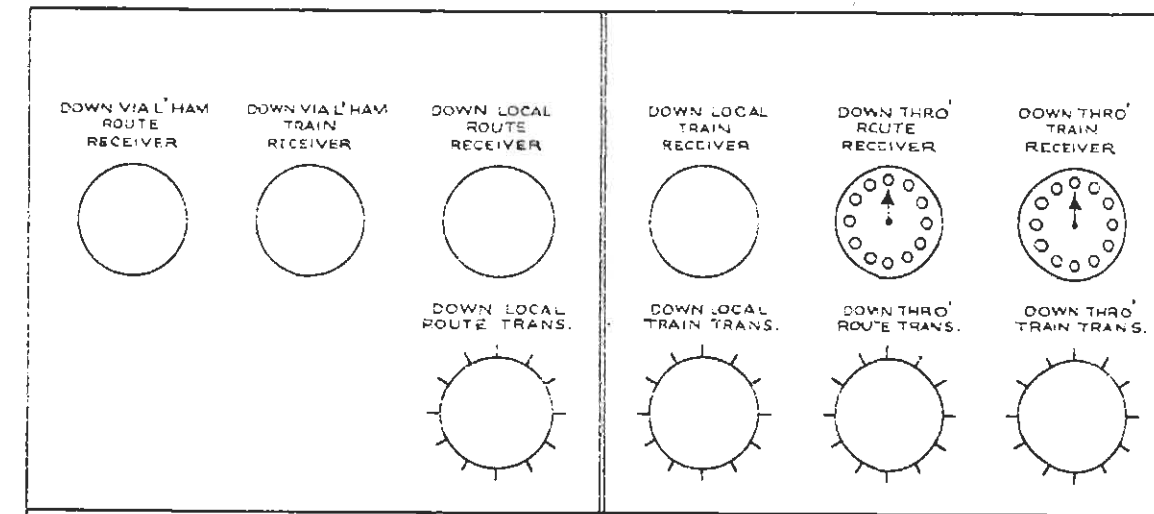
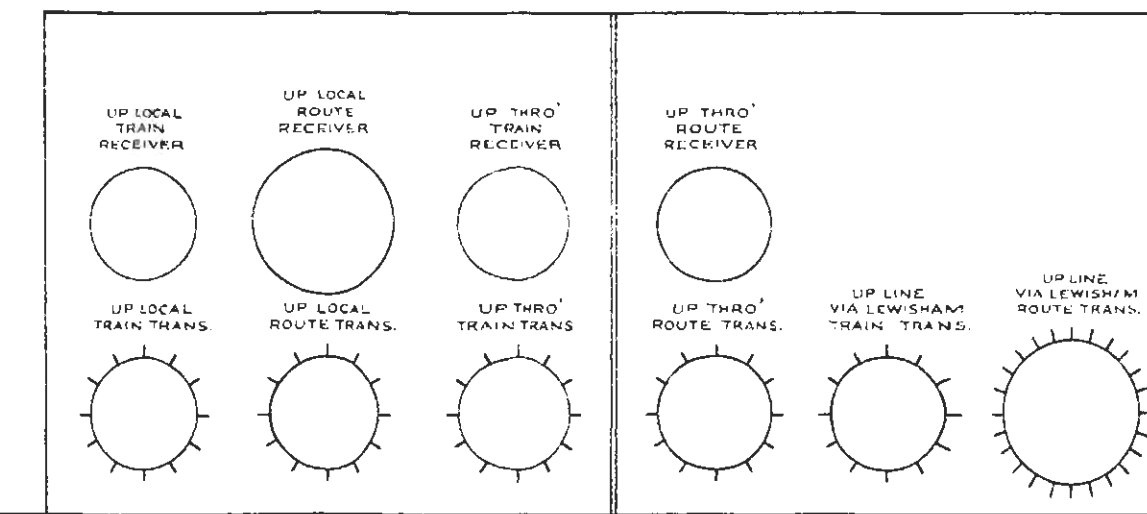
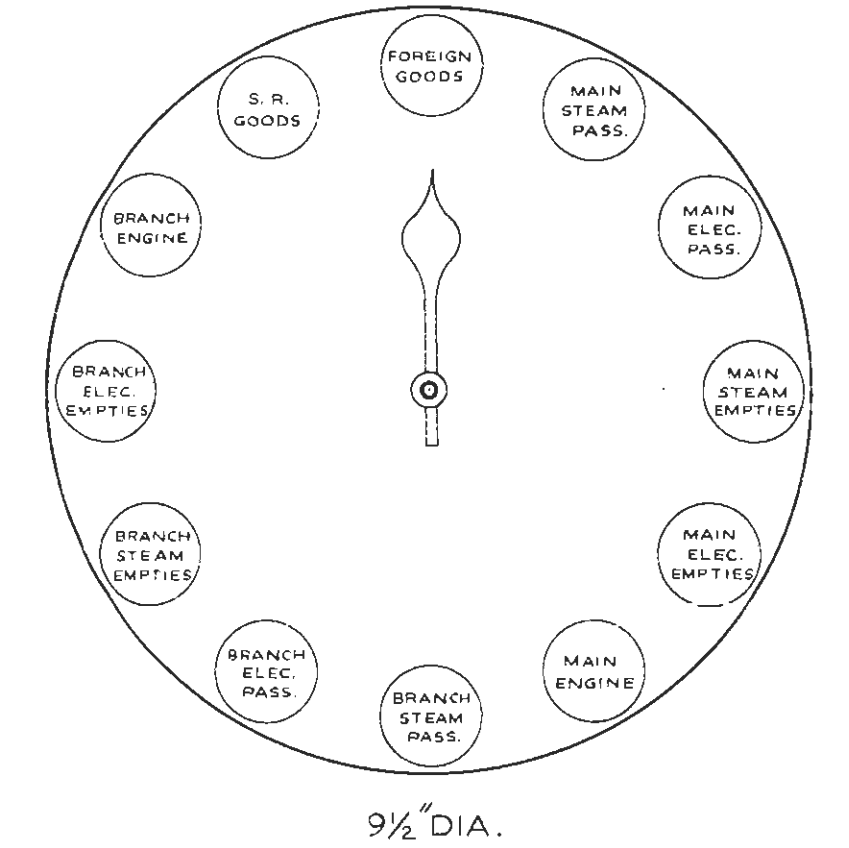
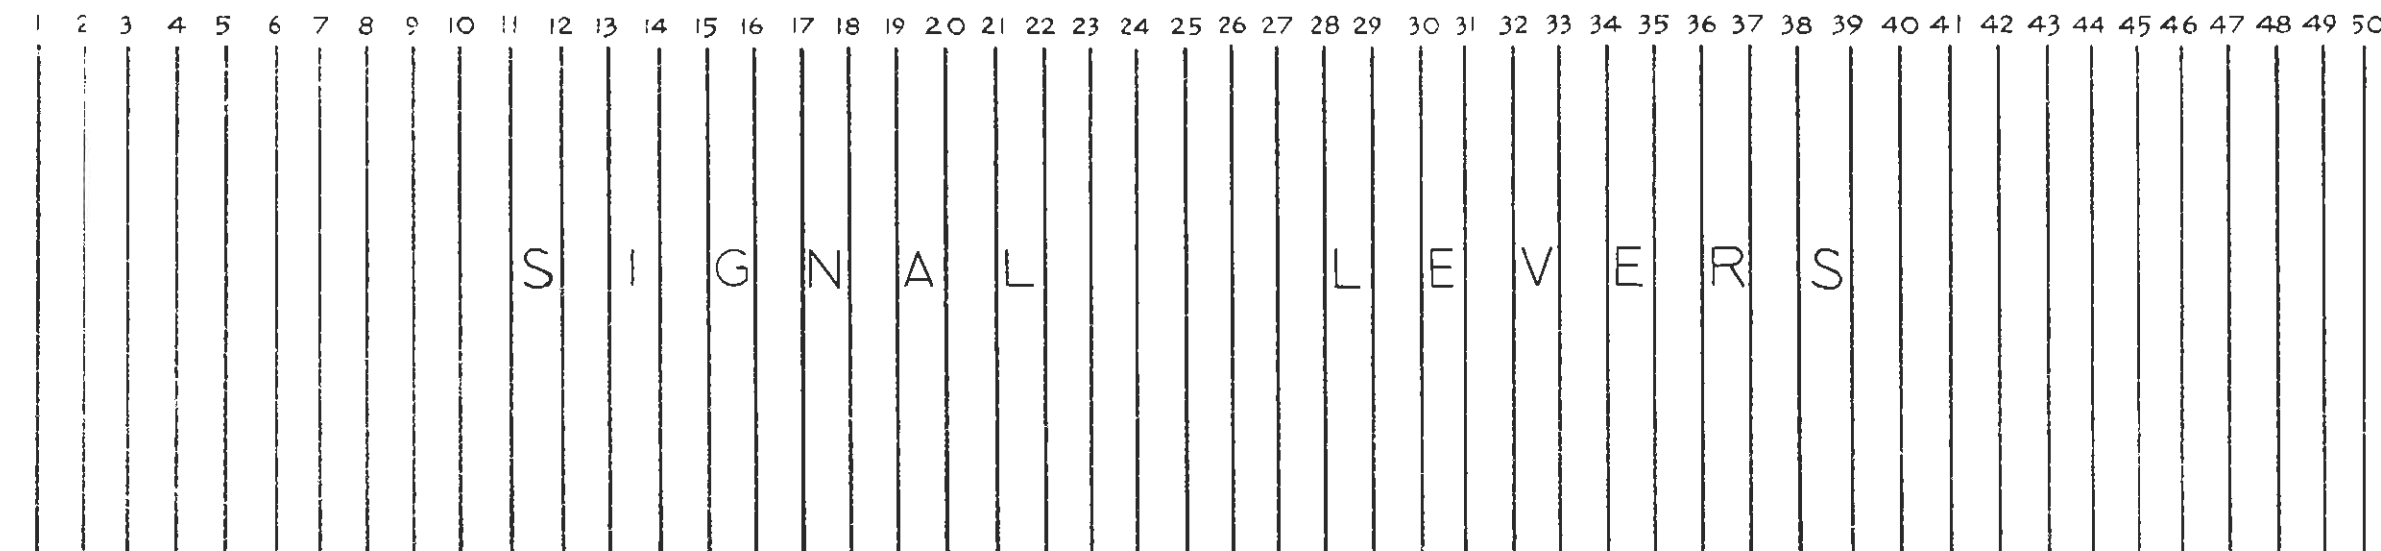
FIG. 7

18. With all the signal aspects under track circuit control there is no manual block working, and the trains are announced from one box to the next by Walker's pattern train describers—see the Appendix and Fig. 7. These train describers are of old-fashioned design, but they have proved very reliable over the years, and all the signalmen on this route are thoroughly accustomed to their working.
