DEPARTMENT OF TRANSPORT

RAILWAY ACCIDENT

Report on the Derailment that occurred on 12th February 1976 at Shortlands Junction

IN THE
SOUTHERN REGION
BRITISH RAILWAYS

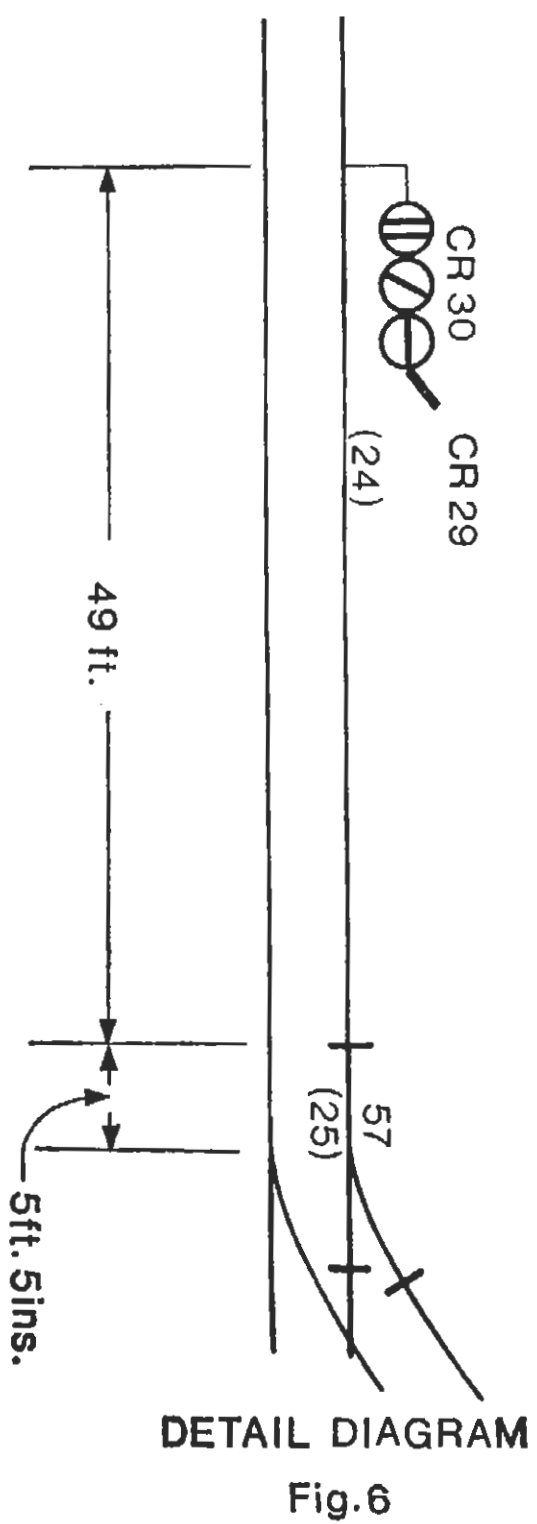
DETAIL DIAGRAM
Fig. 6

37. The signalman had previously set the route for the 18.02 Victoria to Gatwick Airport train from the Down Through to the Down Local line via points No. 22 reversed and was in the act of setting the route for the Brighton train from the Down Main to the Down Through line via points No. 57 reversed and No. 22 Normal when the front of the train passed over No. 57 facing points as they were moving, and travelled a further 50 yards with its leading bogie derailed before coming to a stand. The train suffered little damage.
