RAILWAY ACCIDENT

Report on the Derailment
that occurred on 15th June 1976
at Southerham Junction

IN THE
SOUTHERN REGION
BRITISH RAILWAYS

DERAILMENT AT SOUTHERHAM JUNCTION ON 15th JUNE 1976

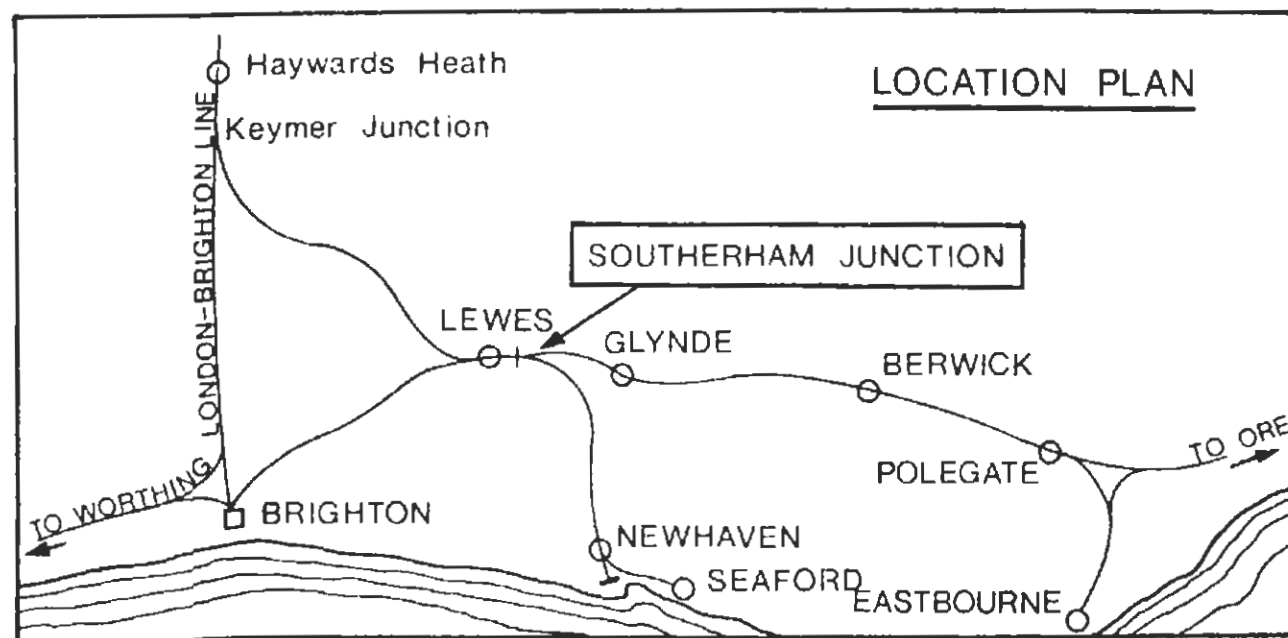
7. The train was signalled correctly through the junction on the Down main line and approached the junction under power at between 35 and 40 mile/h. Sometime after the leading coach had passed correctly over the facing points (No. 10A) the point motors started to operate under the second coach and the trailing bogie of this coach struck the partially open points and was diverted onto the branch line. This caused the second coach to slew sideways out of line until its rear bogie was forced into derailment and dragged across the junction, seriously damaging the switch diamonds. The third and fourth coaches were similarly dragged into derailment. Meanwhile the driver had felt the effects of the derailment and had made a gentle brake application, and the guard had used his brake handle to make a full emergency application. The train stopped just beyond the junction, in the position shown on the drawing.

8. The second, third, and fourth coaches each sustained damage to their bogies and wheels, and to various parts of the underfloor gear, head stocks, brake pipes, step boards etc. On the ground there was extensive damage to the permanent way, part of the switch and crossing work at the junction needing replacement together with some 300 yards of plain track, and to signalling and electric traction lineside equipment.
