Rail Accident Report

Collision at Plymouth station 3 April 2016

Report 02/2017
February 2017

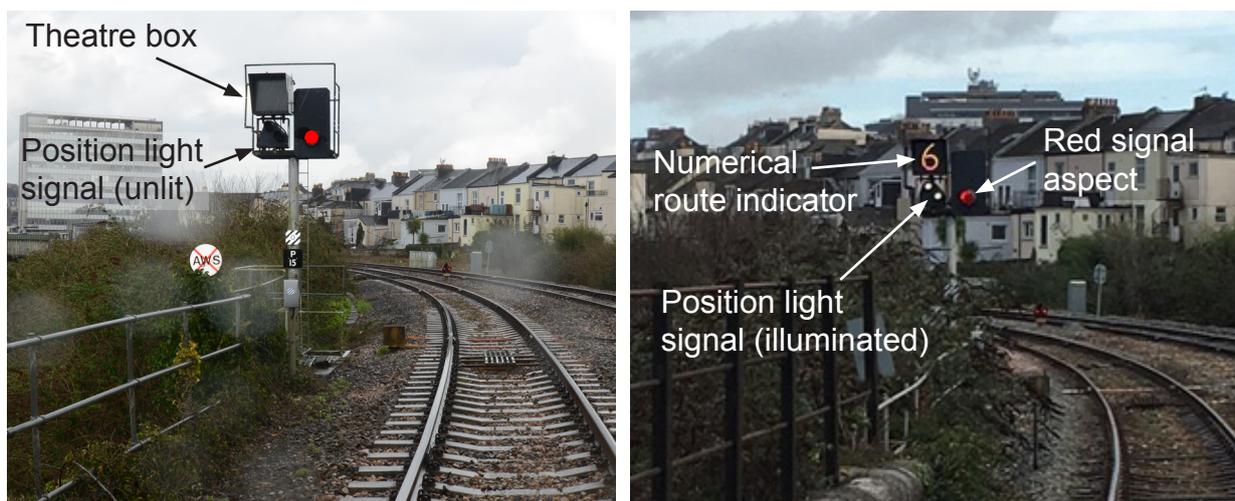
Figure 5: Signal P15 showing a stop indication (left image) and a permissive working authority towards platform 6 (right image)

- 17 There is no evidence that the functioning of signal P15 was a factor in the accident. Although the signal was re-positioned before the current Railway Group standard was introduced, the distance of 270 metres between the signal and the platform is compatible with Railway Group standard GK/RT0044 'Controls for signalling a train onto an occupied line'. The December 2014 version of this standard required the distance to be 'minimised, as far as reasonably practicable', and the previous version (February 2000) required that the spacing 'shall not be greater than 400 metres'.

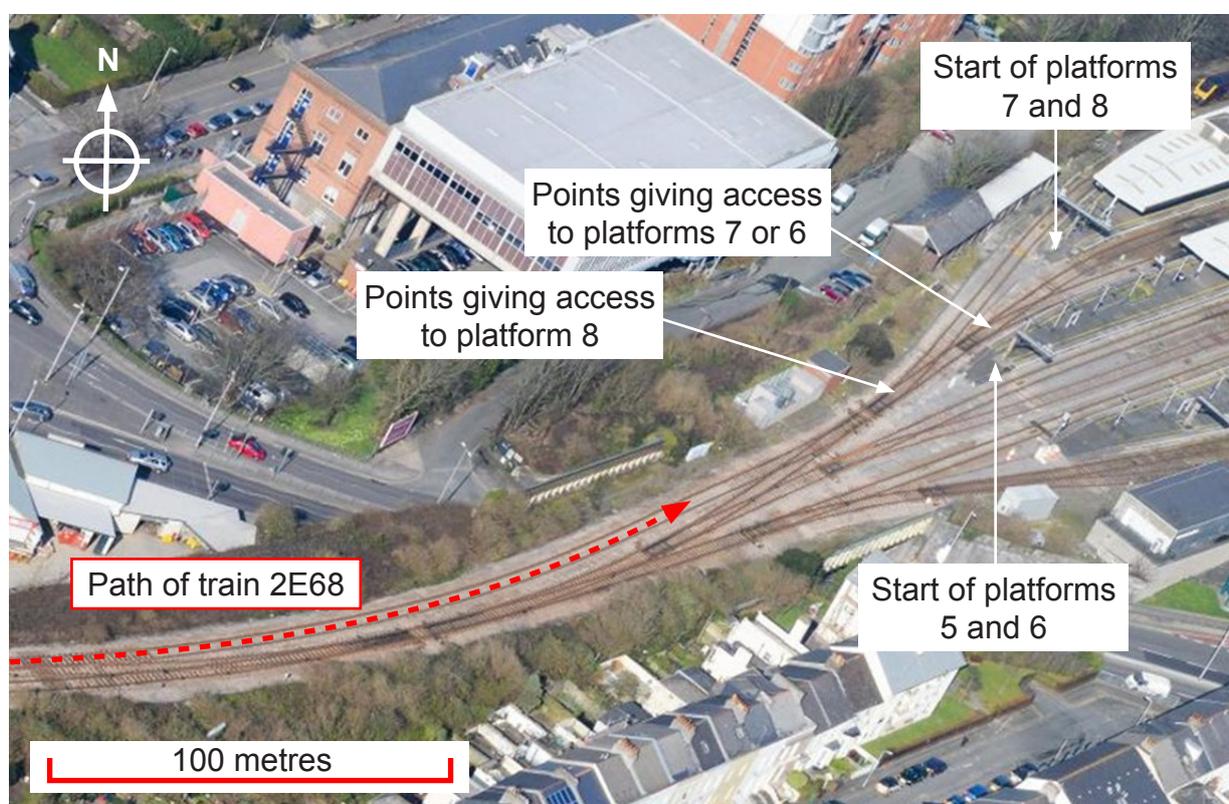
- 18 Around 46 metres after passing signal P15, trains pass over a set of *facing points* which provide routes to platforms 3, 4, and 5. A second set of *points*, located around 32 metres before the western end of platform 6, provide a left-hand route to platform 8 or a straight-ahead route towards platforms 6 and 7. A third set of points, located at the start of platform 6, provides a straight-ahead route into platform 7, or a right-hand route into platform 6 (figure 6).

Figure 6: The points giving access to platform 8, and platforms 7 and 6 (image courtesy of Network Rail)

- 68 About 10 seconds (91 metres) before the collision, train 2E68 approached the points giving access to platform 8 (figures 6 and 14). The driver stated he looked at the points and saw that they were set for the straight ahead route, and continued to believe that his train was not going into the platform occupied by train 1A91.

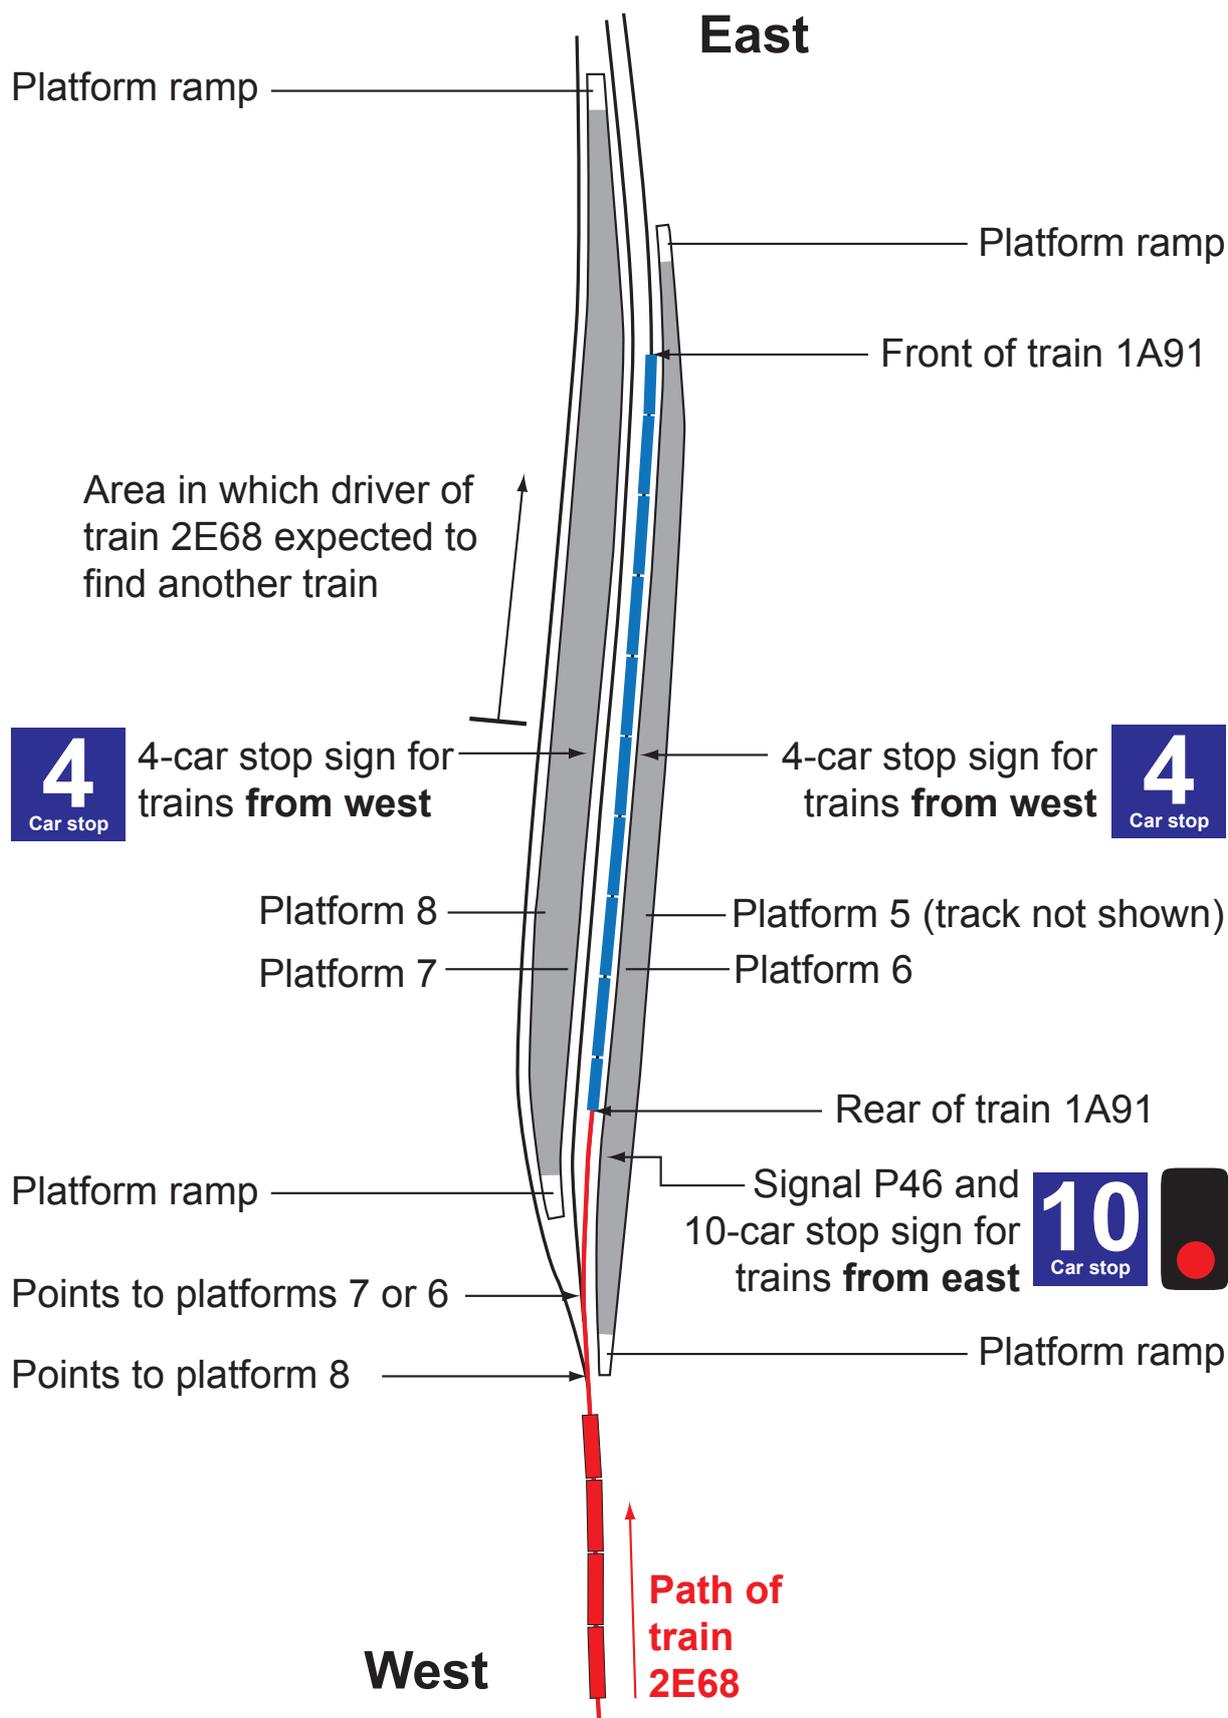
Figure 8: The location of the signs on platform 6 (note: not all tracks, platforms or platform curvature shown)

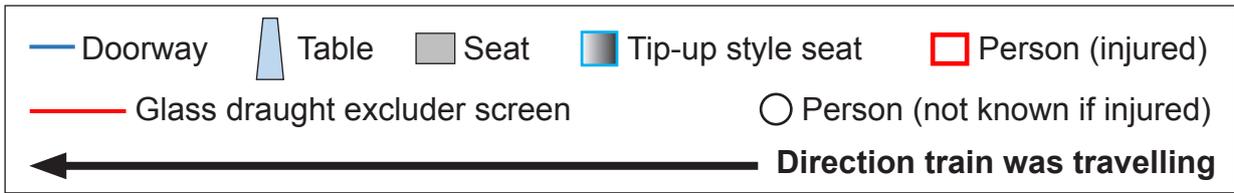
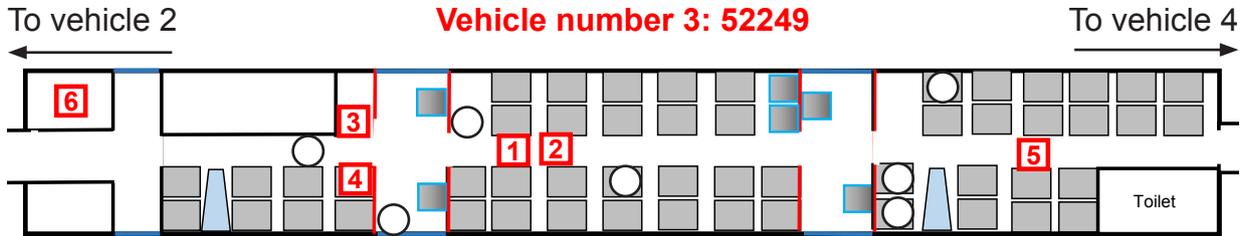
Identifier	Seated/standing	Cause
1	Standing	Impact with other passenger
2	Standing	Impact with other passengers
3	Standing	Impact with vehicle interior
4	Seated	Impact with seat in front and being thrown to the floor
5	Standing	Thrown to the floor
6	Standing	Hit head on door frame

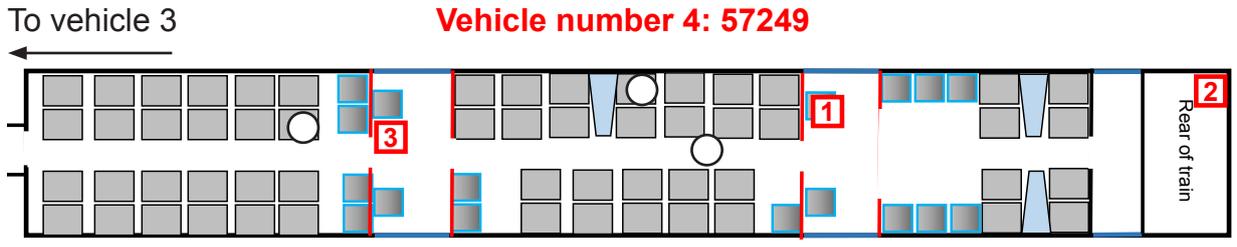
Identifier	Seated/standing	Cause
1	Standing	Impact (and shattering) with glass internal panel
2	Standing	Impact with bulkhead wall in rear cab
3	Standing	Impact with arm rest
