Rail Accident Report

Wrong side signalling failure and derailment at Dalwhinnie, Badenoch and Strathspey 10 April 2021

Report 10/2022
September 2022

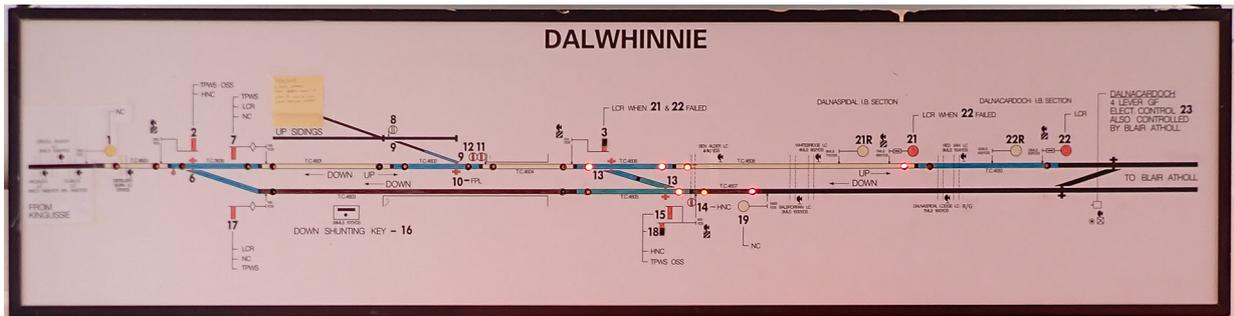
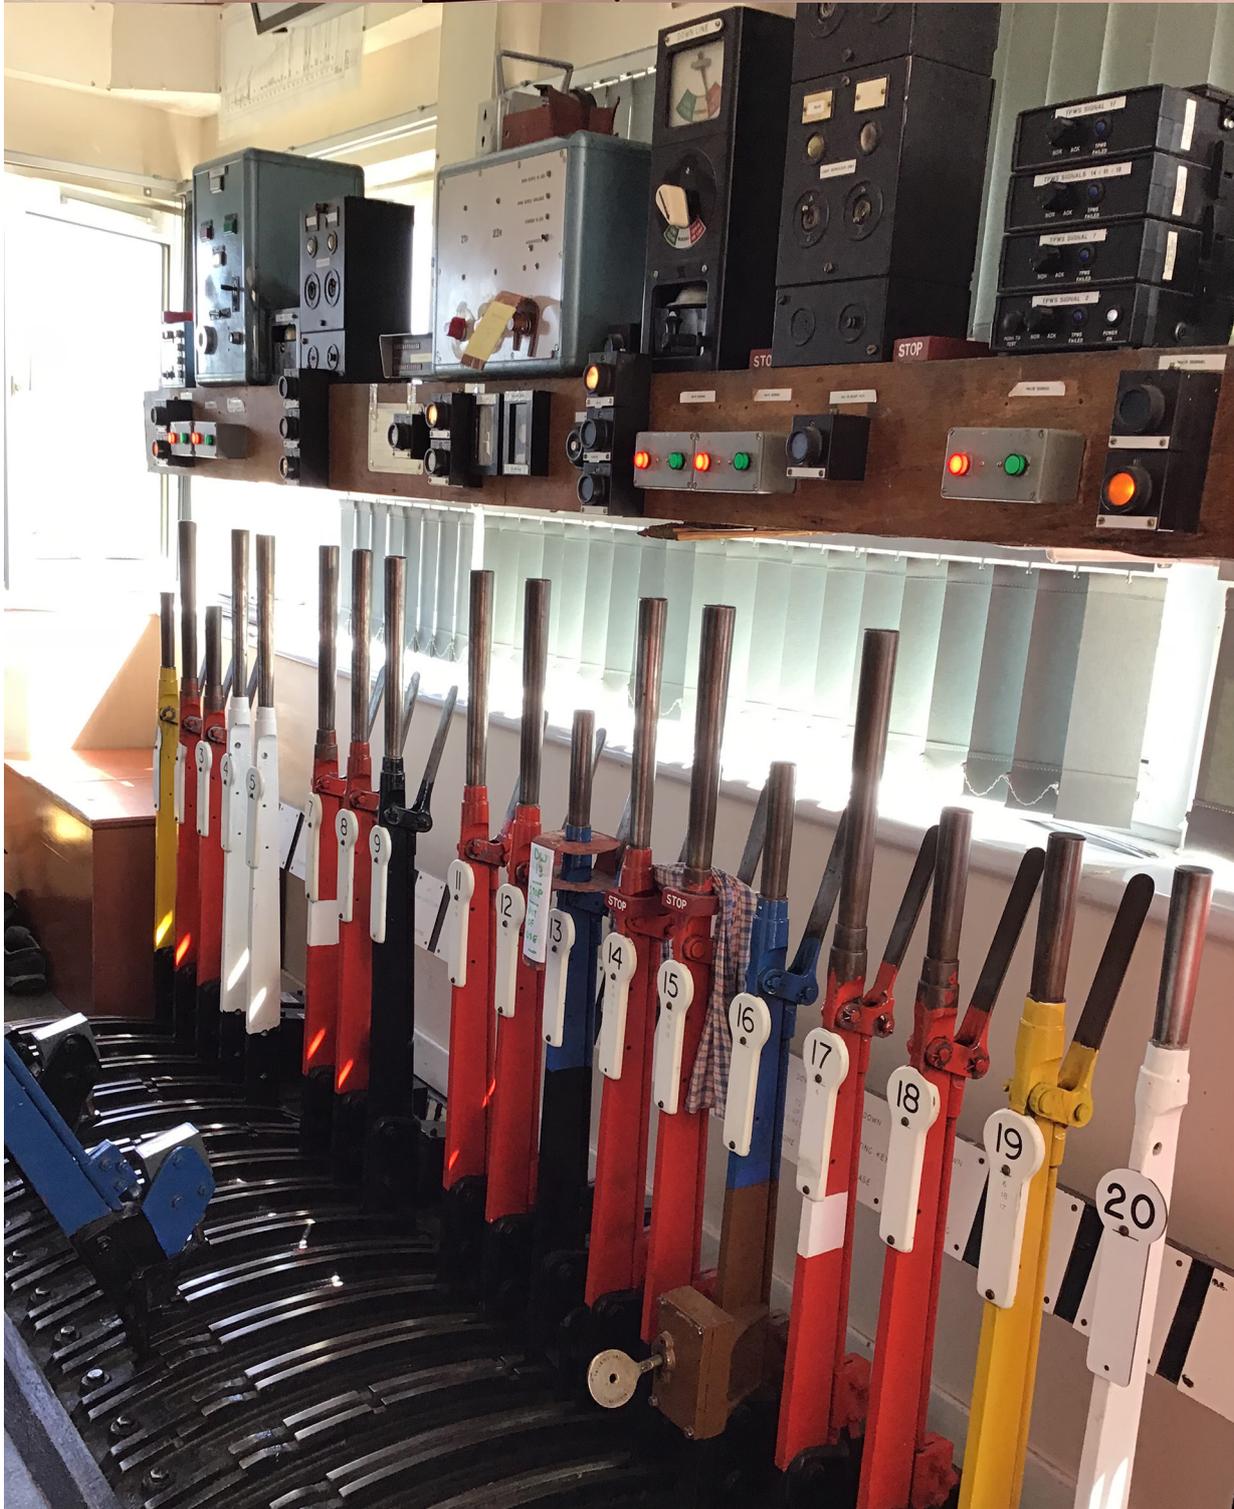
Figure 4: Signalling controls in Dalwhinnie signal box (main photograph courtesy of Network Rail)

- 16 The signals and points at Dalwhinnie are controlled from the lever frame in the signal box. On a shelf above this are the instruments for offering and accepting trains to and from Kingussie and Blair Atholl, and indicator lamps showing the status of signals and points. There is also a diagram of the railway. Track circuits are installed through the station and lamps on the diagram indicate when these are detected as occupied by trains. The signalling controls and the diagram are shown in figure 4.

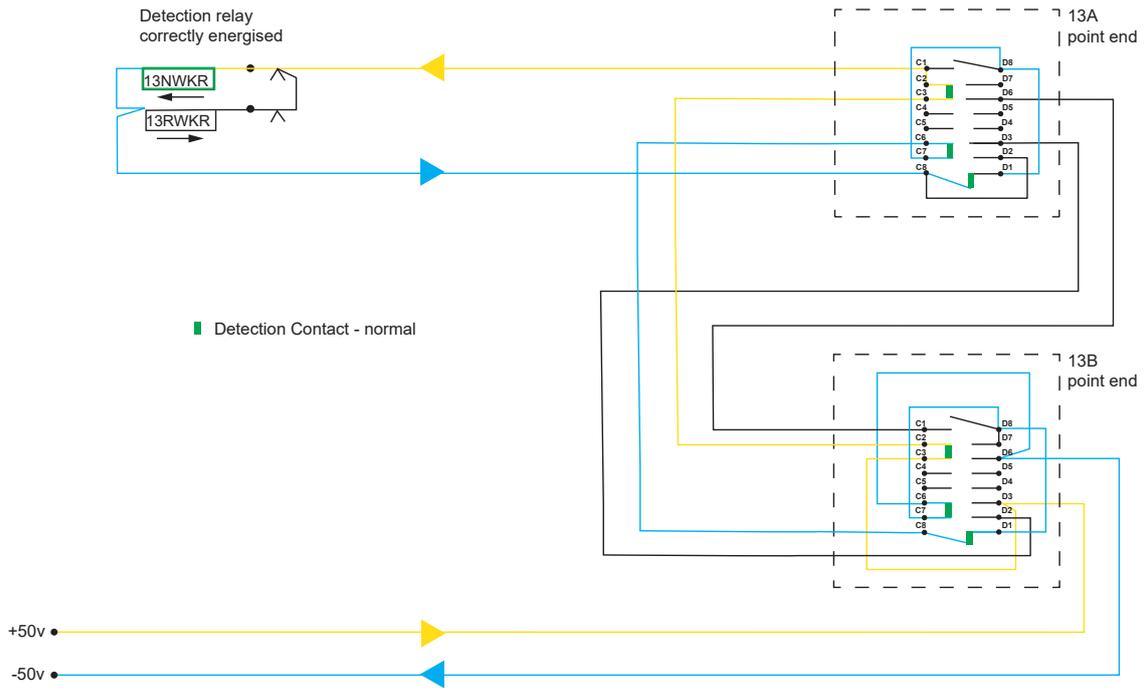
Figure B1: Simplified diagram of the detection circuit associated with 13 points as designed (showing switch rails detected in normal position at both point ends)

- B5 Figure B1 shows a simplified diagram of the detection circuit associated with 13 points. The detection contacts are contained inside the point machines and are wired in series between each point end. The detection contacts need to be made, in either the normal or reverse position, in both point machines for the appropriate detection relay (13NWKR or 13RWKR) to energise. This should only occur when the associated switch rails are in the correct position.

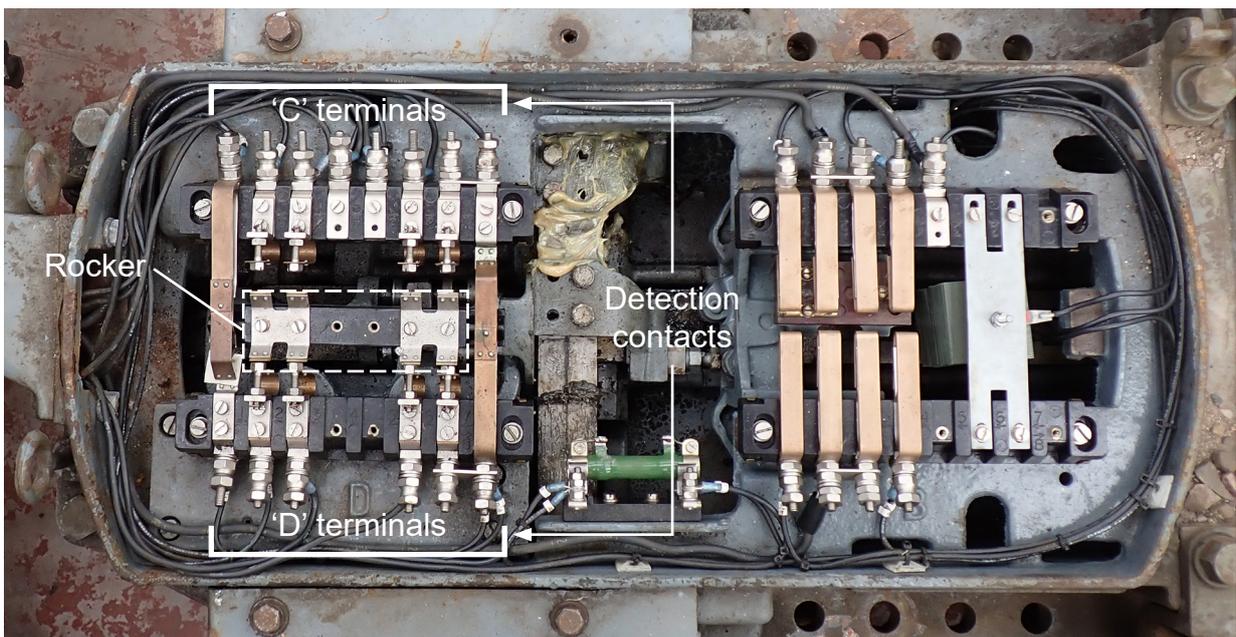
Figure B2: GRS 5E type point machine detection contacts

B6 On a GRS 5E type point machine, detection contacts comprise two metal H-shaped pieces which are attached to a rocker. The rocker moves from one side to the other side depending on the position of the switch rails. For 13 points, when detection is obtained in the normal position, the H-shaped pieces are in contact with fixed springs connected to the terminals designated by prefix ‘C’; for detection in the reverse position, they are in contact with springs connected to terminals designated by prefix ‘D’ (figure B2). If detection is lost, a back contact of the appropriate detection relay energises the respective points calling relays (13ANWR and 13BNWR, or 13ARWR and 13BRWR) to command the points to move back to the required position, in an attempt to regain detection.
