Rail Accident Investigation Branch

Rail Accident Report

**Two trains in the same signal section at South
Wingfield, Derbyshire
26 October 2022**

Report 11/2023
October 2023

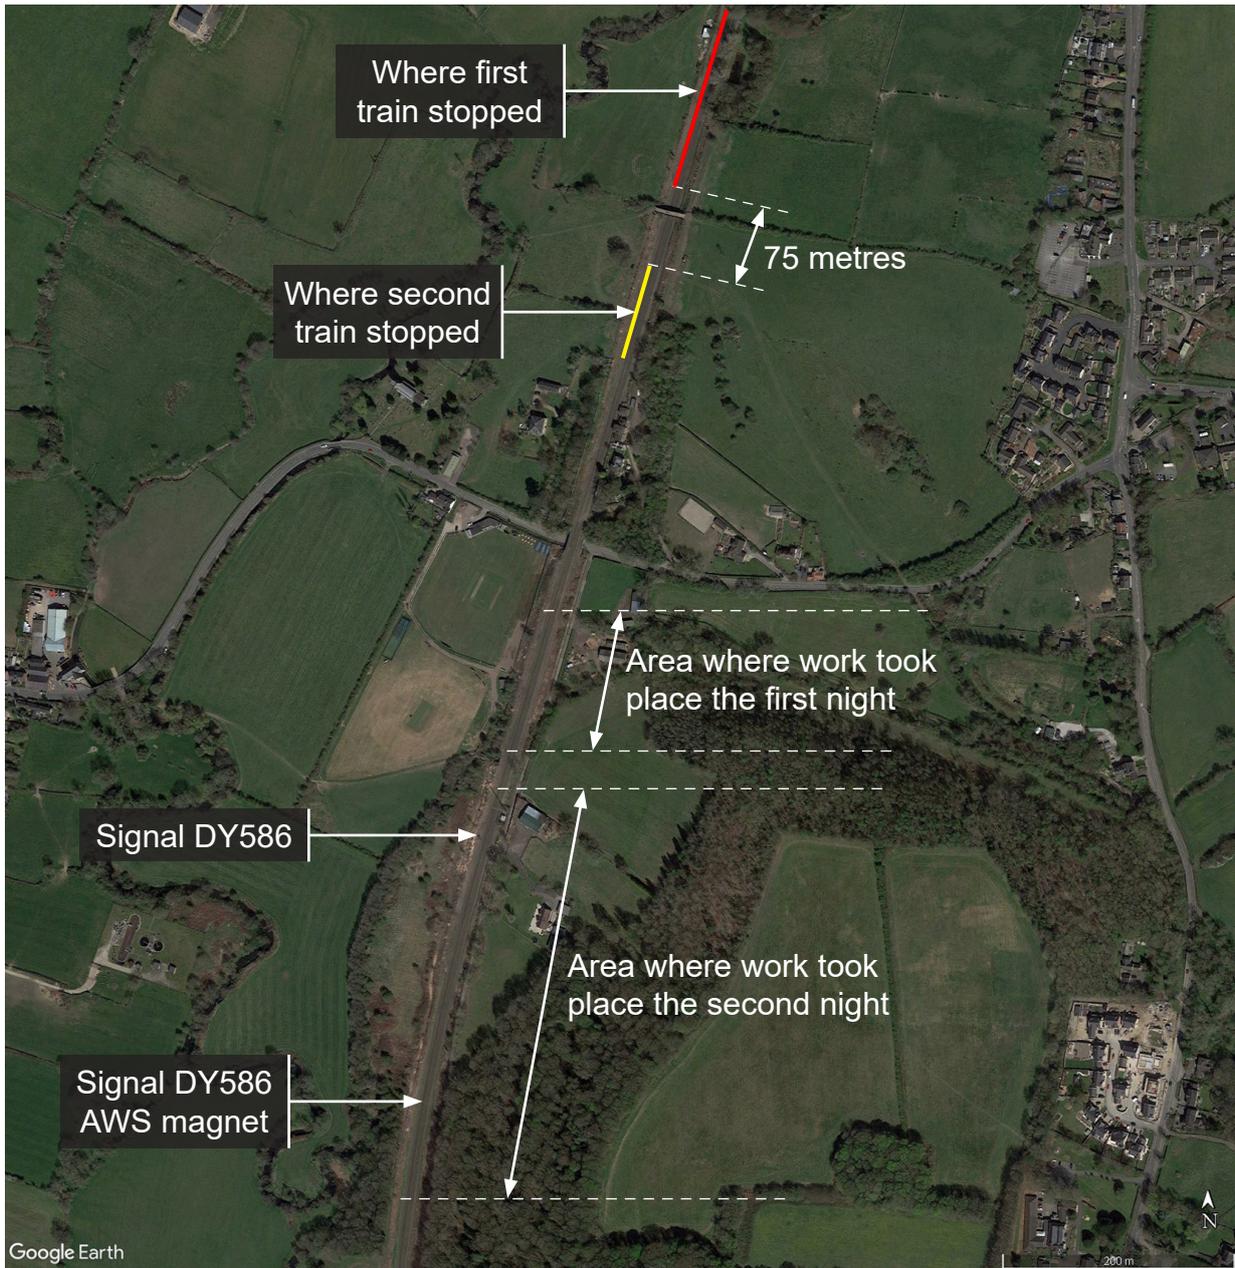
- 5 At about 07:19 hrs, the passenger train approached the signal that the previous train had passed at red. The signal was now displaying a yellow (caution) aspect. After passing this signal at a speed of about 20 mph (32 km/h), the passenger train driver saw the taillights of the first train, which was stationary on the line ahead (figure 2). The driver brought the passenger train to a controlled stop about 75 metres from the first train, with both trains now in the same signal section (figure 3). There were no significant consequences and both trains were able to continue their journeys.

Figure 3: Overview of the location where the two trains stopped.

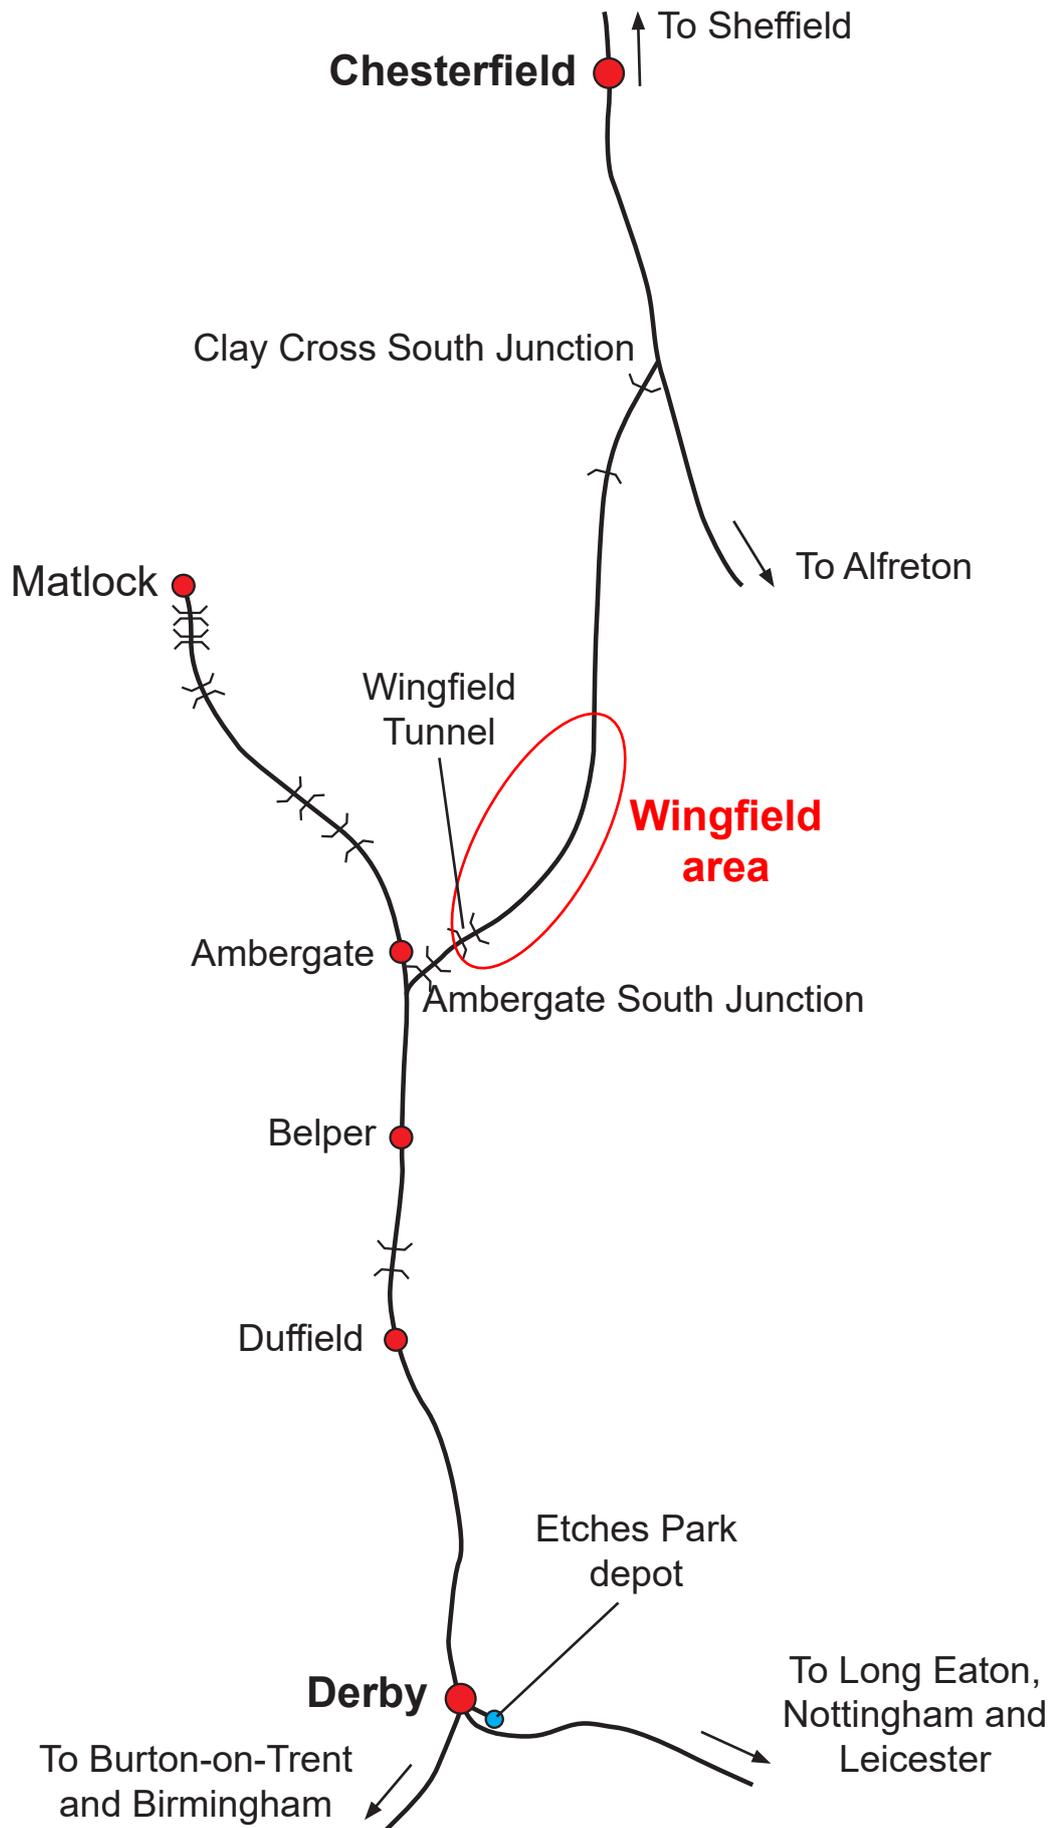
Figure 4: Layout of the railway in the Wingfield area.

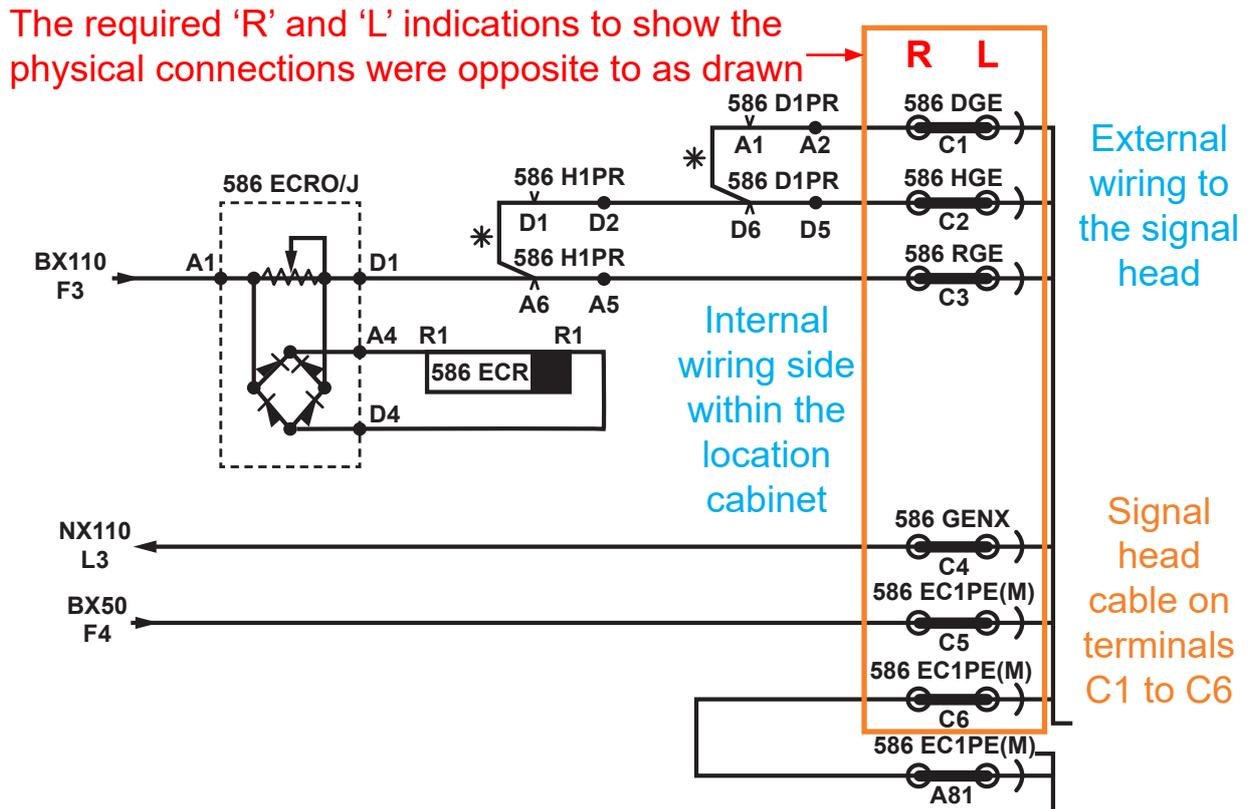
- 69 The signalling circuit diagram (figure 9) depicts the internal wiring on the left and the external wiring for the signal cable on the right. This was drawn the opposite way to how the wiring was physically connected in the location case. As the signalling circuit diagram had been updated in 2015 when the signal head was changed (paragraph 32), the diagram could have been amended with 'L' and 'R' markings to show that the physical arrangement was the opposite way round to how it was drawn (figure 13). However, this amendment was not present on the diagram.

Figure 13: How the signalling circuit diagram could have been annotated.

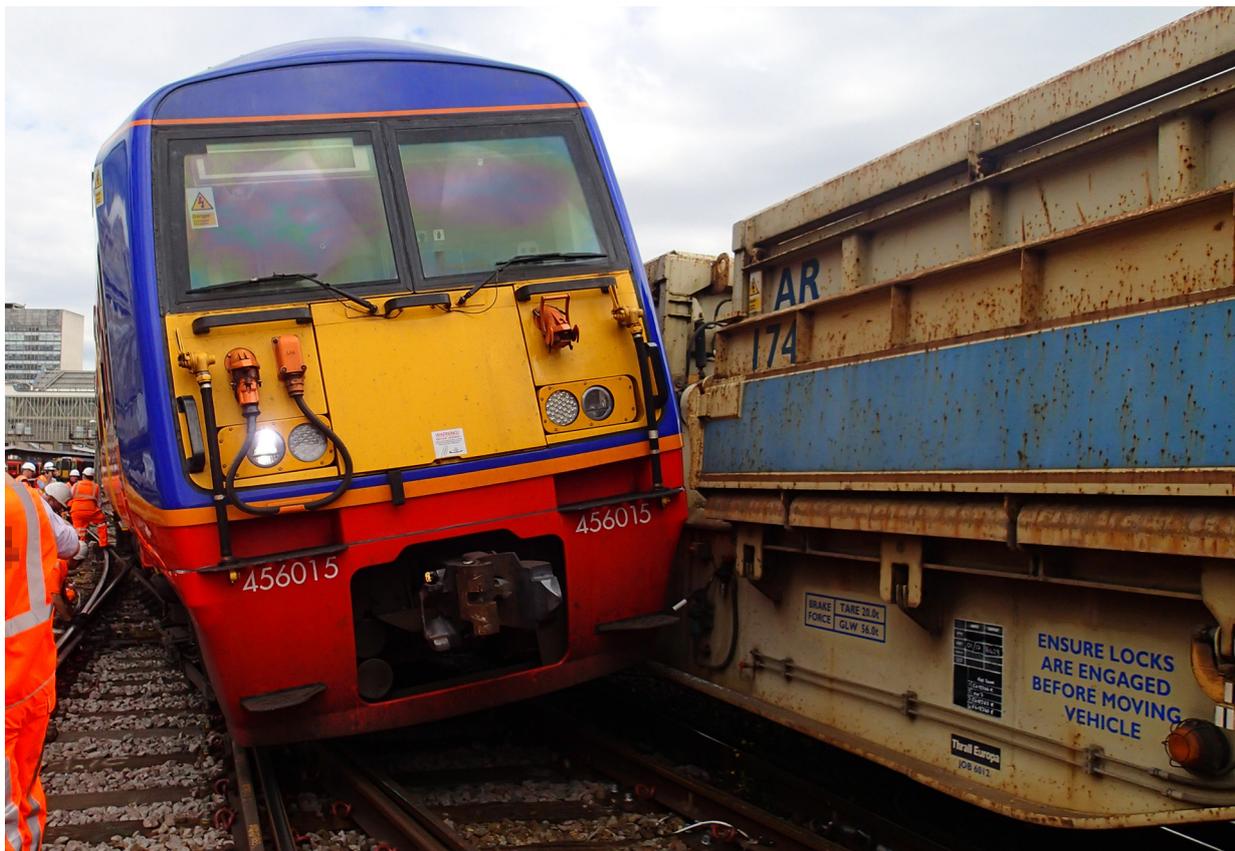
- 198 RAIB's report into a collision at London Waterloo station ([RAIB report 19/2018](#)) explains how a set of points, which was not in the correct position, directed a passenger train away from its intended route and into the side of a freight train (figure 18). The train driver and signaller had received indications that the points were correctly set. However, the signalling system did not detect that the points were in the wrong position because staff had made an uncontrolled modification to the signalling system during testing and commissioning activities. The investigation found the actions of the staff involved in this testing work indicated that appropriate non-technical skills were not applied.

Figure 18: The accident at Waterloo.

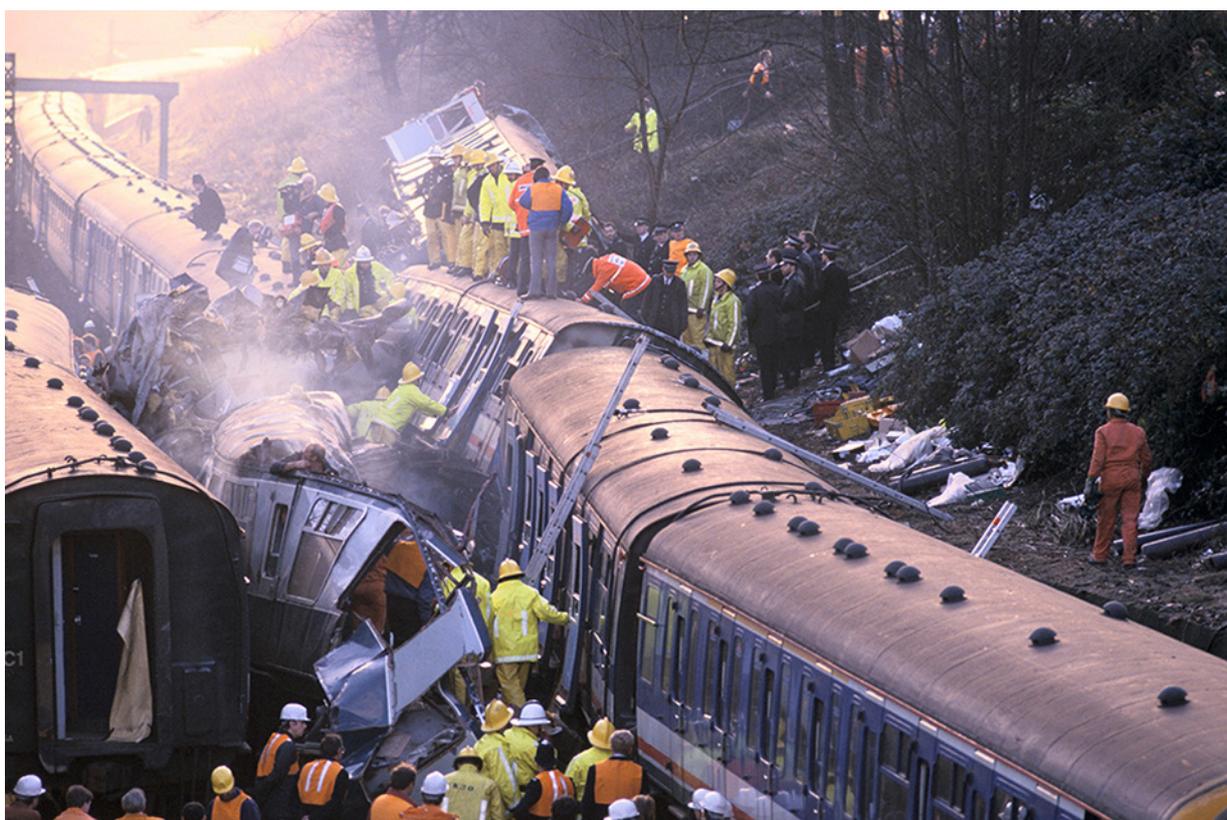
199 The investigation into the accident at Waterloo, supported by RAIB's investigation of a serious irregularity at Cardiff East Junction ([RAIB report 15/2017](#)), suggested that some in the railway industry might be forgetting the lessons learnt from the Clapham Junction accident²⁷ in which 35 people died (figure 19). This accident, which happened on 12 December 1988, involved three trains colliding just south of Clapham Junction, in London. A train driver received a proceed aspect at a signal which should have been displaying a red aspect, and collided with the train in front which should have been protected by the signal. A third train then collided with the wreckage. The incorrect proceed aspect was shown because inadequate working practices during a re-signalling project had resulted in a loose, uninsulated, redundant wire remaining close to, and eventually coming into contact with, other circuitry.

Figure 19: The accident at Clapham Junction (Christopher Pillitz / Alamy Stock Photo).

200 The Clapham Junction accident is of particular relevance to the incident at Wingfield. Both involved a train driver receiving a proceed aspect at a signal which should have been displaying a red aspect, as there was a train in front which should have been protected by the signal, due to a problem with the signal's wiring after work had taken place on it.
