Rail Accident Investigation Branch

# Rail Accident Report

**Two signal passed at danger incidents, at Reading Westbury Line Junction, 28 March 2015, and Ruscombe Junction, 3 November 2015**

Report 18/2016  
September 2016

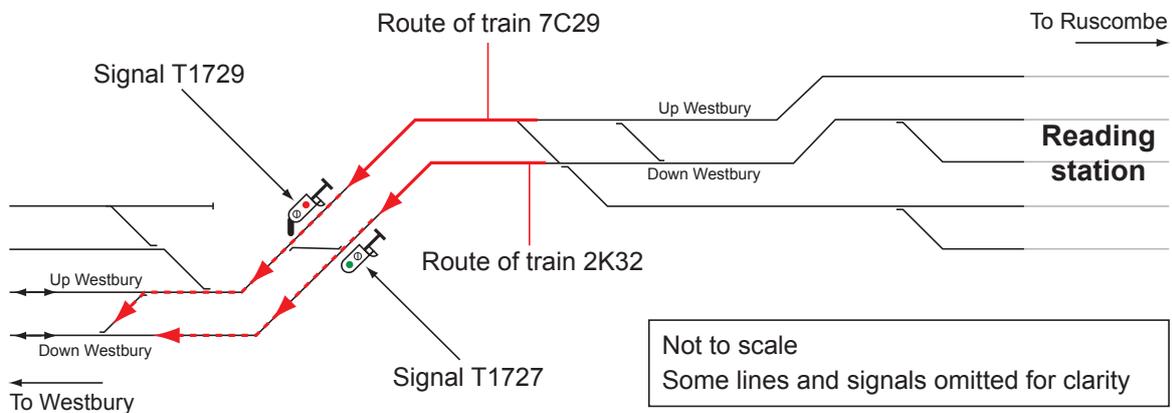
- 7 T1729 is a four-aspect LED signal located on the right-hand side of the *bidirectional* Up Westbury line at 36 miles 29 *chains*, approaching Reading Westbury Line Junction to the west of Reading station (figure 2). For the path that train 7C29 took on 28 March 2015, this signal is preceded by two similar four-aspect signals. Permissible speed at this location is 40 mph (64 km/h).
- 8 On the morning of 28 March 2015, signal T1729 was being held at danger because the parallel signal (T1727) was showing a proceed aspect to allow for the passage of passenger train 2K32 (figure 3).

Figure 3: Simplified track layout showing the location of signal T1729 and the intended paths of both trains

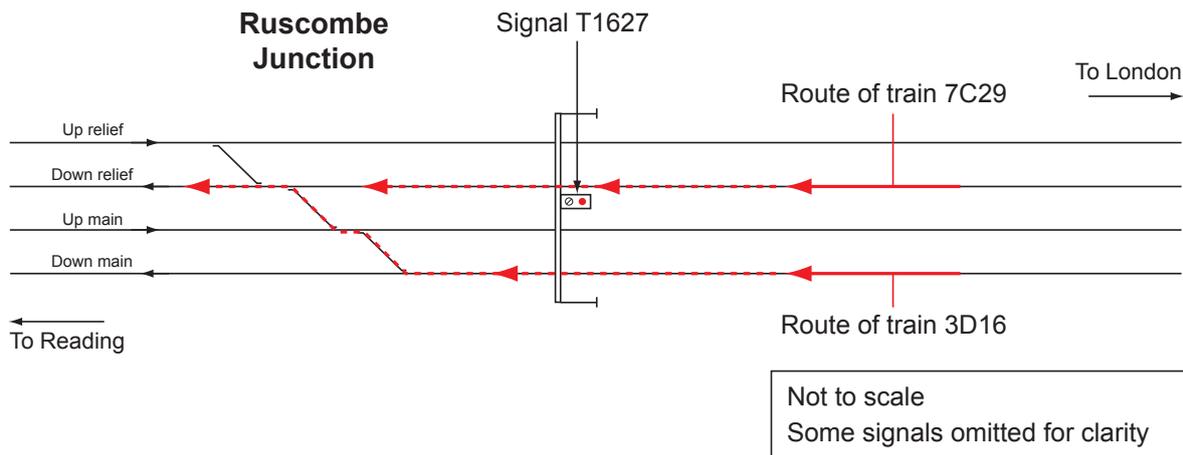
- 10 When the incident occurred on 3 November 2015, signal T1627 was showing a red aspect, protecting a route which had been set for train 3D16, an empty high speed passenger train (HST), to cross from the Down Main to the Down Relief line at Ruscombe Junction (figure 5).

Figure 5: Simplified track layout showing the location of signal T1627
