RAILROAD ACCIDENT INVESTIGATION.

REPORT NO. 4168 LIBRARY

CHICAGO, ROCK ISLAND AND PACIFIC RAILROAD COMPANY

UNION, MISSOURI

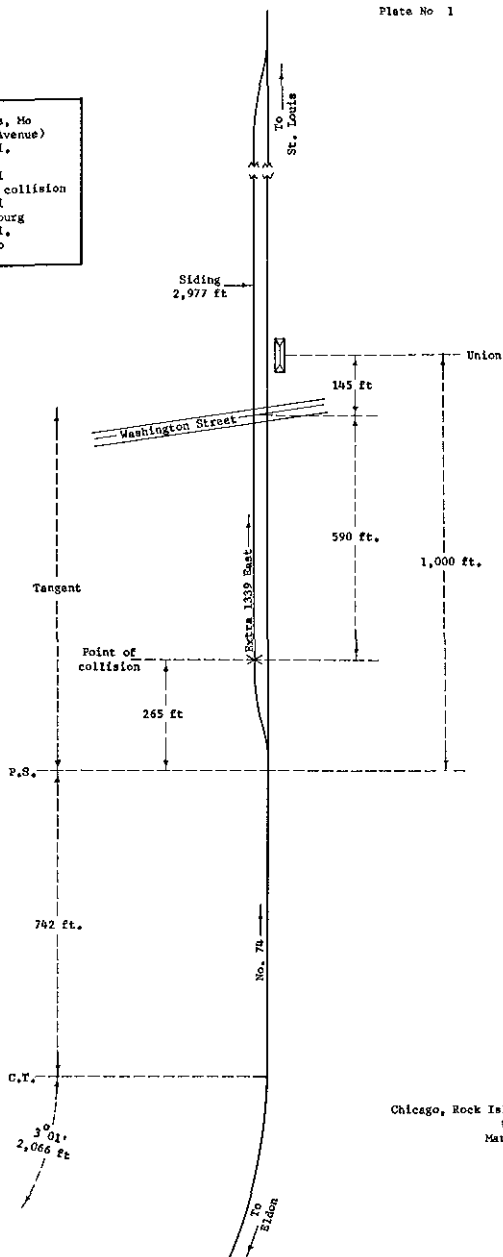
West siding-switch at Union, from distance of 310 feet.

At the time of the collision, the switch stand for the west switch of the siding at Union had neither a switch lamp nor a reflectorized target. This condition was brought to the attention of the Missouri Public Service Commission two days after the accident, the State agency initiated action to ensure the CRI&P's compliance with the order of September 10, 1968.

2 Failure of the conductor of Extra 1339 East to restore the west siding-switch at Union to normal position after his train entered the siding and cleared the main track was the primary cause of the accident. The reason for this failure appears to be that due to fatigue resulting from having been up and about for 23 or 24 hours, the conductor forgot to restore the switch to proper position, lined for movements on the main track.

5. Apparently because of it being somewhat dark at the time, the engineer of No. 74 did not notice the west switch of the Union siding was improperly lined before reaching a point a relatively short distance from the switch.
