RAILROAD ACCIDENT INVESTIGATION

REPORT NO 4173

UNION PACIFIC RAILROAD COMPANY

ATCHISON, TOPEKA AND SANTA FE RAILWAY COMPANY

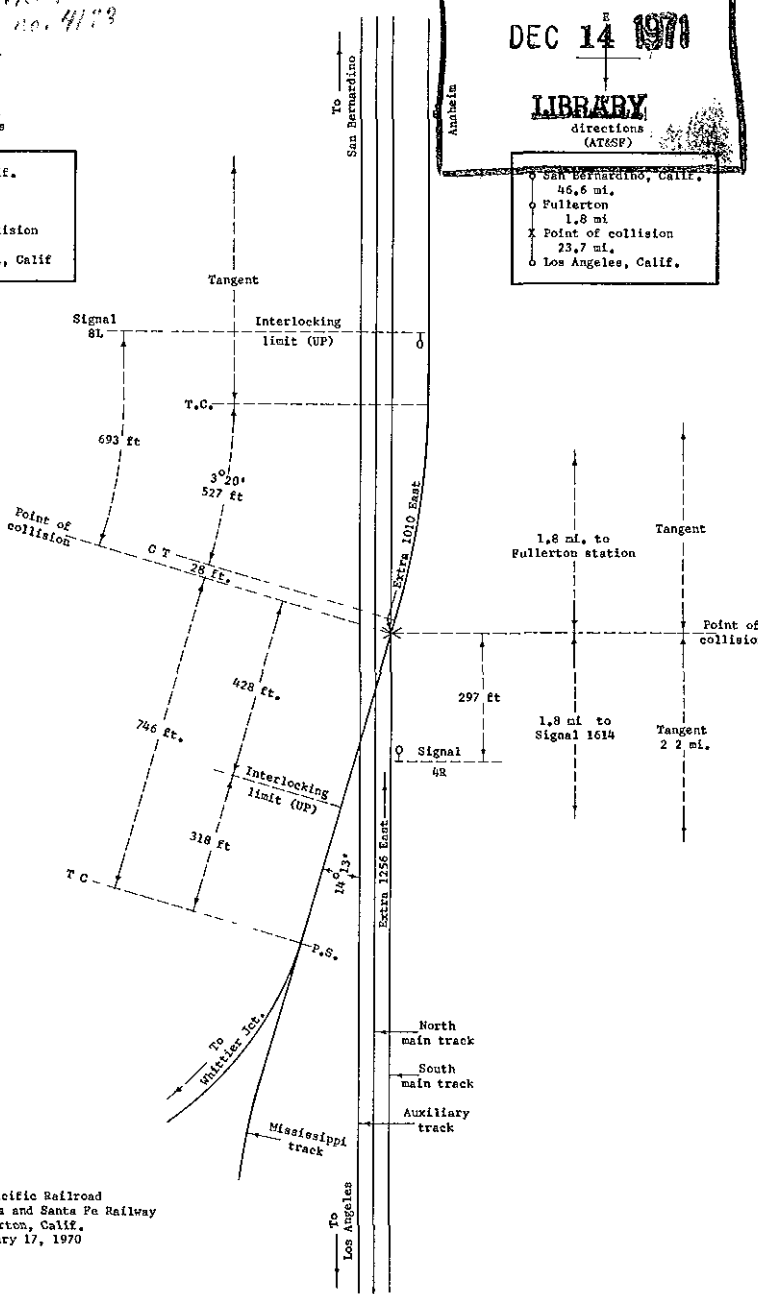
- San Bernardino, Calif. 46.6 mi.
- Fullerton 1.8 mi.
- X Point of collision 23.7 mi.
- Los Angeles, Calif.

- Anaheim, Calif. 2.7 mi.
- Fullerton 1.8 mi.
- X Point of collision 15.5 mi.
- Whittier Jct., Calif.

Union Pacific Railroad  
Atchison, Topeka and Santa Fe Railway  
Fullerton, Calif.  
February 17, 1970
