INTERSTATE COMMERCE COMMISSION

**REPORT OF THE DIRECTOR OF THE BUREAU OF SAFETY IN RE
INVESTIGATION OF AN ACCIDENT WHICH OCCURRED ON THE
LINE OF THE KEY SYSTEM TRANSIT COMPANY AT OAKLAND,
CALIF, DECEMBER 4, 1924**

JANUARY 12, 1925

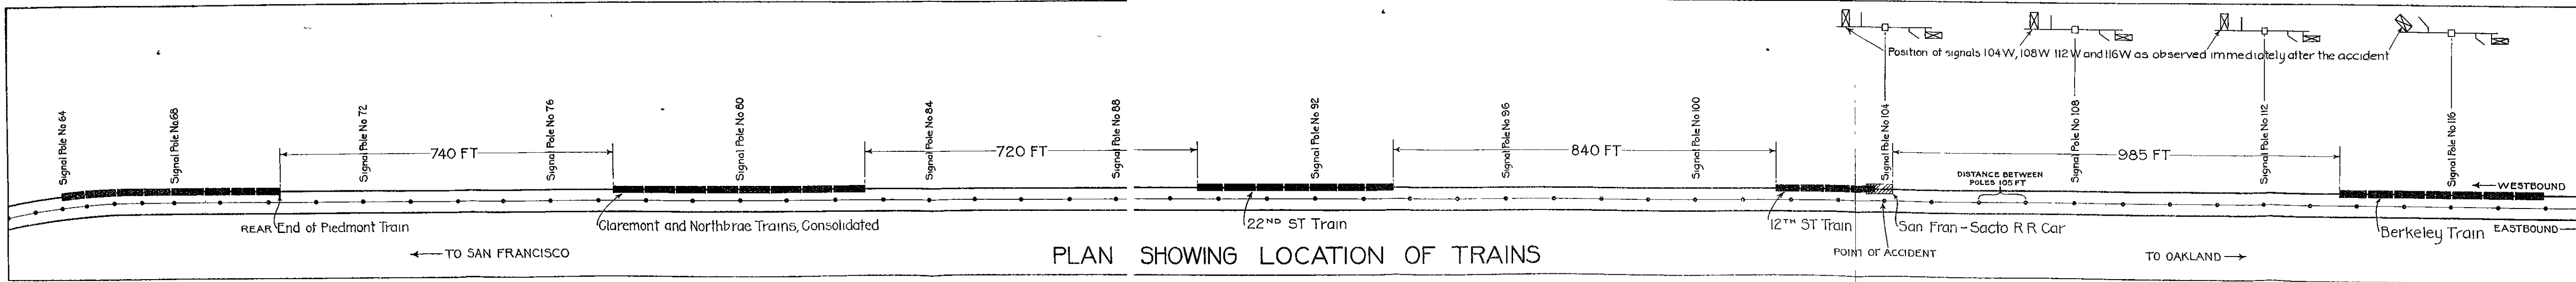
Signal 104 is located 11,321 feet west of signal 46 at tower No. 2. Approaching the point of accident from signal 46 the track is tan-

gent for a distance of 6,197 feet, then there is a 30' curve to the right 633 72 feet in length, followed by 4,491 feet of tangent to signal 104, the tangent extending a considerable distance beyond that signal. The accident occurred practically opposite signal 104, located at a point about 1½ miles east of the Pier Terminal, at about 7 54 a. m.
