INTERSTATE COMMERCE COMMISSION

REPORT OF THE DIRECTOR OF THE BUREAU OF SAFETY CONCERNING AN
ACCIDENT AT THE INTERSECTION OF THE TRACKS OF THE ILLINOIS
CENTRAL RAILROAD AND THE CHICAGO AND EASTERN ILLINOIS
RAILWAY AT MARION, ILL., ON AUGUST 3, 1933.

Inv. No. 1841
Illinois Central RR
Chicago & Eastern Illinois Ry
Marion, Ill.
August 3, 1933.

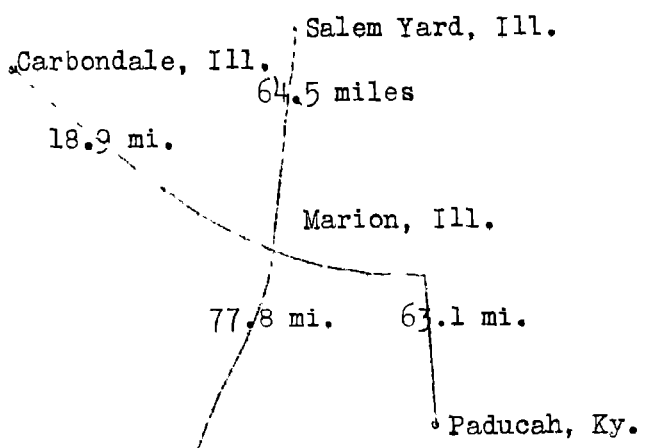
There are no signals at this crossing, the only protection afforded consisting of stop signs; the sign for south-bound IC trains is located on the south side of the track 310 feet west of the crossing, while the stop sign for north-bound C&EI trains is located on the west side of the track 221 feet south of the crossing. These stop signs also govern the crossing on each line of a Missouri Pacific track which cross at an angle from the northwest to the southeast. The stop board on the C&EI is black with white letters and has a lamp just above it, while the board on the IC line is unpainted, the letters being completely obliterated.

IC eng. cab 358 ft. from Xing. Pilot at stop board. Clear view of C&EI engine 86 ft. from crossing.

C&EI eng. cab 256 ft. from Xing. Pilot at stop board. Clear view of IC eng. coming from behind tanks
