INVESTIGATION NO. 2675
THE NEW YORK CENTRAL RAILROAD COMPANY
REPORT IN RE ACCIDENT
AT UTICA, N. Y., ON
FEBRUARY 13, 1943

Railroad: New York Central
Date: February 13, 1943
Location: Utica, N. Y.
Kind of accident: Derailment
Train involved: Freight
Train number: Extra 2774 East
Engine number: 2774
Consist: 81 cars, caboose
Speed: 25-30 m. p. h.
Operation: Automatic block-signal and
automatic train-stop system
Track: 4; 1°02' left curve;
practically level
Weather: Snowing
Time: About 5:50 p. m.
Casualties: 1 killed; 3 injured
Cause: Accident caused by a broken
truck side-frame

Accident at Utica, N. Y., on February 13, 1943, caused by
a broken truck side-frame.

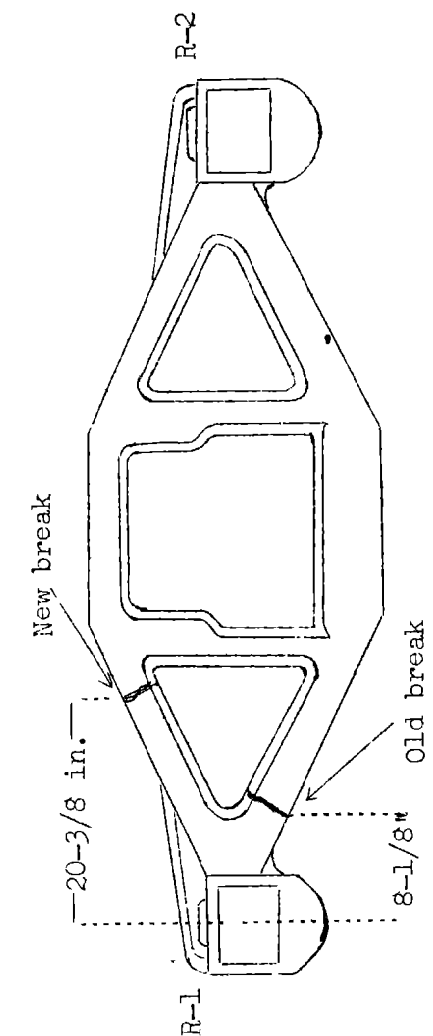
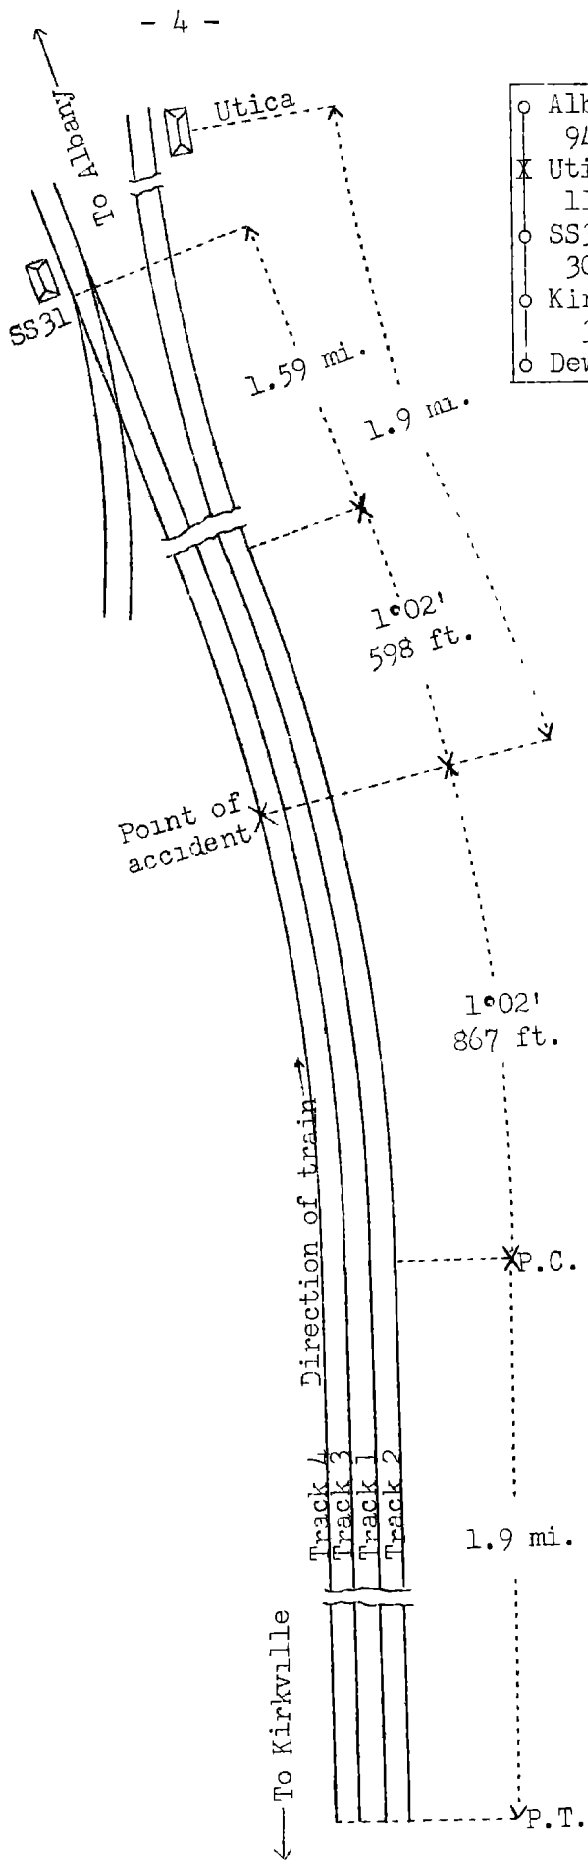
Cross section of tension member

After the accident the right side-frame was found to be broken through the compression member and the tension member at points, respectively, 20-3/8 inches and 8-1/8 inches ahead of the center-line of the rear journal box. The fracture in the compression member was new and there was no evidence of defective metal. The fracture in the tension member was 10 percent old break through the outside wall and 20 percent through the inside wall.

porosity present. The fracture through the compression member was new, but 10 percent of the cross-sectional area of the outside wall of the tension member and 20 percent of the inside wall were old breaks. The fracture of the tension member occurred 8-1/2 inches ahead of the center-line of the rear journal box. The old fracture extended from the beaded edge downward 1-5/8 inches in the outside wall and 1-5/4 inches in the inside wall. The fracture of the bottom part was new; however, sand holes were present and a gas pocket, which was 1/8 inch wide at the top and 3/8 inch wide at the bottom, extended throughout this member 1-1/2 inches inward from the outer surface. Areas adjacent to the fracture of the tension member indicated that welding had produced added cross-sectional area to the beading and that the old fractures had originated in this built-up portion. Near the front journal-box, several cracks were found in the beaded portion of the tension member but there was no evidence of fracture at these points. Throughout the side-frame considerable oxidation existed and fractures that had not opened could not be detected by ordinary inspection.
