INVESTIGATION NO. 2751  
THE ATLANTIC COAST LINE RAILROAD COMPANY  
REPORT IN RE ACCIDENT  
NEAR RENNERT, N. C., ON  
DECEMBER 16, 1943

Railroad: Atlantic Coast Line  
Date: December 16, 1943  
Location: Rennert, N. C.  
Kind of accident: Side collision  
Trains involved: Passenger : Passenger  
Train numbers: 91 : 8  
Engine numbers: Diesel-electric : Diesel-electric  
units 515-753-514 : units 506-503-500  
Consist: 18 cars : 16 cars  
Estimated speed: Standing : 80 m. p. h.  
Operation: Timetable, train orders and  
automatic block-signal and  
automatic train-stop system  
Track: Double; tangent; 0.42 percent  
descending grade northward  
Weather: Clear  
Time: About 1:30 a. m.  
Casualties: 72 killed; 187 injured  
Cause: Failure to provide adequate  
protection for derailed cars  
which fouled adjacent main track

Accident near Rennert, N. C., on December 16, 1943, caused  
by failure to provide adequate protection for derailed  
cars which fouled adjacent main track.

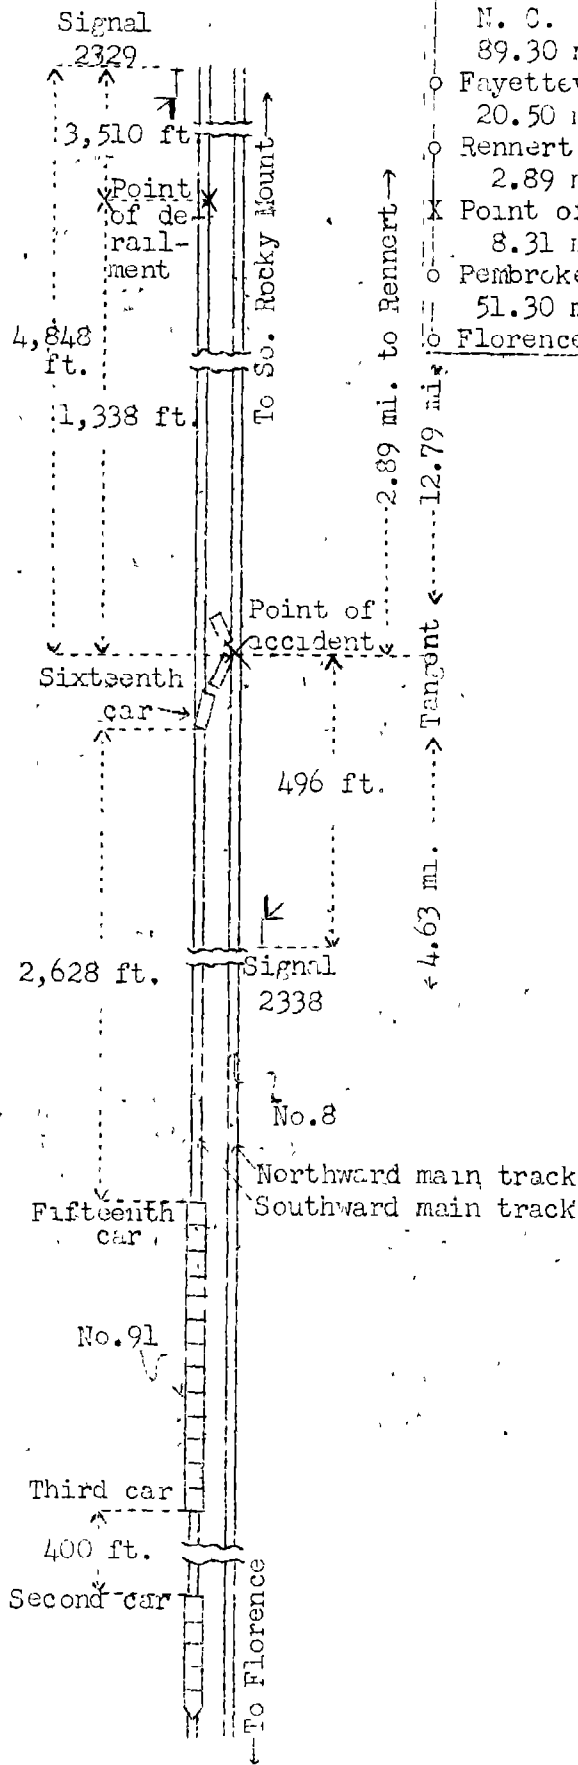
Sketch showing locations of fractures and transverse fissures in portion of rail recovered

After the accident a broken rail was found on the east side of the southward main track. The rail was broken into many pieces, 64 of which were recovered. The pieces were scattered throughout a distance of about 400 feet south of the point of derailment. The first break occurred between two ties at a point 5 feet 10-11/16 inches south of the receiving end of the rail. This piece of rail remained in normal position. At the first break there was a transverse fissure covering about 15 percent of the cross-sectional area of the head of the rail. At the second and third breaks, which occurred at points 7 feet 6-3/8 inches and 10 feet 2-1/8 inches south of the receiving end, there were transverse fissures covering, respectively, 1-1/2 percent and 15 percent of the cross-sectional area of the head. None of these fissures had progressed to the outer surface. Wheel marks on the rail at the south end of the third broken section indicated that the derailment occurred at that point. The other breaks in the rail appeared to have resulted during the derailment. Since the first automatic signal north of the broken rail displayed proceed and no abnormal condition of the track was felt when the front portion of No. 91 passed the point where the derailment occurred, it is apparent that the rail broke under the train. The track involved was last inspected by the section foreman from his motor-car on December 13, 1943, and no defective condition was found. A detector car was last operated over the track in this vicinity on October 17, 1943.
