# NATIONAL TRANSPORTATION SAFETY BOARD

## RAILROAD ACCIDENT REPORT<sub>ND.</sub>

REAR END COLLISION OF TWO  
CHICAGO TRANSIT AUTHORITY TRAINS  
NEAR THE MONTROSE AVENUE STATION  
CHICAGO, ILLINOIS  
AUGUST 17, 1984

NTSB/RAR-85/11.

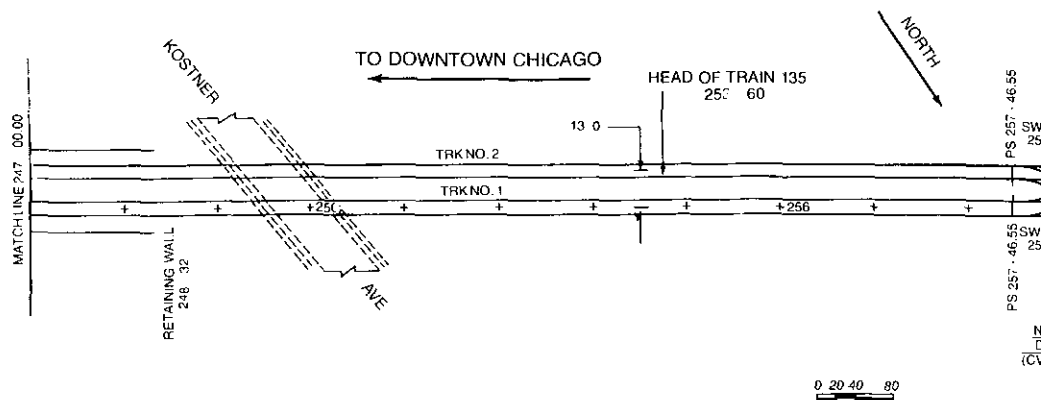
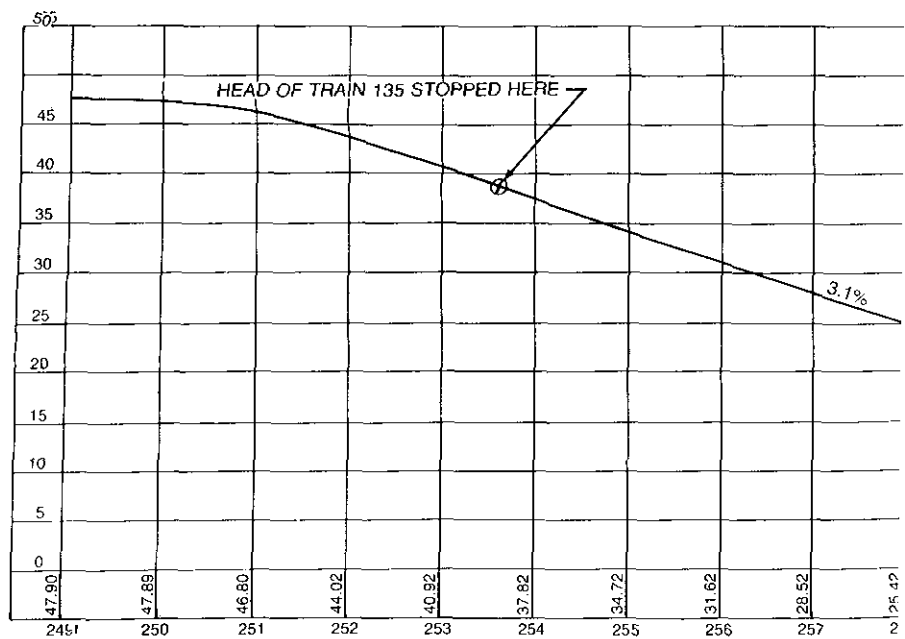
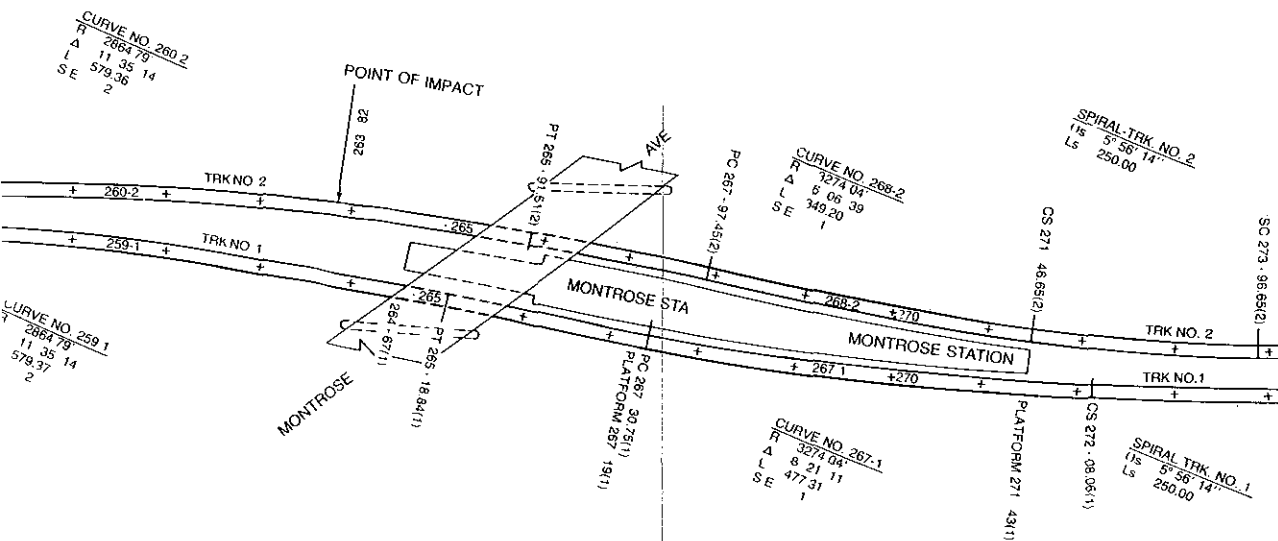
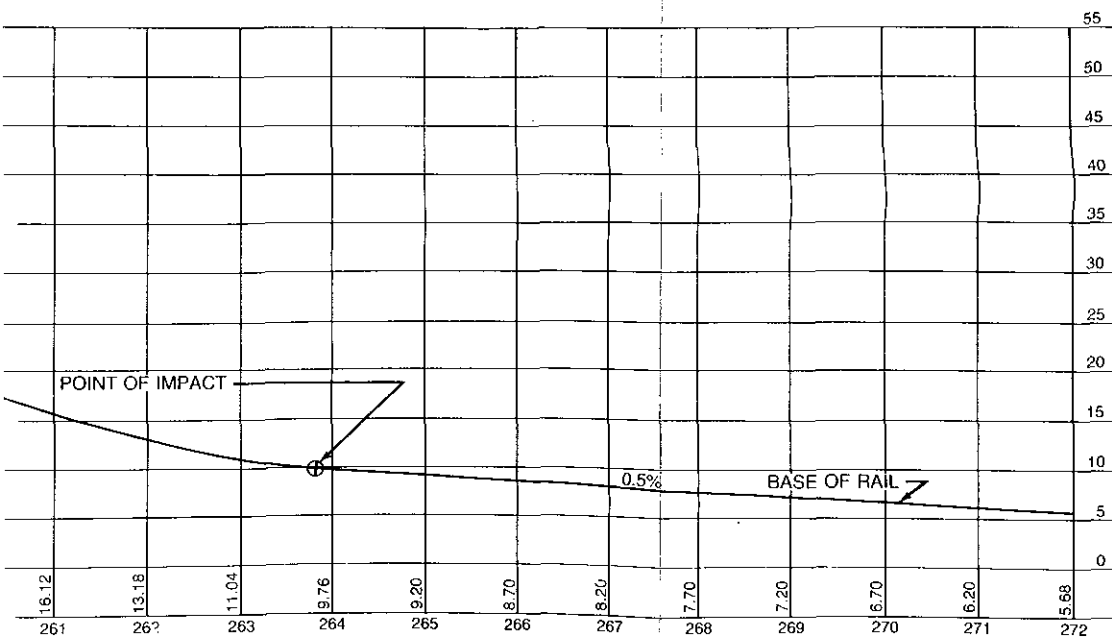
FIGURE 1 - - TRACK

After the train left the station and as it slowly ascended a 3.1-percent grade; the motorman saw "yellow dynamic" lights on the second and seventh cars. The train rolled to a stop just before reaching the top of the grade. (See figure 1.) The motorman stated that he "... put the train in power to move on," but the train did not move. The motorman decided to go back to the second car and pull the seven-point switch. <sup>2/</sup> He said he put the master controller in the off position, took out the master controller key, closed and locked the door of the operator's cab, and started back to the second car. The friction brakes were applied. He did not apply the track brakes. He did not notify the CTA Control Center (controller) that he had stopped or that he was troubleshooting.

The accident occurred on the CTA's west-northwest route, which extends from O'Hare International Airport southward to downtown Chicago. The west-northwest line is composed of a southbound and a northbound track, each paralleled by a third rail which supplies the traction power. The station at Montrose Avenue is located between the northbound and southbound tracks, just north of the Montrose Avenue overpass. (See figures 1 and 3.)
